Vehicle Collision or Rollover

Incident Overview Morenci, July 11, 2024 Bagdad, July 15, 2024

Actionable Event: Haul Truck Steering Wheel Came Off

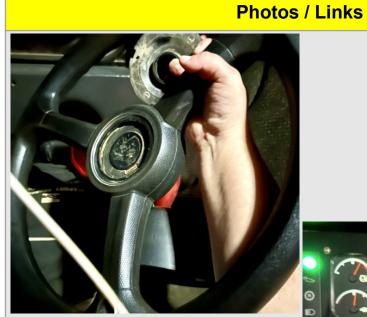
• Steering wheel retaining nut was loose.

Preliminary Incident Details	
Operation	Morenci
Date / Time	July 11, 2024 / 7:20 a.m.
Event Type	Near Miss
Summary	A haul truck operator was traveling uphill, at low speed, on the haul road when the steering wheel fell off. The operator was able to stay in their traffic lane and stop the truck. There was no exposure to oncoming traffic.
Risk Category	Actionable – Significant (3) Likely (3)
Findings / Missing Controls	 Steering wheel locknut was not torqued to specified 60 lb./ft. Quality check to verify torque specifications was not applied by service contractor. The verification was to be conducted as part of the action plan following a previous PFE incident with a similar failure.
Applicable Policies / Procedures	 Manufacturer (OEM) Caterpillar Steering Column Assembly (RENR2535-16)
Employee Condition	No injuries.
Contact	 Gary Anderson, Manager-Mine Maintenance Rassie Ras, Manager-Health and Safety

Detached haul truck steering wheel.

- Administrative Perform an audit of the steering wheel retaining nuts on all 789 and 793 Cat haul trucks.
 - Implement a white marking on all vehicles to signify the retaining nut has been audited and properly torqued.

Administrative – Add a torque inspection of the steering wheel retaining nut to the monthly preventative maintenance list for Cat haul trucks.

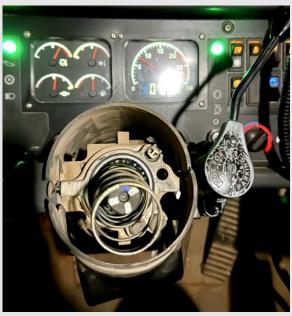
A photo showing the unsecure haul truck steering wheel locknut.

Administrative – Test a positive driving mechanism prototype for the steering wheel retaining nut. A global action item will be evaluated based on results.

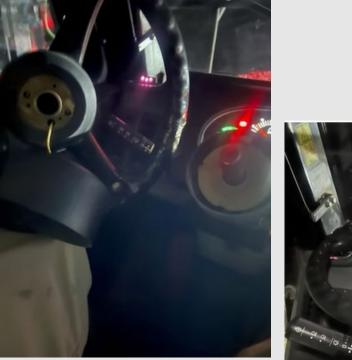
Preliminary Incident Details
Operation	Bagdad
Date / Time	July 15, 2024 / 6:49 a.m.
Event Type	Near Miss
Summary	A haul truck operator was preparing to reverse to a shovel when the steering wheel came off. The operator used the secondary brake to stop, put the truck in neutral and set the parking brake.
Risk Category	Actionable – Significant (3) Likely (3)
Findings / Missing Controls	 Steering wheel keeper nut was not torqued to proper specifications. Quality check to verify torque specifications was not applied by service contractor.
Applicable Policies / Procedures	 Manufacturer (OEM) Caterpillar Steering Column Assembly (RENR2535-16)
Employee Condition	No injuries.
Contact	Danielle Murphey, Sr. Supervisor-Industrial HygieneBenny Corbell, Manager-Mine

Detached steering wheel.

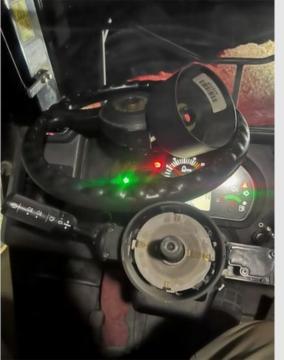
Steering wheel assembly after wheel was detached.
