Actionable Event: Lowboy Fender Falls

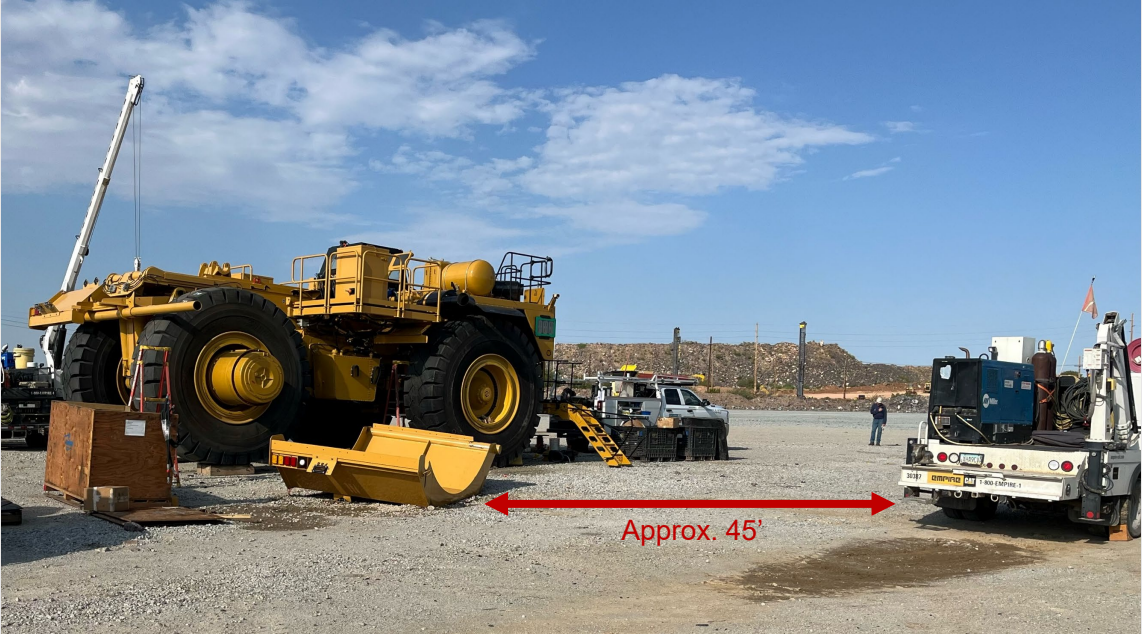
Preliminary Incident Details	
Operation	Bagdad
Date / Time	July 25, 2024 / 7:30 a.m.
Event Type	Near Miss
Summary	Contractor technicians were replacing a lowboy rear fender. The night crew positioned the fender with a crane but did not tack weld it in place before removing the crane and leaving site. The next morning, the fender fell to the ground as the day crew was preparing for work approximately 45 feet away.
Risk Category	Actionable – Significant (3) Likely (3)
Findings / Missing Controls	<ul style="list-style-type: none">• Failure to follow standard operating procedure.• Failure to stop work when a welder was unavailable during the evening shift.
Applicable Policies / Procedures	<ul style="list-style-type: none">• Contractor standard work practice• FCX-HS32 Crane and Rigging Policy
Employee Condition	<ul style="list-style-type: none">• No injuries.
Contact	<ul style="list-style-type: none">• Danielle Murphey, Sr. Supervisor-Industrial Hygiene• Benny Corbell, Manager-Mine

Lowboy fender after falling to ground (approximately 45 feet to crew members gathered at truck).
