Potential Fatal Event: Employee Jumps from Crane Counterweight

FREEPORT-McMoRAN PFE # 2024-20 Event ID # 20017409

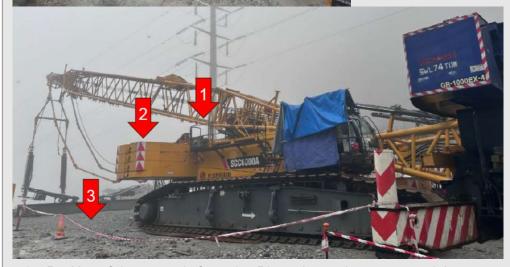
Super lift mast collapsed backward over car body.

- 1 Position of rigger on platform. 2 Rigger jumped to counterweight.
- 3 Location rigger landed after jump.
