Uncontrolled
Release of Energy

Potential Fatal Event: Mechanic Struck with Metal Wedge

Preliminary Incident Details

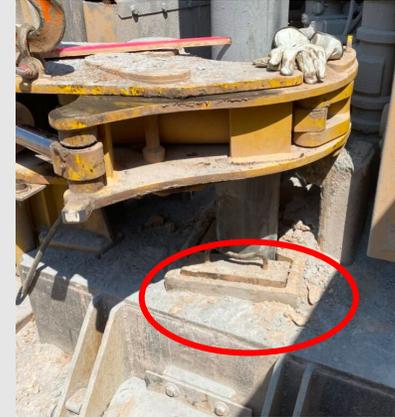
Position where steel wedge was installed and later dislodged.

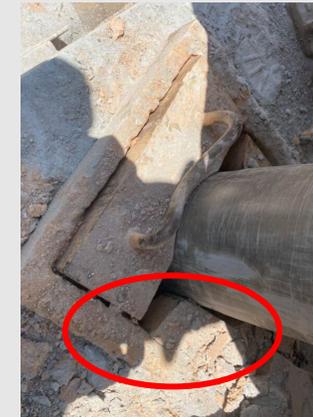
Top view where steel wedge was installed and later dislodged.

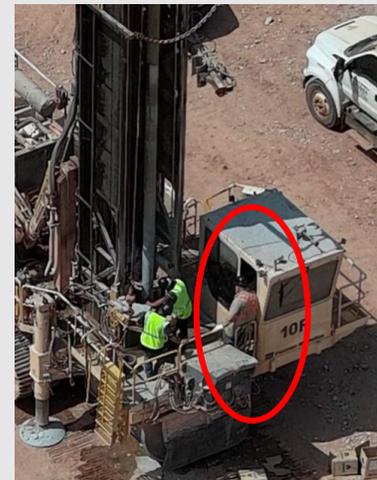
Position where the mechanic was standing at the time of the event.

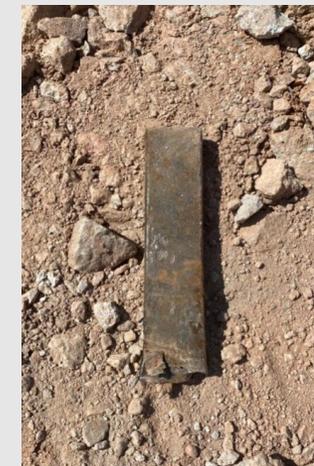
Steel wedge (3 lbs) landed 51ft from the drill.
