Freeport Safety Updates

April 2024

(Incidents and Communications from March 2024)

Freeport Safety Incidents, Successes, & Alerts

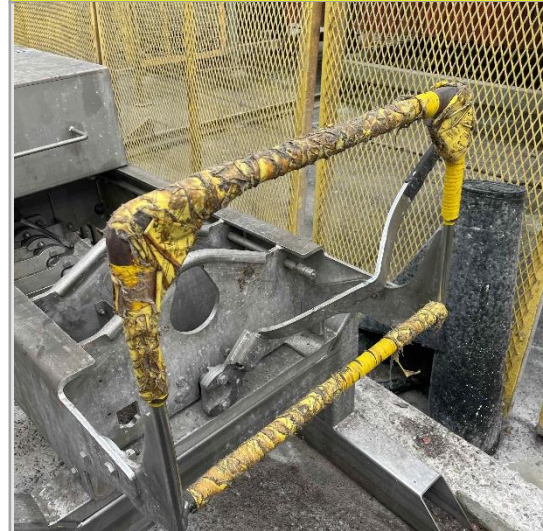
Operation	Chino
Date / Time	March 6, 2024 / 12:30 p.m.
Event Type	Injury, first aid – electrical shock
Summary	A crane operator was harvesting cathodes from cell 8 inside a jumper frame. The employee was removing the second pull when a wet pantleg came into contact with the jumper frame above the boot. The operator sustained a minor shock.
Risk Category	Actionable – Significant (3) Likely (3)
Findings / Missing Controls	<ul style="list-style-type: none"> The insulator on the crane hook was wet and offered no insulating value (showed no resistance) The insulating material on the strongback was worn
Applicable Policies / Procedures	FCX Policy - EW ER Electrical Safety Rev. 2.pdf
Employee Condition	Employee was evaluated and released to full duty.
Contact	Jim Cook, Manager-Health and Safety

Strongback handle

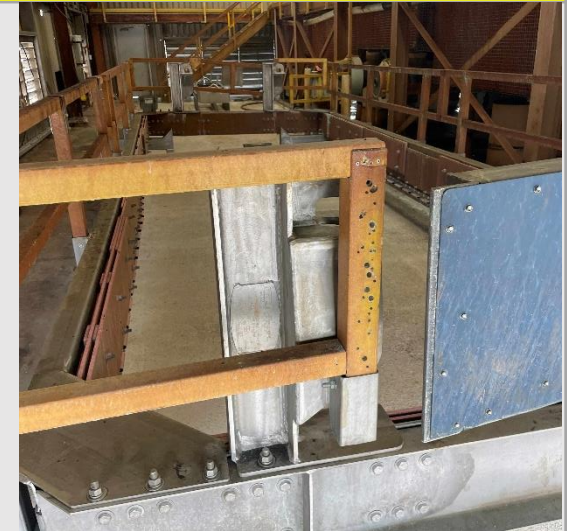
Area the operator's leg contacted the jumper frame

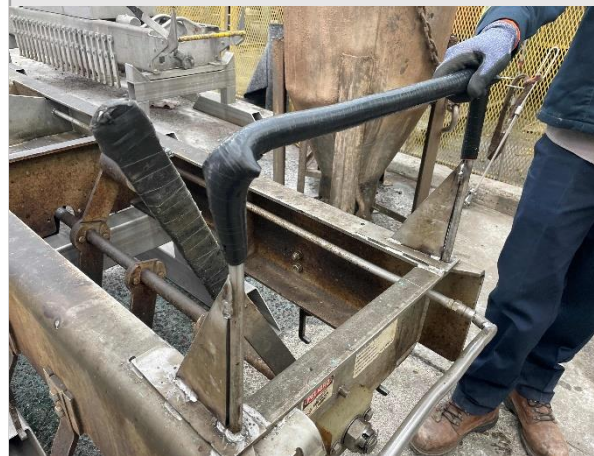
Handle with replaced insulation

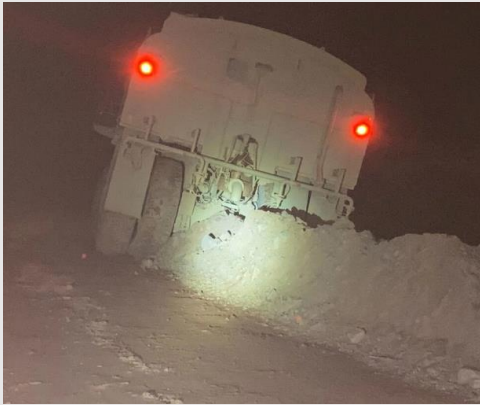
Operation	Morenci
Date / Time	March 10, 2024 / 2:05 a.m.
Event Type	Property Damage
Summary	During a second run to water drills, a water truck was travelling on a ramp with approximately 10,000 gallons of water in the tank. At the top of the ramp, the operator identified the area was no longer adequate to safely turn around without running over drill holes. The operator decided to back down the ramp to exit the work area. While backing down, the truck drove through a berm and was high centered at a 45-degree angle. On the other side of the berm was an approximate 180-foot drop.
Risk Category	Actionable – Significant (3) Likely (3)
Findings / Missing Controls	<ul style="list-style-type: none"> Berms were sufficient height and width Operator failed to follow operating procedure inhibiting reverse travel with water load
Applicable Policies / Procedures	Applicable Morenci SOP
Employee Condition	No injuries

Water truck on berm

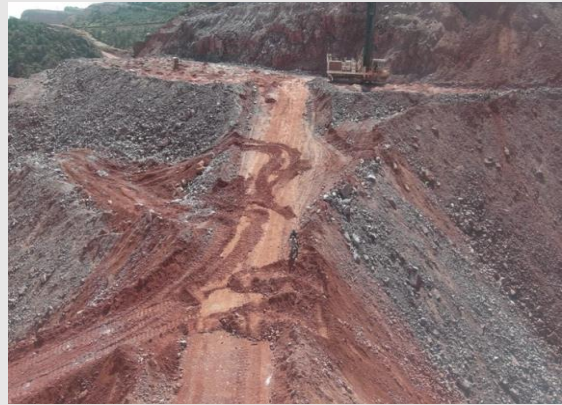
Water truck tire marks on ramp and impacted berm

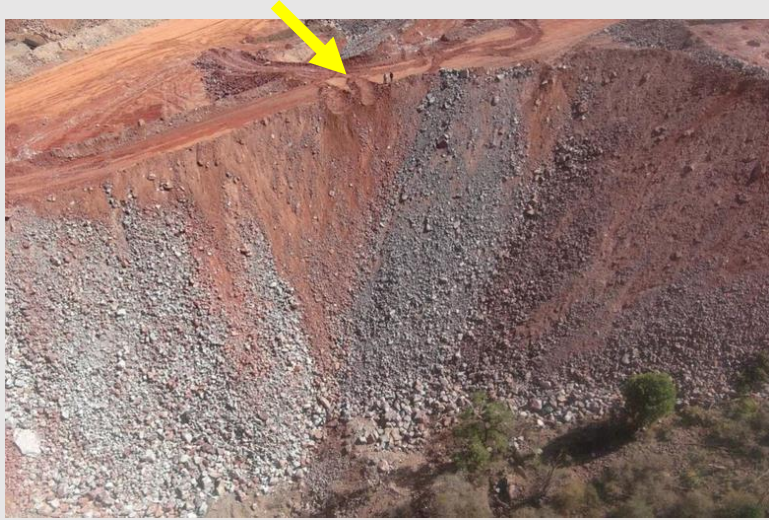
Arrow points to location of water truck on berm

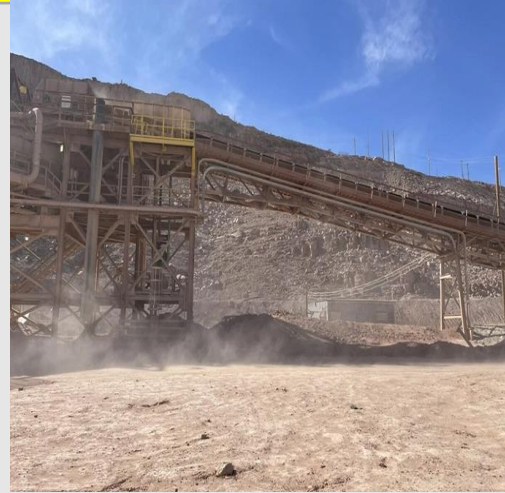
Operation	Morenci
Date / Time	March 11, 2024 / 1:15 p.m.
Event Type	Near Miss
Summary	A contractor crew was cleaning buildup underneath the head end of a conveyor near the transfer tower. While on their lunch break and stationed across the street, the crew witnessed a return idler that fell 20 feet down from the conveyor. The idler landed close to the crew's working area. The conveyor was running, the idler was mounted and in use at the time of the event.
Risk Category	Actionable – Significant (3) Likely (3)
Findings / Missing Controls	<ul style="list-style-type: none"> • Conveyor was left on while unattended • Need to set up segregation or turn off belt while unattended • No baskets or guarding were used under the idler
Applicable Policies / Procedures	N/A
Employee Condition	No injuries
Contact	Corina Rodriguez- Senior Supervisor-Health and Safety

Location where idler fell

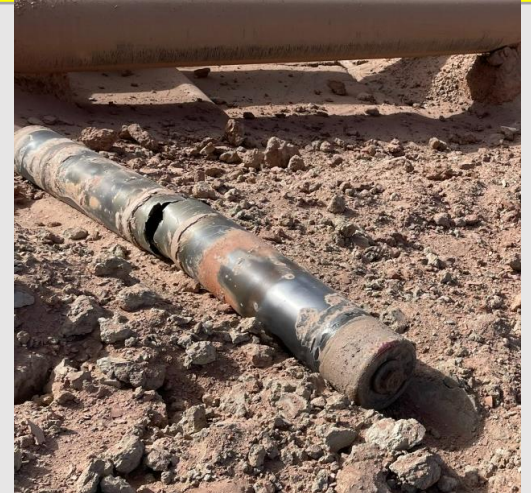
Worn idler that fell from conveyor

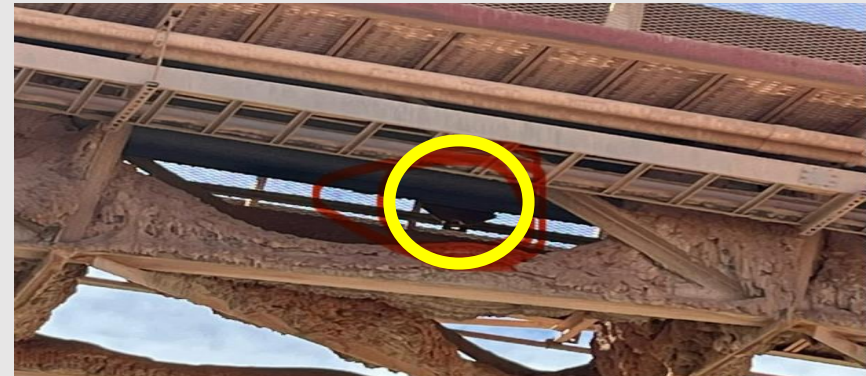
Idler fell from section of conveyor circled in yellow

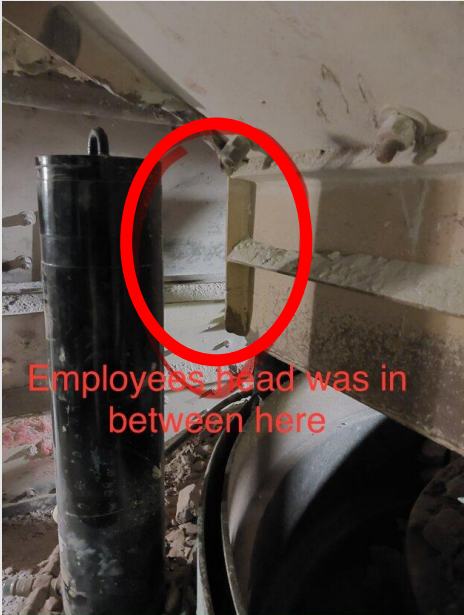
Preliminary Incident Details	
Operation	Morenci
Date / Time	March 22, 2024 / 9:20 p.m.
Event Type	Injury – First Aid
Summary	While attempting to clean out material in a 2B shorthead, an employee’s head became stuck between the mill locking post and discharge chute. When the employee realized they were stuck, they tapped a supervisor’s shoulder. The equipment was backed off, and the employee was released.
Risk Category	Actionable – Significant (3) Likely (3)
Findings / Missing Controls	Control of Hazardous Energy
Applicable Policies / Procedures	FCX HS04 Control of Hazardous Energy
Employee Condition	Employee was treated by first aid
Contact	Jacob Sweet, Manager-Health & Safety Jason Bartlett, Manager-Mill

Pinch Point – Hydraulic ram and feeder

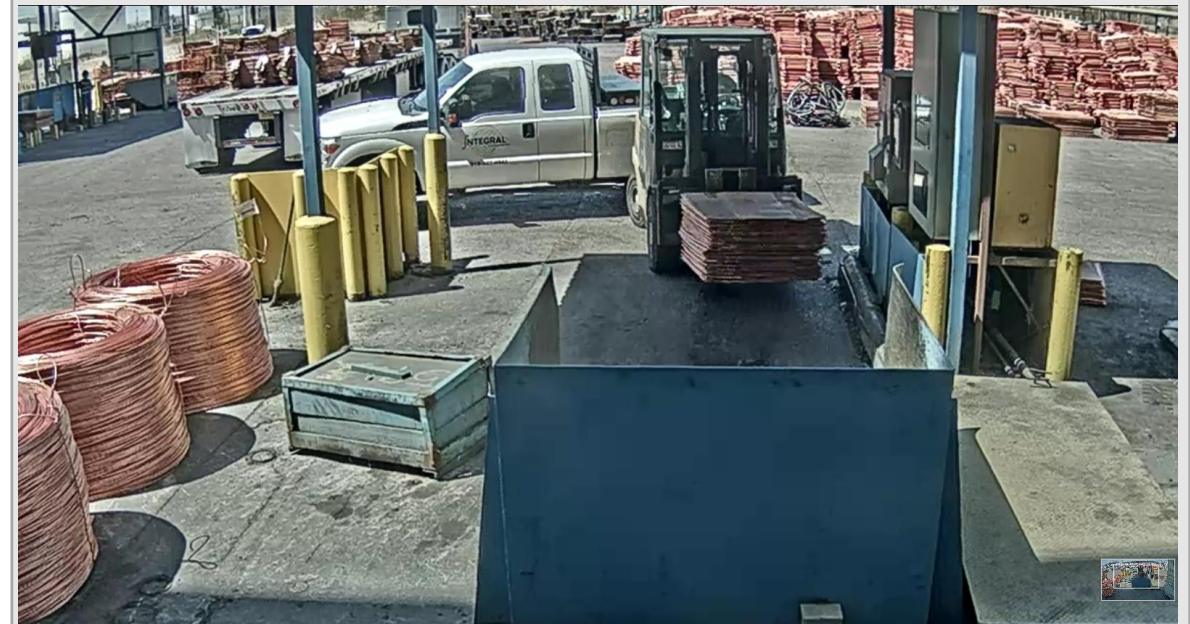
Operation	El Paso
Date / Time	March 22, 2024 / 1:32 p.m.
Event Type	Property Damage
Summary	A forklift operator was weighing a cathode bundle at the scale. When complete, the operator reversed and struck a travelling pickup truck. Both operators failed to look in the direction of travel and identify other mobile equipment in the area. Both continued work without stopping.
Risk Category	Actionable – Significant (3) Likely (3)
Findings / Missing Controls	<ul style="list-style-type: none"> • Failure to make eye contact with equipment operators • Failure to yield to moving equipment • Failure to look in direction of travel • Failure to utilize horn signals for movement notification
Applicable Policies / Procedures	<ul style="list-style-type: none"> • SAF-0220 Powered industrial equipment operations
Employee Condition	No employees were injured.
Contact	Roland Ruybe, Manager-Health & Safety

Position of forklift and truck upon collision.

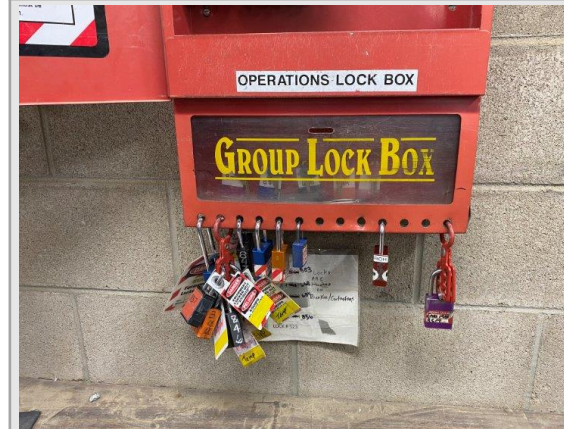
Operation	Henderson
Date / Time	March 22, 2024 / 8:20 a.m.
Event Type	Near Miss
Summary	Four contractor employees were working to align a belt system motor next to a gear box and break disk with removed guarding. The energy control coordinator (ECC) released the belt brake to initiate the lock out process which caused the belt to move one foot. Contractor employees recognized the system was not locked out and notified site supervision.
Risk Category	Actionable – Significant (3) Likely (3)
Findings / Missing Controls	<ul style="list-style-type: none"> Lack of lock out, tag out, try out (LOTOTO) Contractor missed ECC radio notification
Applicable Policies / Procedures	<ul style="list-style-type: none"> Henderson Operations LOTOTO Program FCX HS04 Control of Hazardous Energy
Employee Condition	No employees were injured.
Contact	Benjamin Goertz, Manager-Health & Safety

Operations lock box. Contractor was locked on this box without the ECC lock.

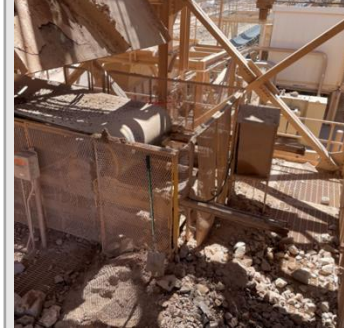
Operation	Morenci
Date / Time	March 27, 2024 / 9 a.m.
Event Type	Injury – First Aid
Summary	A contractor employee was cleaning a tail pulley belt on crusher level one when struck on the head by a rock weighing about 30 pounds. The rock fell from an upper-level dribble shoot where other crews were actively working nearby.
Risk Category	Actionable – Significant (3) Likely (3)
Findings / Missing Controls	<ul style="list-style-type: none"> • Failure to conduct line out prior to task start. • Failure to identify loose material. • Failure to identify employee work locations. Crews should not be working directly above other workers.
Applicable Policies / Procedures	<ul style="list-style-type: none"> • FCX-HS19 Flagging and Barricading • FCX-HS02 Working at Heights
Employee Condition	The employee was transported for evaluation and was released for full duty.
Contact	Jacob Sweet, Manager-Health and Safety

Area where rock fell.

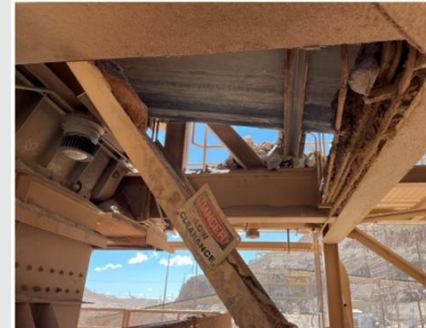
Spillage on edge of support beams over dribble chute on second level.

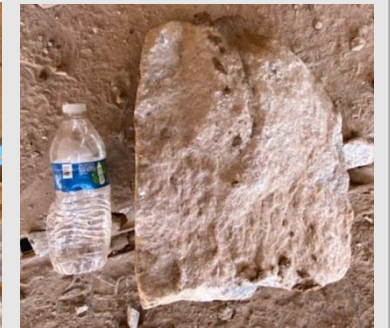
Rock size.

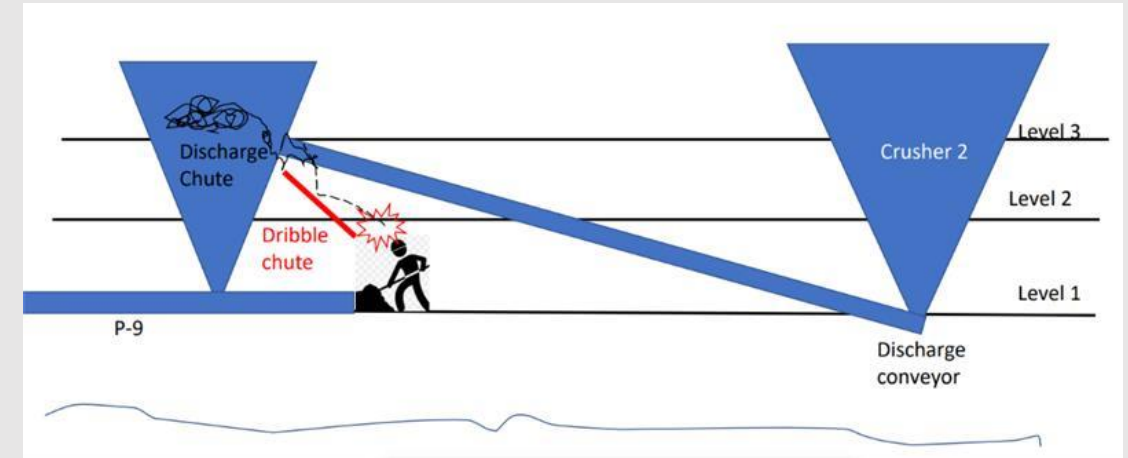
Illustration of work area and location of affected contractor.

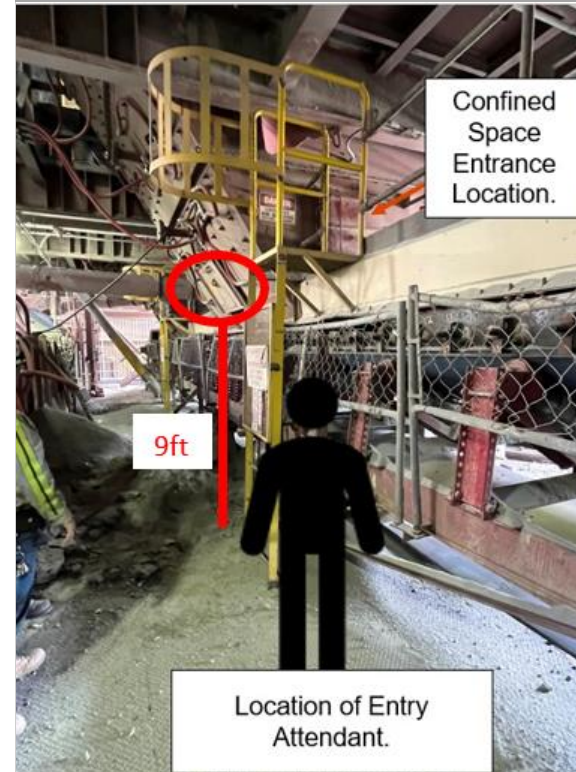
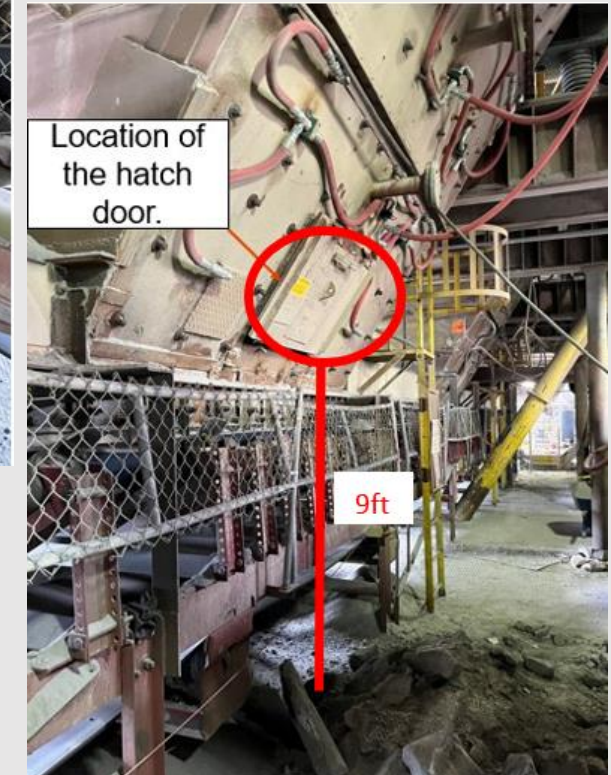
Operation	Sierrita
Date / Time	March 28, 2024 / 8:30 a.m.
Event Type	Near Miss
Summary	Three employees were clearing deadbed material stuck on catch bars in the secondary chute. The confined space attendant opened a hatch on the north side of the chute to help improve access to the material. An employee inside the chute, unaware of the opened hatch, stepped on deadbed material covering the hatch, pushing one foot through the opening, and was exposed to a nine-foot fall.
Risk Category	Actionable – Significant (3) Likely (3)
Findings / Missing Controls	<ul style="list-style-type: none"> Lack of risk assessment Failure to communicate Failure to initiate stop work authority
Applicable Policies / Procedures	<ul style="list-style-type: none"> FCX-HS05 Confined Space FCX-HS02 Working at Heights FCX-HS04 Control of Hazardous Energy
Employee Condition	<ul style="list-style-type: none"> No injuries
Contact	<ul style="list-style-type: none"> Procopio Gonzales, Superintendent-Crush/Convey Cara Forbregd, Manager-Health and Safety

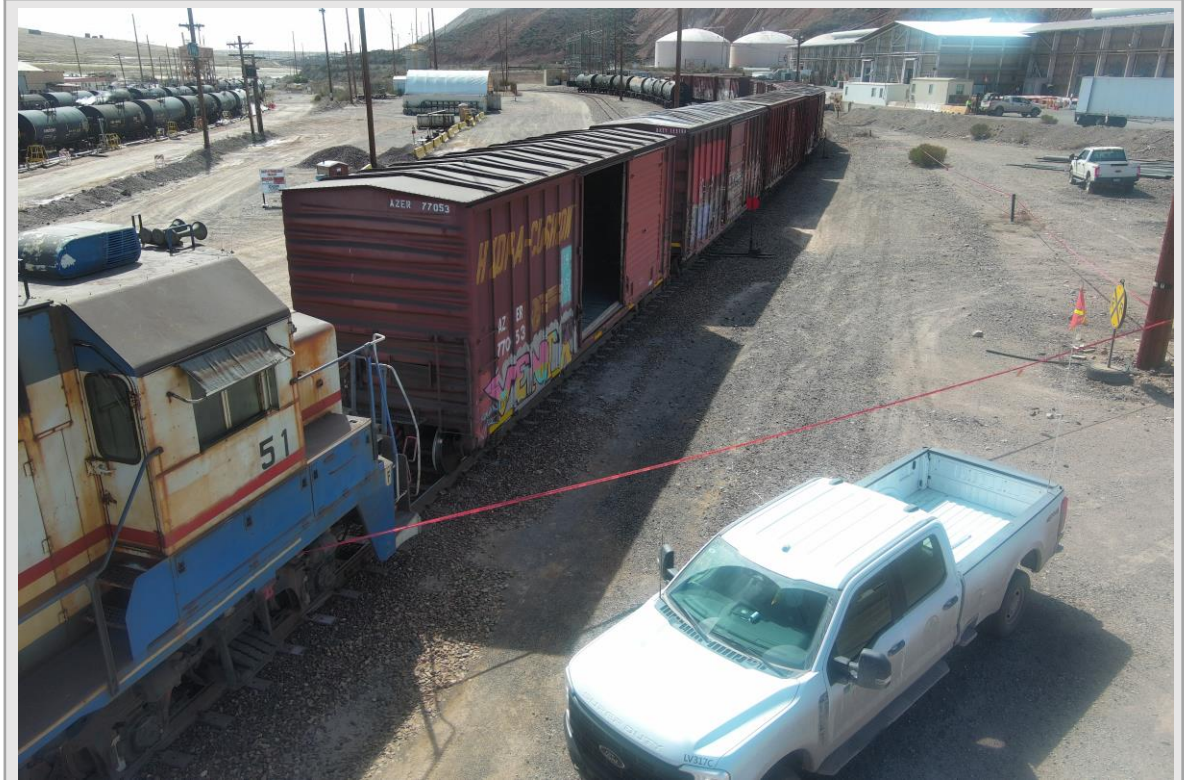
Operation	Morenci
Date / Time	March 5, 2024 / 11:00 a.m.
Event Type	Injury with Medical Treatment
Summary	The Industrial Railroad crew was switching out boxcars at the south side of a copper dock. The locomotive operator and a trainee were standing on the engine stairs and leaned out facing away from the direction of travel. While doing so, the operator's body struck a rail switch guard sign. The operator flipped over the handrail, landing face down on the ground. The operator's right arm landed on the track and was run over. A Mayday was called, and emergency services were dispatched to the area.
Risk Category	Actionable – Significant (3) Likely (3)
Findings / Missing Controls	<ul style="list-style-type: none"> Employee leaned out of moving train while standing on stairs At least 30 inches of continuous clearance from the farthest projection of moving railroad equipment was not maintained with rail switch guard sign placement

Employees were riding on the stairwell of the 51 locomotive when event occurred

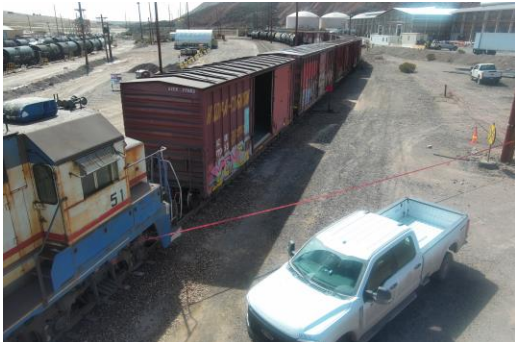
The Industrial Railroad crew was switching out boxcars at the south side of a copper dock. The locomotive operator and a trainee were standing on the engine stairs and leaned out facing away from the direction of travel. While doing so, the operator's body struck a rail switch guard sign. The operator flipped over the handrail, landing face down on the ground. The operator's right arm landed on the track and was run over. A Mayday was called, and emergency services were dispatched to the area.

- Locomotive operator and trainee leaned out from the engine stairs while facing away from the direction of travel.
- Clearance from the rail switch lever to the outside of rail cars was minimal.

- **Administrative Control** – Re-create a Global Railroad Steering Team to share best practices, standards, and findings amongst all sites. All relevant standard operating procedures, work standards and training records will be reviewed for deficiencies, then corrected.

- **Administrative Control** – Within 30 days, evaluate the Morenci rail system for unidentified impaired clearance situations (any distance under 30 inches) and high-risk areas (i.e., switches on steep grades).

- **Engineering Control** – Within 60 days, identify impaired distances that can be mitigated by extending switches, lowering switches or clearly marking impaired distances and mapping those switches (i.e., docks and unloading stands).

- **Elimination Control** – Conduct an assessment as outlined in the Freeport Industrial Railroad Policy section 3.4. Determine alternative means to minimizing or eliminating the need for train ground crews to mount/dismount a train in motion.

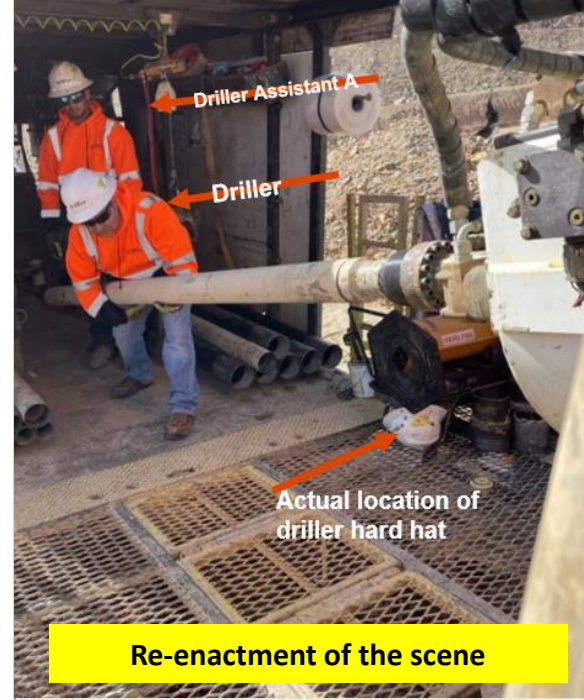
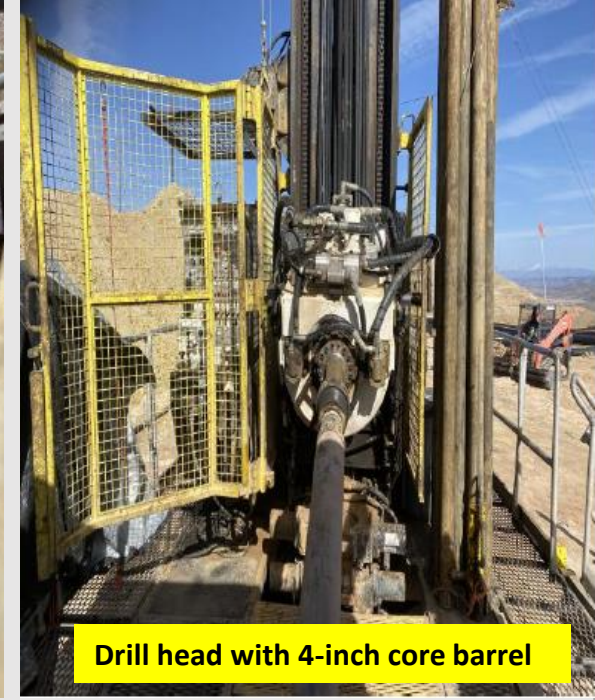
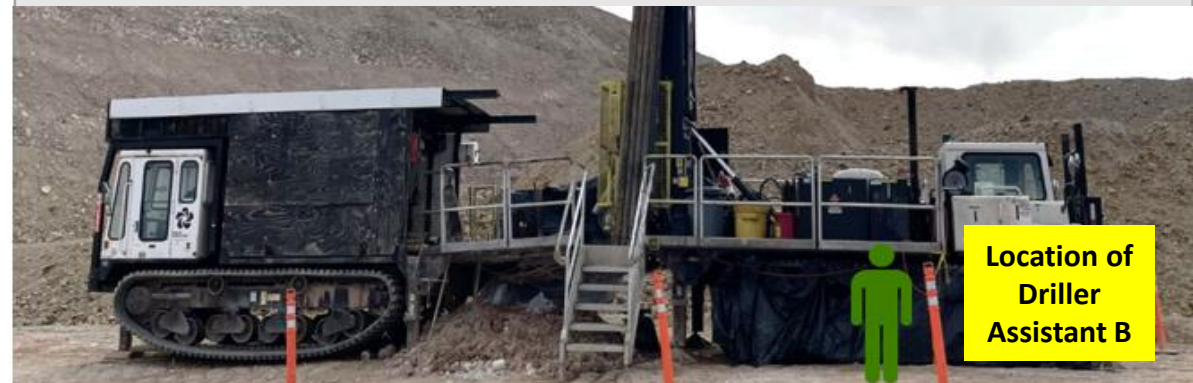
Operation	Tyrone
Date / Time	March 10, 2024 / 1:43 p.m.
Event Type	Lost Time Injury
Summary	A contractor driller became bound and entangled when their jacket snagged on a 4-inch core barrel as they tried to remove it from a running sonic drill. The assistant on deck and the one on the ground were unable to reach the emergency stop button based on their positions. The driller rotated with the core barrel until becoming unbound and sustained multiple injuries.
Risk Category	Actionable – Significant (3) Likely (3)
Findings / Missing Controls	<ul style="list-style-type: none"> • Failure to follow contractor standard operating procedure for barrel removal • Improper/missing tool for the task • Rotation Barrier Interlock was bypassed
Applicable Policies / Procedures	FCX-HS04 Control of Hazardous Energy Policy
Employee Condition	The driller sustained multiple injuries to the left leg requiring surgery as well as minor cuts and scrapes. They are expected to make a full recovery.

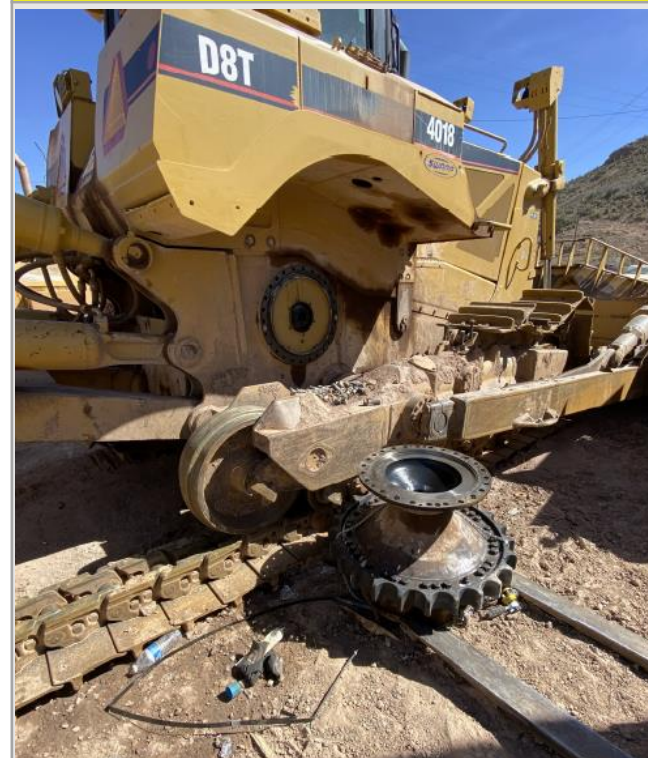
Operation	Morenci
Date / Time	March 12, 2024 / 11:45 a.m.
Event Type	Injury – First Aid
Summary	Two contractor mechanics were replacing a 1600-pound final drive on a D8 dozer with the assistance of a forklift. One mechanic was operating the forklift while the other mechanic was greasing the mounting seal. The loaded forklift, positioned 6 to 10 feet behind the mechanic, began to roll forward. The operator applied the brakes which caused the final drive to roll off the forklift. The ground mechanic’s leg became pinned between the final drive and the dozer.
Risk Category	PFE - Significant (3) Likely (3)
Findings / Missing Controls	<ul style="list-style-type: none"> Engineered lifting device was not used Forklift parking brake was not set Forklift load was not properly secured
Applicable Policies / Procedures	<ul style="list-style-type: none"> Lack of forklift applicable policies and procedures
Employee Condition	<ul style="list-style-type: none"> Mechanic – knee injury Forklift Operator – hand laceration from helping lift the final drive off the pinned mechanic

Final resting place of final drive after rotating off the forklift

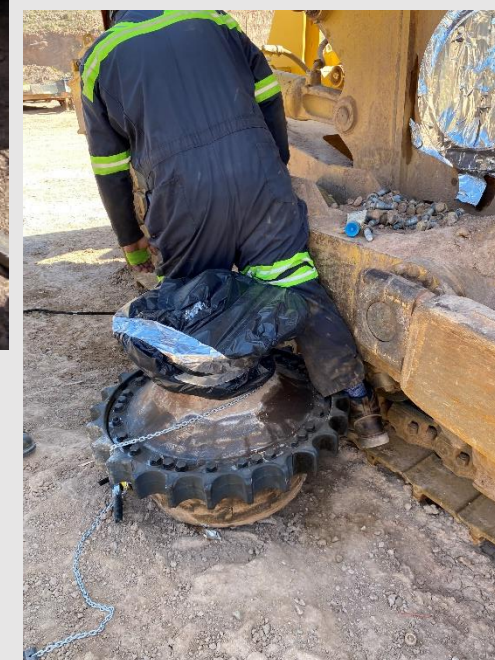
Re-enactment of employee’s leg pinned between final drive and D8

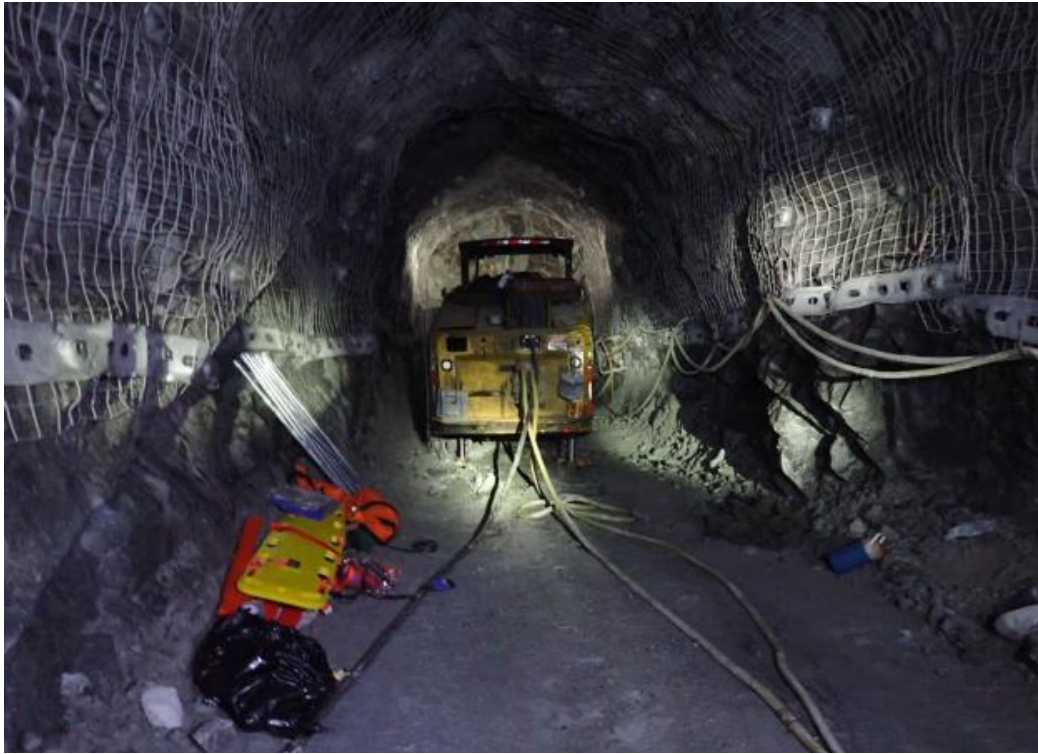
MINE FATALITY – On November 13, 2023, a rotating drill steel of a roof bolting machine entangled a miner, causing fatal injuries.

- Always follow manufacturer recommendations when conducting maintenance on equipment, including:
 - Turn off or de-energize the machine.
 - Secure the equipment against hazardous motion.
- Never touch or hold the drill steel, wrench, or bolt while it is rotating.
- Do not wear loose-fitting or bulky clothing when working around any machinery with rotating parts.

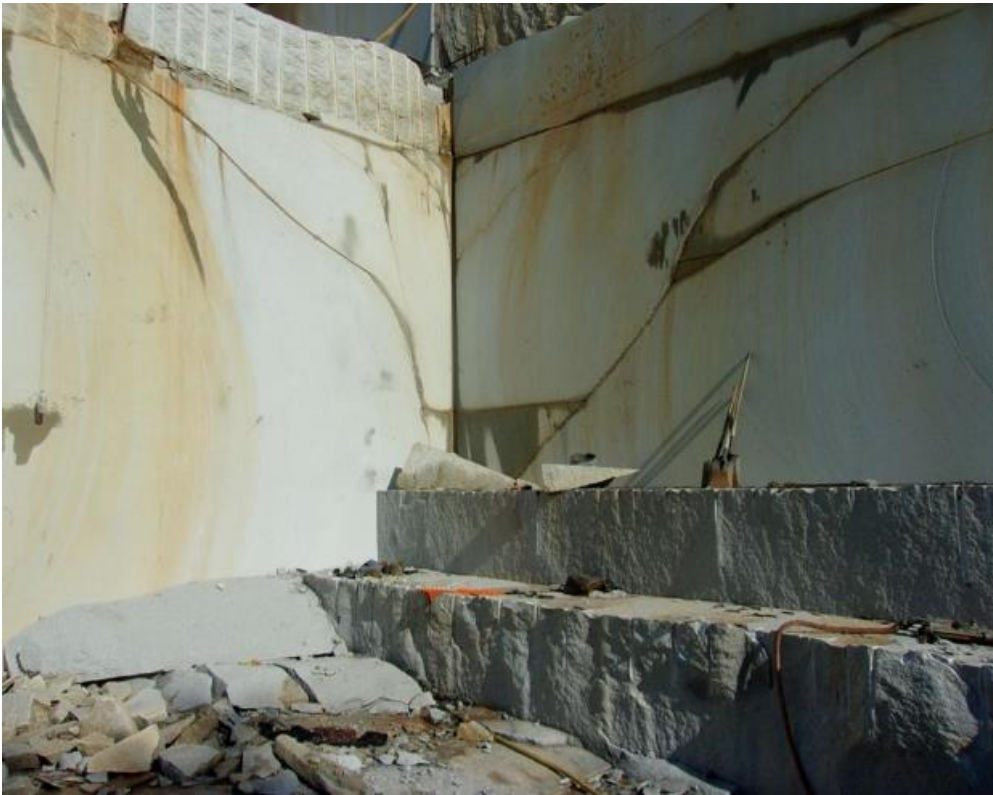
MINE FATALITY – On August 5, 2023, a piece of granite fell, striking two miners, killing one and seriously injuring the other.

- Examine work areas to identify loose ground or unstable conditions before work begins and as conditions change. Report hazards and do not work in unsafe conditions.
- Correct unsafe conditions or barricade areas to prevent access before beginning work.
- Consider mining methods that do not require miners to work or travel near the base of a highwall.

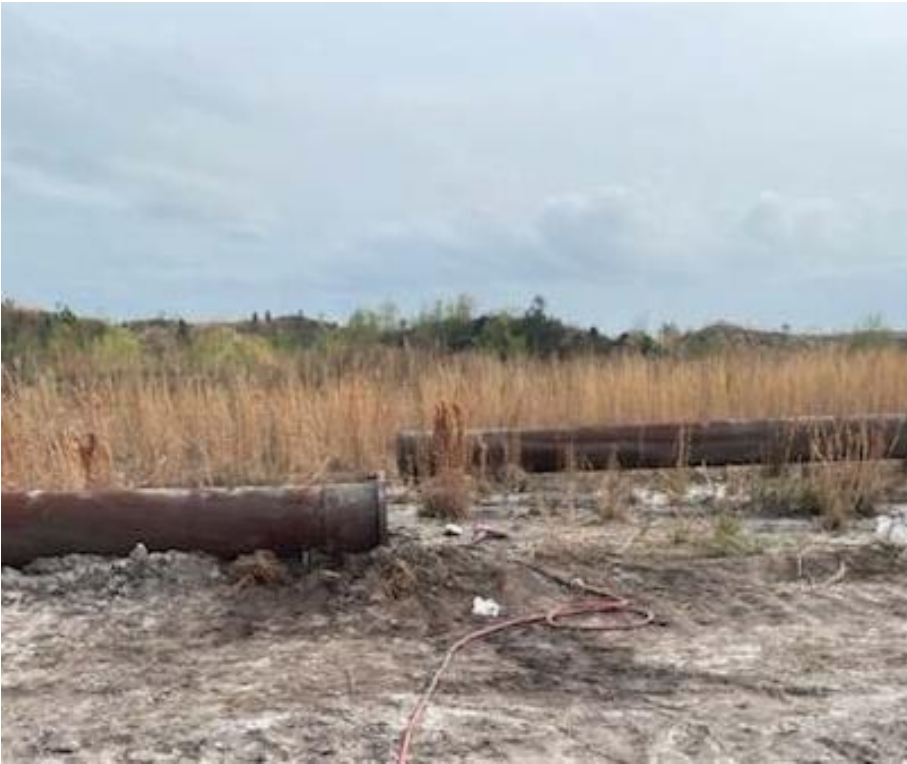
MINE FATALITY – On March 1, 2024, a miner died after a metal slurry pipe struck him. The miner was removing the last bolt connecting two metal slurry pipes when the pipe broke free and swung in his direction.

- Prevent miners from positioning themselves in a manner that will expose them to hazards while performing a task.
- Examine work areas before and during the shift for hazards.
- Ensure that blocking material is competent, substantial, and adequate to stabilize the load.
- Train miners in safe work procedures and hazard recognition. Monitor personnel routinely to ensure they follow safe work procedures.

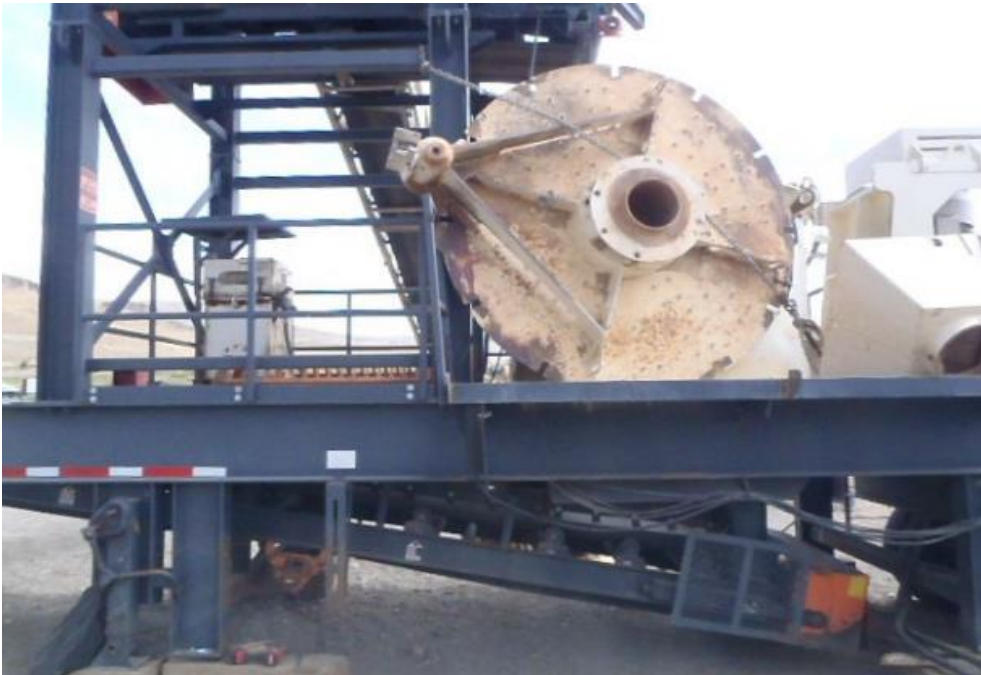
MINE FATALITY – On August 21, 2023 a crusher lid that was being moved into place struck a miner when the rigging broke. The miner died from his injuries on August 23, 2023.

- Do not work under suspended loads.
- Use properly rated lifting equipment and ensure that the load is well secured.
- Attach tag lines to suspended loads to steady or guide the load.
- Communicate lift plans to all persons working in the lift zone. Follow manufacturer's recommended work procedures.

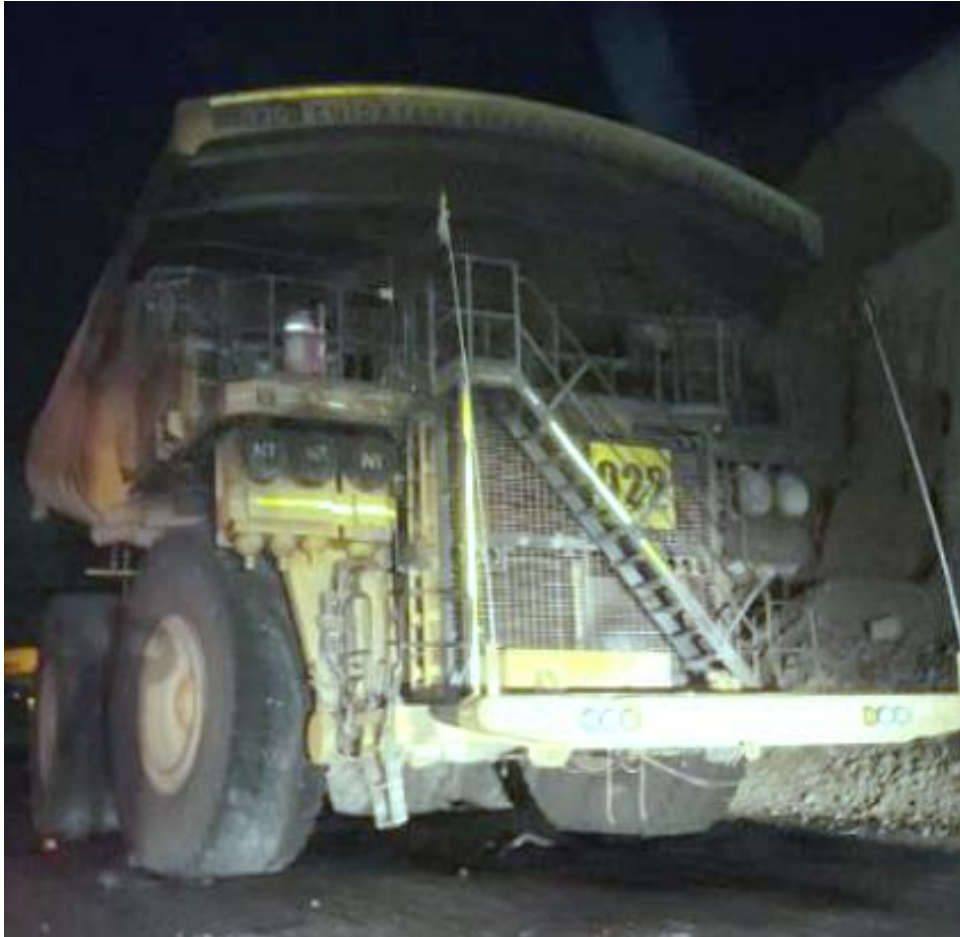
MINE FATALITY – On March 8, 2024, a haul truck driver was killed after the vehicle caught fire. The driver was unable to evacuate the truck and could not activate the manual fire suppression equipment.

- Inspect and maintain fire suppression equipment
- Know procedures for fire suppression activation
- Perform fire drills on equipment
- Practice equipment evacuations
- Check for leaks
- Take equipment out of service if needing repair
