## Freeport Safety Updates

August 2024

## Freeport Safety Incidents, Successes & Alerts

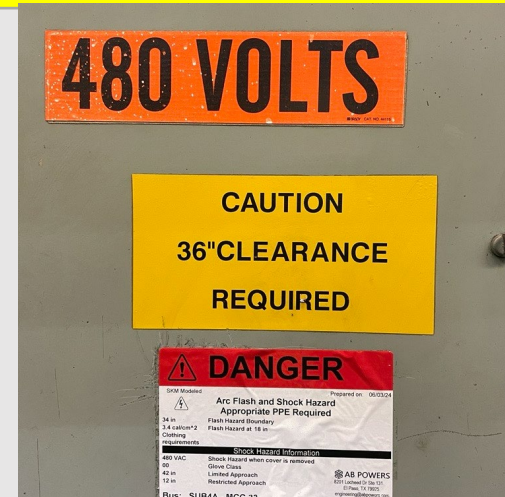
Arc flash label

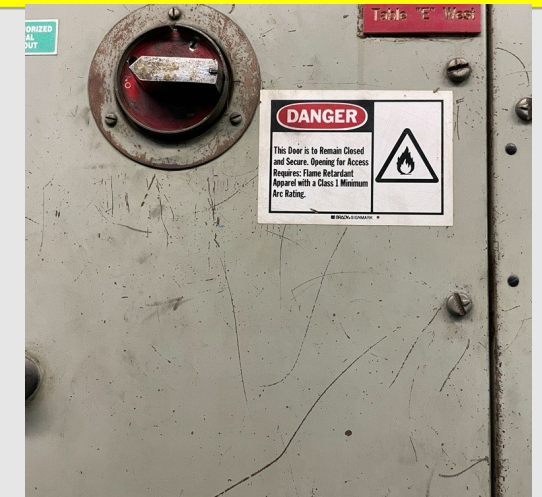
Table E conveyor door

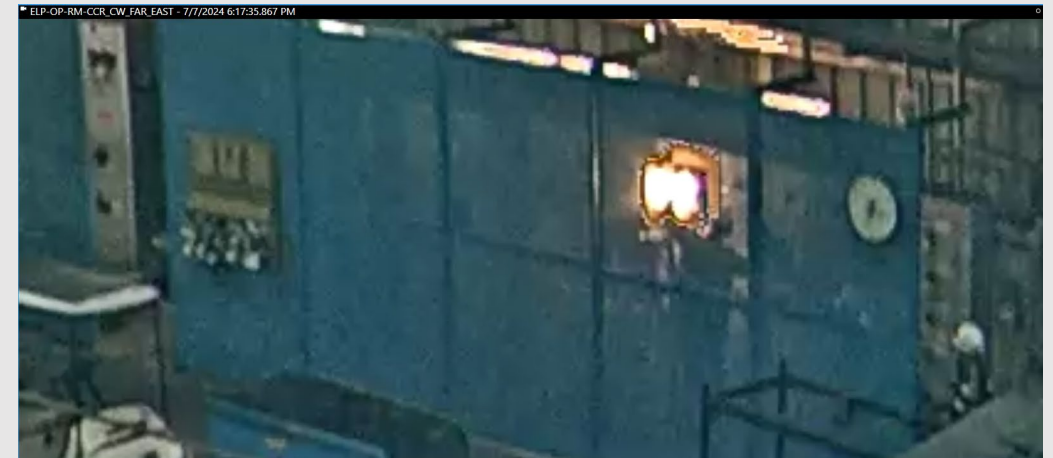
<b>Operation</b>	El Paso
<b>Date / Time</b>	July 7, 2024 / 6:30 p.m.
<b>Event Type</b>	Near Miss
<b>Summary</b>	An electrician was called to reset an overloaded and tripped breaker at the coil collecting process of the Rod Plant. After the first reset, the table section of the conveying system did not respond. As the electrician returned to the breaker to troubleshoot, an arc occurred when a voltmeter contacted a contactor.
<b>Risk Category</b>	Actionable – Significant (3) Likely (3)
<b>Findings / Missing Controls</b>	<ul style="list-style-type: none"> <li>Faulty electrical equipment</li> </ul>
<b>Applicable Policies / Procedures</b>	<ul style="list-style-type: none"> <li><a href="#">FCX-HS03 Energized Electrical Work Technical Supplement</a></li> </ul>
<b>Employee Condition</b>	<ul style="list-style-type: none"> <li>Employee was uninjured</li> </ul>
<b>Contact</b>	<ul style="list-style-type: none"> <li>Roland Ruybe, Manager-Health and Safety</li> <li>Alejandro Valadez, Manager-Rod Mill Operations</li> </ul>

Electrician inside of the motor control center when arc flash occurred

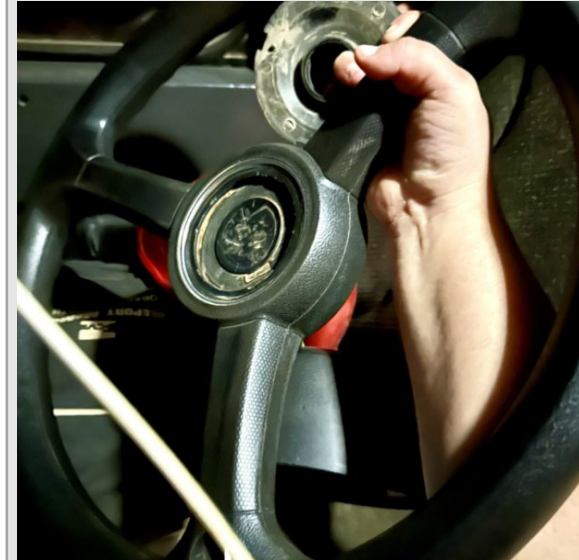
<b>Operation</b>	Morenci
<b>Date / Time</b>	July 11, 2024 / 7:20 a.m.
<b>Event Type</b>	Near Miss
<b>Summary</b>	A haul truck operator was traveling uphill, at low speed, on the haul road when the steering wheel fell off. The operator was able to stay in their traffic lane and stop the truck. There was no exposure to oncoming traffic.
<b>Risk Category</b>	Actionable – Significant (3) Likely (3)
<b>Findings / Missing Controls</b>	<ul style="list-style-type: none"> <li>Steering wheel locknut was not torqued to specified 60 lb./ft.</li> <li>Quality check to verify torque specifications was not applied by service contractor. The verification was to be conducted as part of the action plan following a previous PFE incident with a similar failure.</li> </ul>
<b>Applicable Policies / Procedures</b>	<ul style="list-style-type: none"> <li>Manufacturer (OEM) Caterpillar Steering Column Assembly (REN2535-16)</li> </ul>

*Detached haul truck steering wheel.*

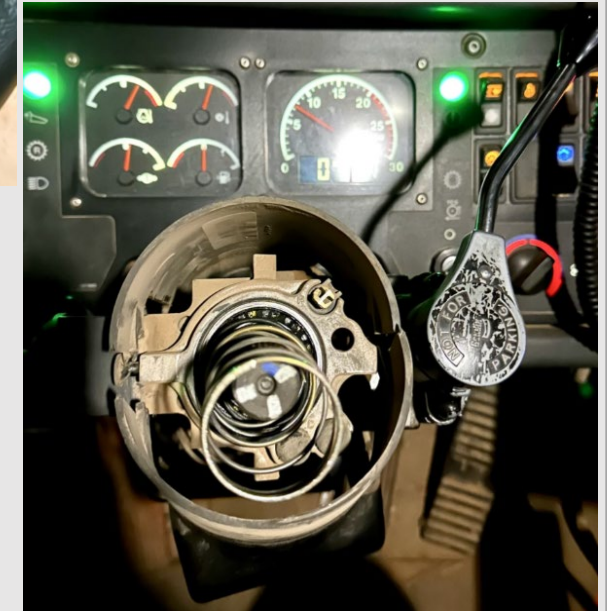
*A photo showing the unsecure haul truck steering wheel locknut.*

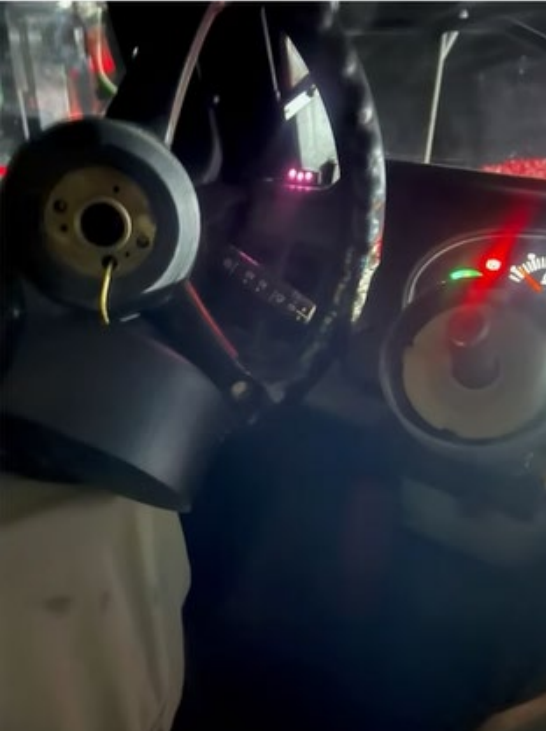
Preliminary Incident Details	
Operation	Bagdad
Date / Time	July 15, 2024 / 6:49 a.m.
Event Type	Near Miss
Summary	<p>A haul truck operator was preparing to reverse to a shovel when the steering wheel came off. The operator used the secondary brake to stop, put the truck in neutral and set the parking brake. There was exposure to oncoming traffic.</p>
Risk Category	Actionable – Significant (3) Likely (3)
Findings / Missing Controls	<ul style="list-style-type: none"> <li>Steering wheel keeper nut was not torqued to proper specifications.</li> <li>Quality check to verify torque specifications was not applied by service contractor.</li> </ul>
Applicable Policies / Procedures	<ul style="list-style-type: none"> <li>Manufacturer (OEM) Caterpillar Steering Column Assembly (REN2535-16)</li> </ul>
Employee Condition	<ul style="list-style-type: none"> <li>No injuries.</li> </ul>
Contact	<ul style="list-style-type: none"> <li>Danielle Murphey, Sr. Supervisor-Industrial Hygiene</li> <li>Benny Corbell, Manager-Mine</li> </ul>

<p><i>Detached steering wheel.</i></p>

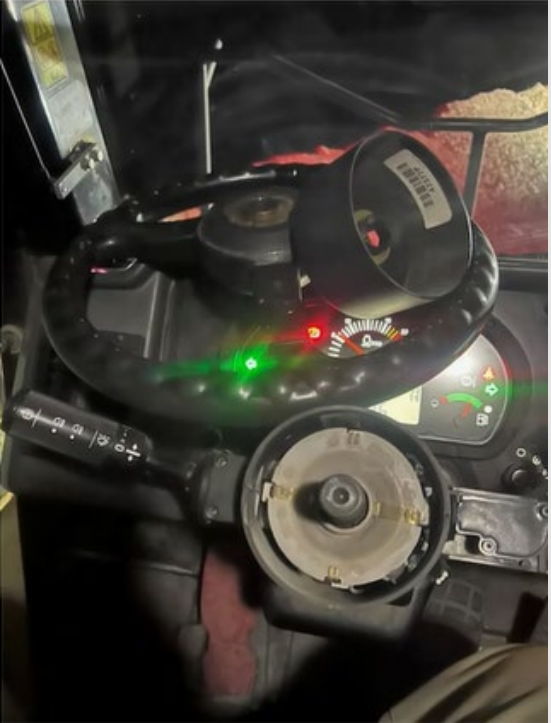
<p><i>Steering wheel assembly after wheel was detached.</i></p>

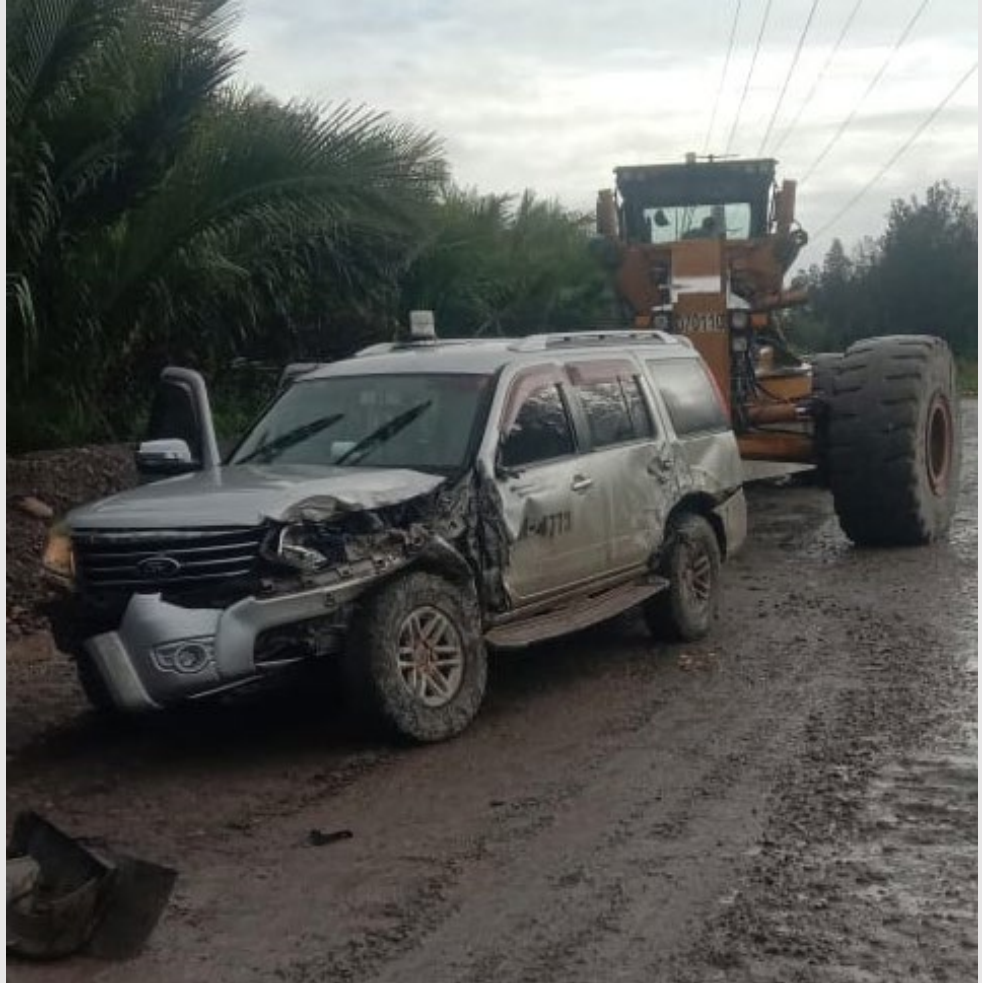
<b>Operation</b>	PTFI
<b>Date / Time</b>	July 1, 2024 / 8:40 a.m.
<b>Event Type</b>	Property Damage
<b>Summary</b>	A light vehicle (LV) stopped on the left side of the road, giving the right of way to a reversing grader approximately 40 meters ahead. As the grader approached the LV, it changed direction, first contacting the LV with the right rear tire against the LV side and then the grader blade against the right front. The grader dragged the LV approximately 10 meters. There were three people inside the LV including the driver. All occupants exited the LV without injury.
<b>Risk Category</b>	Monitor – Significant (3) Likely (2)
<b>Findings / Missing Controls</b>	<ul style="list-style-type: none"> <li>Grader operator did not respond to warning horns from LV operator.</li> </ul>
<b>Applicable Policies / Procedures</b>	<ul style="list-style-type: none"> <li><a href="#">GDL-4.04.10-PTFI-001 Operational Safety Mobile Assets</a></li> </ul>

• Damaged light vehicle following collision with grader.

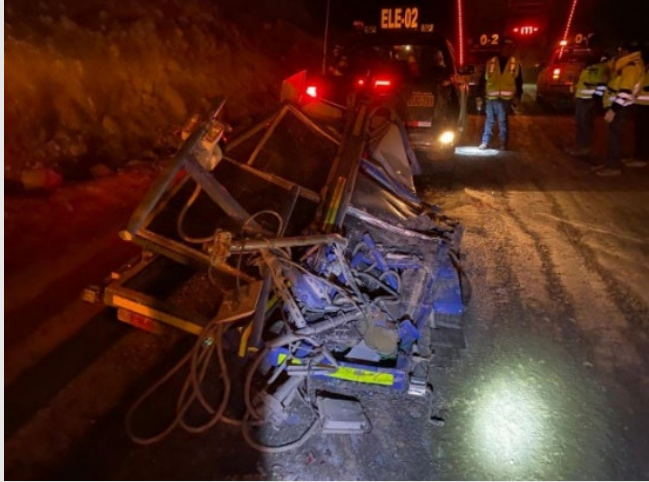
<b>Operation</b>	Cerro Verde
<b>Date / Time</b>	July 2, 2024 / 12 a.m.
<b>Event Type</b>	Property Damage
<b>Summary</b>	A haul truck was travelling down a ramp behind a light vehicle towing a solar repeater on a trailer and other haul trucks. As traffic slowed, the haul truck drove over the trailer and contacted the rear of the light vehicle with the left front tire. On impact, the haul truck operator veered right. The two workers inside the light vehicle were able to exit the vehicle without injury.
<b>Risk Category</b>	Actionable – Significant (3) Likely (3)
<b>Findings / Missing Controls</b>	<ul style="list-style-type: none"> <li>• Driver fatigue based on initial review of Driver Safety System data and video footage</li> </ul>
<b>Applicable Policies / Procedures</b>	<ul style="list-style-type: none"> <li>• <a href="#">FCX-23 Interaction with Heavy Mobile Equipment – Surface</a></li> <li>• CV procedure - SApr100 Material Hauling</li> </ul>

*Trailer damage following impact*

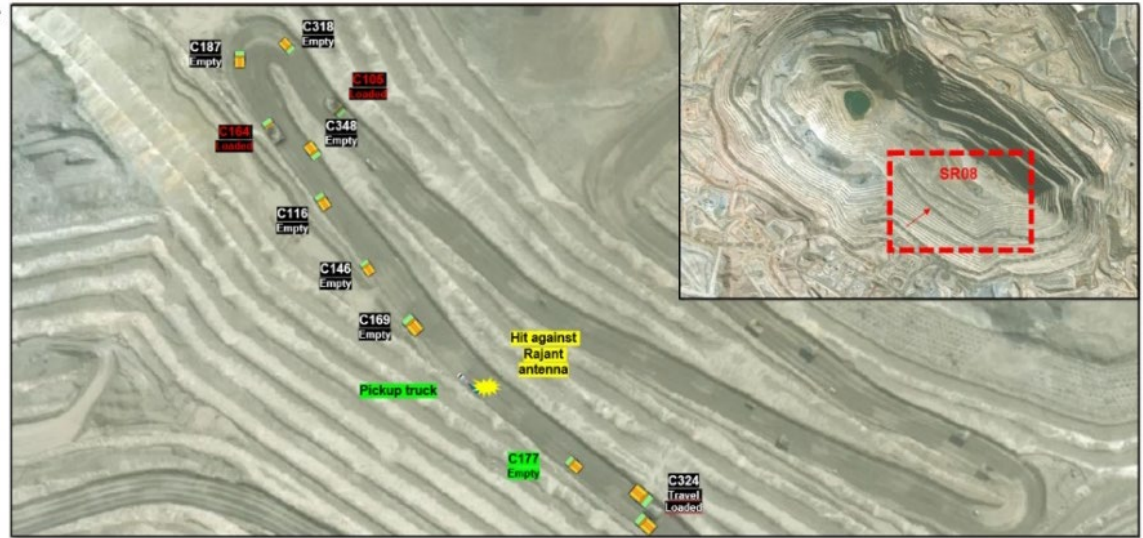
*Incident location*

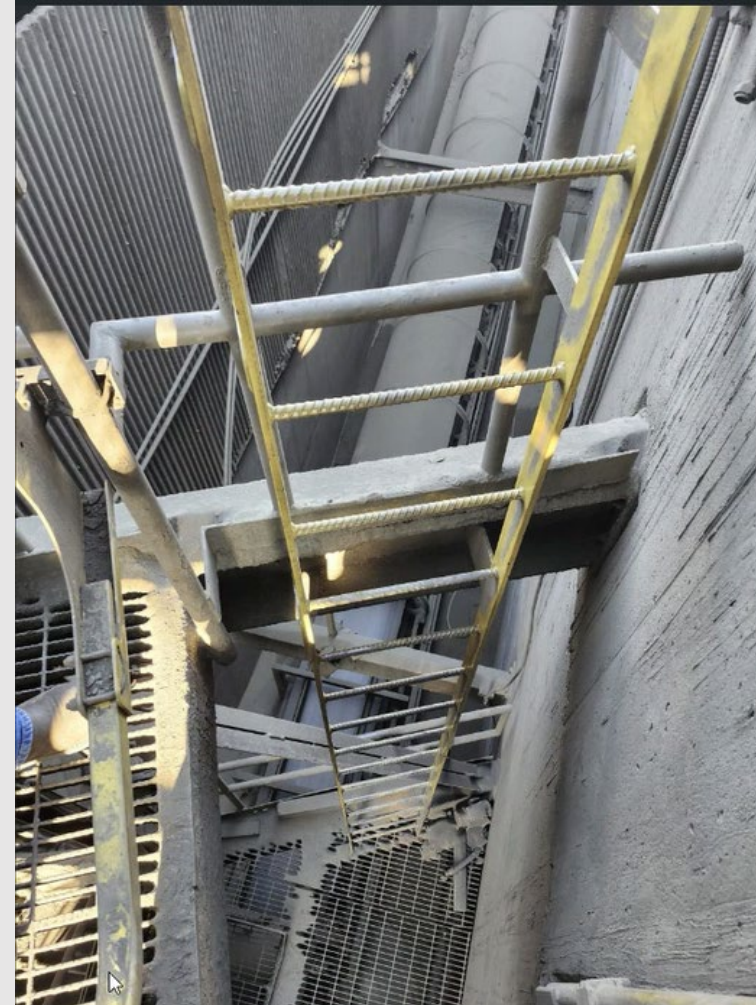
<b>Operation</b>	Miami
<b>Date / Time</b>	July 10, 2024 / 4:55 p.m.
<b>Event Type</b>	Injury – Medical Treatment
<b>Summary</b>	An employee was climbing a fixed ladder after cleaning hoppers. Approximately 12 feet up from the landing, the employee lost their grip and fell to the grating at the base of the ladder. The employee landed on their left arm and struck their head.
<b>Risk Category</b>	Monitor – Significant (3) Possible (2)
<b>Findings / Missing Controls</b>	<ul style="list-style-type: none"> <li>Fall protection was not required</li> </ul>
<b>Applicable Policies / Procedures</b>	<ul style="list-style-type: none"> <li><a href="#">FCX-HS02 Working at Heights</a></li> </ul>
<b>Employee Condition</b>	<ul style="list-style-type: none"> <li>Employee broke thumb</li> </ul>
<b>Contact</b>	<ul style="list-style-type: none"> <li>Justin Taylor, Manager-Health and Safety</li> </ul>

Location of ladder and fall.

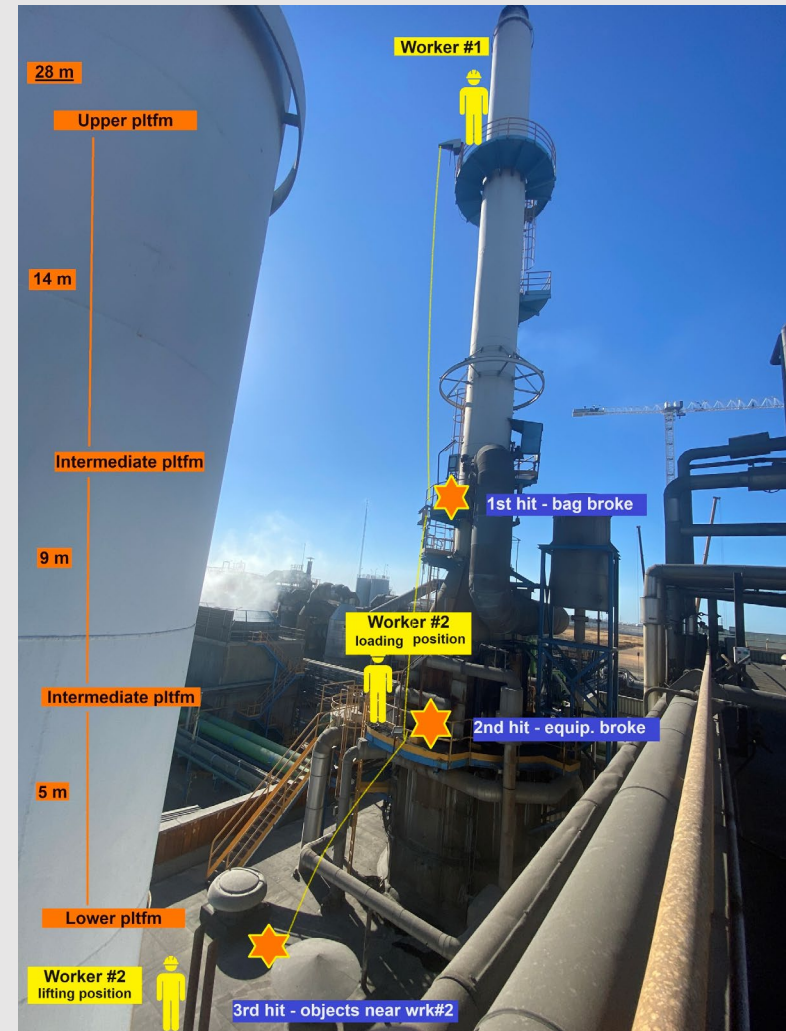
<b>Operation</b>	Atlantic Copper
<b>Date / Time</b>	July 12, 2024 / 11 a.m.
<b>Event Type</b>	Near Miss
<b>Summary</b>	<p>Two contractors were lifting measuring equipment up the stack for environmental samples. Worker #1 was operating the electric winch on the stack's upper platform. Worker #2 put the equipment in a lifting bag and flagged the intermediate platform, then proceeded to walk down to the lower platform.</p> <p>When the lifting bag reached the upper platform, the hoist steel cable broke. The bag, weighing approximately 132 lbs (60 kgs), fell and hit the intermediate platform, releasing the equipment. The equipment continued to fall to the lower platform and stopped near Worker #2.</p>
<b>Risk Category</b>	Actionable – Significant (3) Likely (3)
<b>Findings / Missing Controls</b>	<ul style="list-style-type: none"> <li>The lifting cable was rusty and deteriorated.</li> <li>The area immediately below the winch was flagged, but the lower platform was not barricaded.</li> </ul>

Diagram of the dropped object path, contact points and elevations.

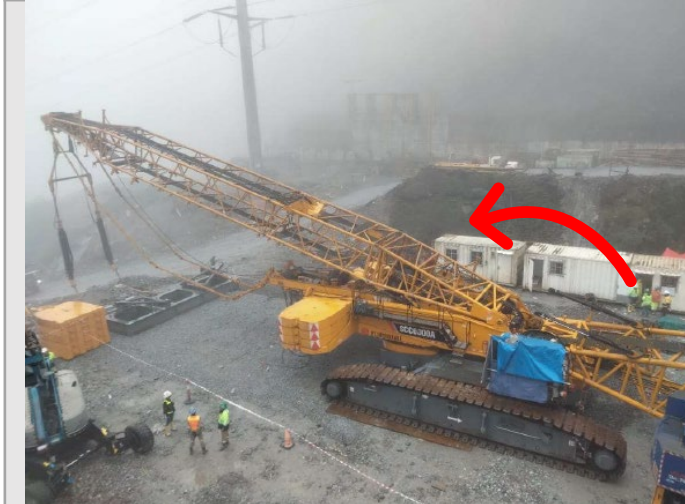
<b>Operation</b>	PT Freeport Indonesia
<b>Date / Time</b>	July 17, 2024 / 8 a.m.
<b>Event Type</b>	Injury – Medical Treatment
<b>Summary</b>	During crane disassembly, the team was working on removing the last section of the main boom. The crane operator was outside the cab using a remote control to adjust the super lift mast within the 75-degree safe working limit, so that a second 100-ton crane could access and lift the last main boom section away. As the super lift mast was adjusted, it started moving backward and collapsed over the rear of the car body. When the rigger saw the mast moving backward, they jumped to the counterweight and then approximately 3 meters (10 feet) to the ground, sustaining injuries to the head, face, and upper body.
<b>Risk Category</b>	Actionable – Significant (3) Likely (3)
<b>Findings / Missing Controls</b>	<ul style="list-style-type: none"> <li>Current crane procedure does not consider disassembly as a critical activity.</li> <li>Failure to discuss safe exit points with crew in case of emergency.</li> <li>Critical evaluation of using remote control unit versus cabin operation during crane dismantlement was not done.</li> <li>Remote control should be turned off when not in use to prevent unexpected crane movements.</li> </ul>

*Super lift mast collapsed backward over car body.*

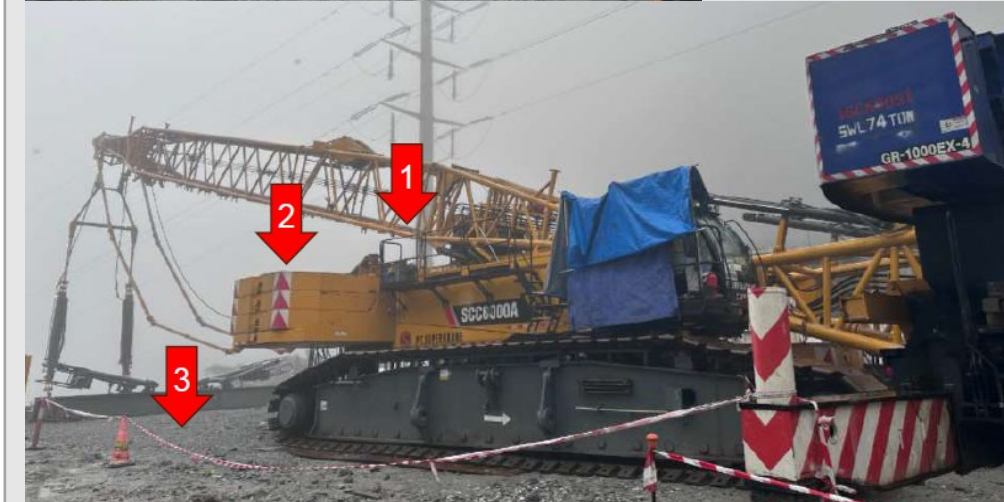
1 – Position of rigger on platform. 2 – Rigger jumped to counterweight. 3 – Location rigger landed after jump.

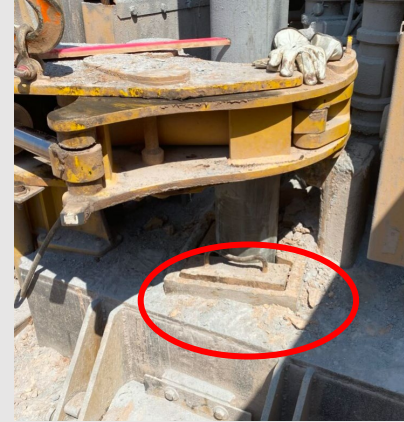
<b>Operation</b>	Morenci
<b>Date / Time</b>	July 23, 2024 / 9 a.m.
<b>Event Type</b>	Injury – Lost Time
<b>Summary</b>	Mechanics were replacing a bit sub on a worn drill pipe. Metal wedges were used to separate the pipe. As the drill operator turned the breakout wrench on the pipe, a metal wedge, approximately three pounds, popped out of place and struck a mechanic on the chin. The wedge landed approximately 51 feet from the drill.
<b>Risk Category</b>	Actionable – Significant (3) Likely (3)
<b>Findings / Missing Controls</b>	<ul style="list-style-type: none"> <li>Diagnostic mechanic had two years of experience.</li> <li>Struck mechanic was an apprentice 1, in the role for nine months.</li> <li>Failure to segregate the employee from fatal energy. No barricading or guard to control energy.</li> <li>Improper tool (steel wedges) was used to secure the stuck drill pipe.</li> </ul>
<b>Applicable Policies / Procedures</b>	<ul style="list-style-type: none"> <li>Operation manual for removing stabilizer.</li> </ul>

*Position where steel wedge was installed and later dislodged.*

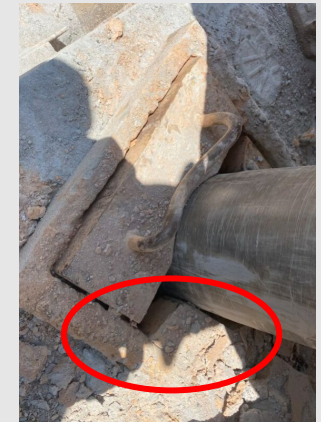
*Top view where steel wedge was installed and later dislodged.*

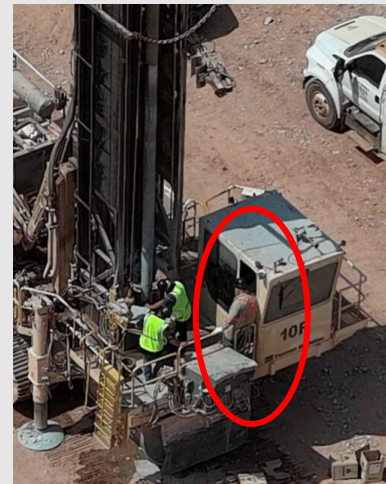
*Position where the mechanic was standing at the time of the event.*

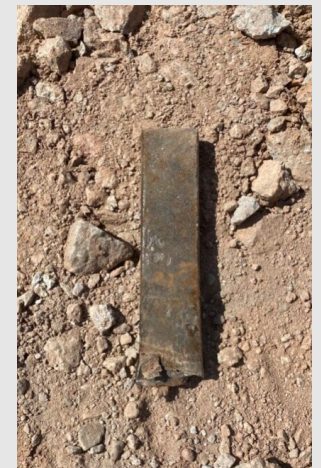
*Steel wedge (3 lbs) landed 51ft from the drill.*

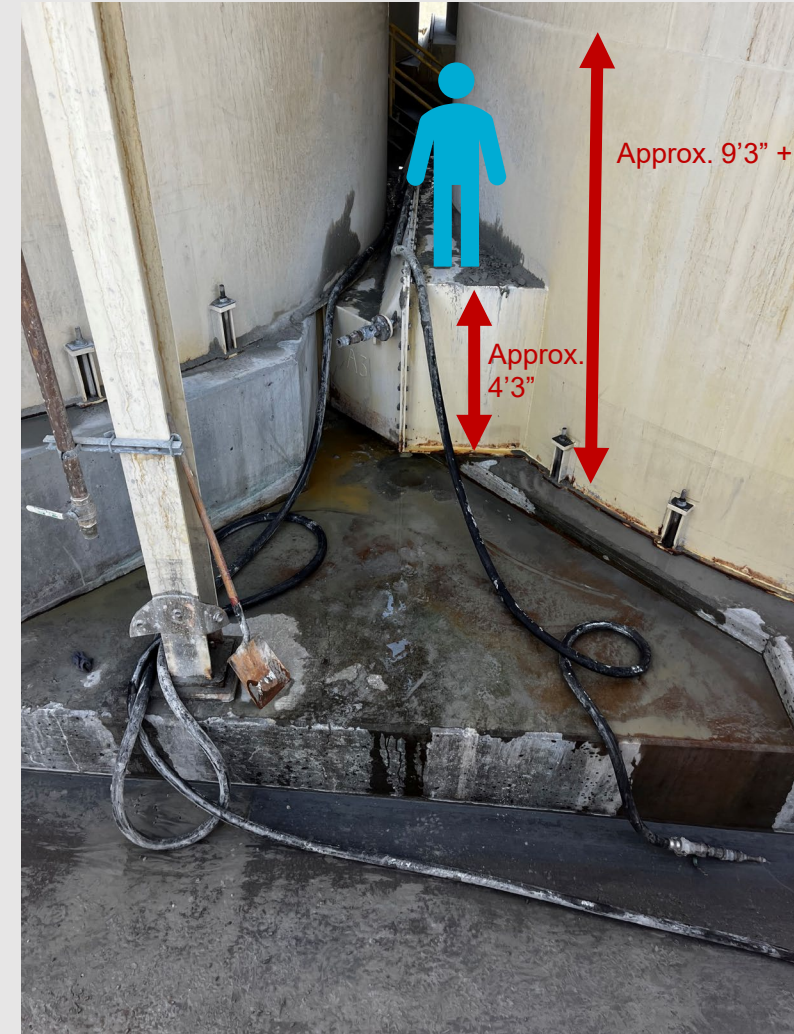
<b>Operation</b>	Bagdad
<b>Date / Time</b>	July 29, 2024 / 9:15 a.m.
<b>Event Type</b>	Injury – Medical Treatment
<b>Summary</b>	<p>A mill employee was standing on top of a rougher flotation crossover approximately four feet from the floor. The employee fell backwards, hit their ribs on a pipe and fell to the floor.</p> <p style="font-size: 48px; color: cyan; opacity: 0.5; transform: rotate(-15deg); position: absolute; top: 50%; left: 50%; transform: translate(-50%, -50%);">DRAFT</p>
<b>Risk Category</b>	Actionable – Significant (3) Likely (3)
<b>Findings / Missing Controls</b>	<ul style="list-style-type: none"> <li>No fall protection was being used above four feet.</li> <li>Employee should not have been on top of crossover.</li> <li>No field verification by supervision that employees were working safely.</li> </ul>
<b>Applicable Policies / Procedures</b>	<ul style="list-style-type: none"> <li><a href="#">FCX-HS02 Working at Heights Policy</a></li> </ul>

Diagram of employee location prior to fall and approximate heights.
