# FCX Monthly Safety Content

## FCX Safety Updates

December 2023

(Incidents and Communications from November 2023)

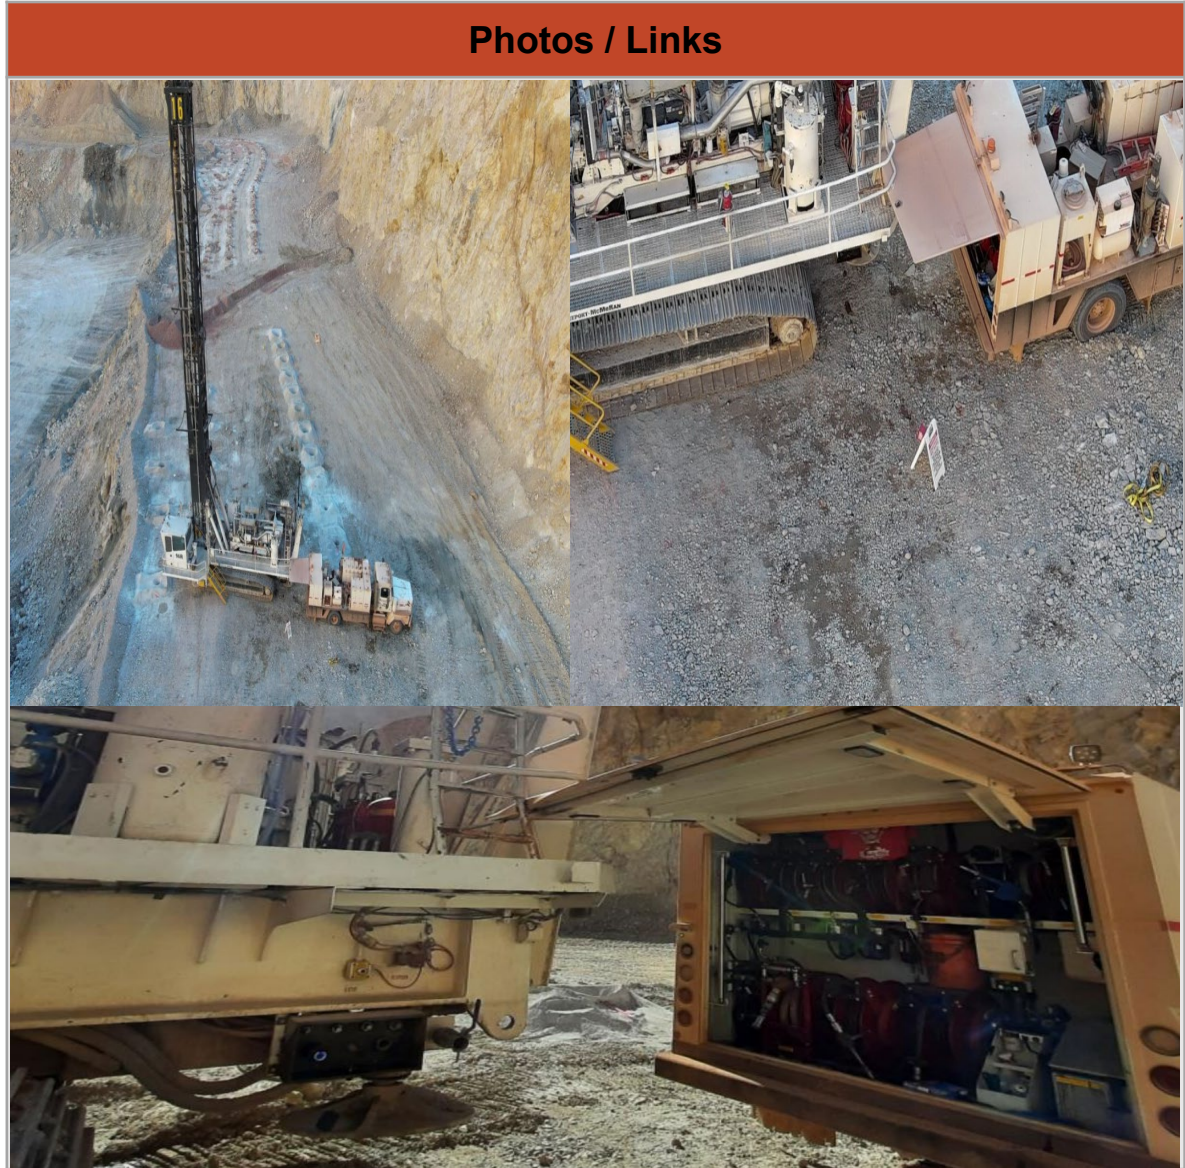
Incident Details	
Operation	Morenci
Date / Time	October 27, 2023 / 1 p.m.
Type	Property Damage
Summary	A mechanic in a lube truck approached a drill that was supposed to be down for protec. The mechanic parked 15-20 feet behind the drill to wait for it to finish a hole. The driller lifted a drill bit and started to back up. The mechanic was standing 20-30 feet from the cab side and tried to get the driller's attention but was neither seen nor heard. The mechanic moved to the rear of the drill and hit the emergency stop to keep it from striking the truck, but contact was still made.
Fatal Risk	Vehicle Impact on Person
Risk Category	Monitor
Pre / Post Rating	Significant (3) Possible (2) <b>NOT A PFE</b>
Absent / Insufficient Controls	<ul style="list-style-type: none"> <li>Lack of positive communication with drill operator</li> </ul>
Applicable Policies / Procedures	<ul style="list-style-type: none"> <li>FCX-23 Heavy Equipment Interaction</li> </ul>

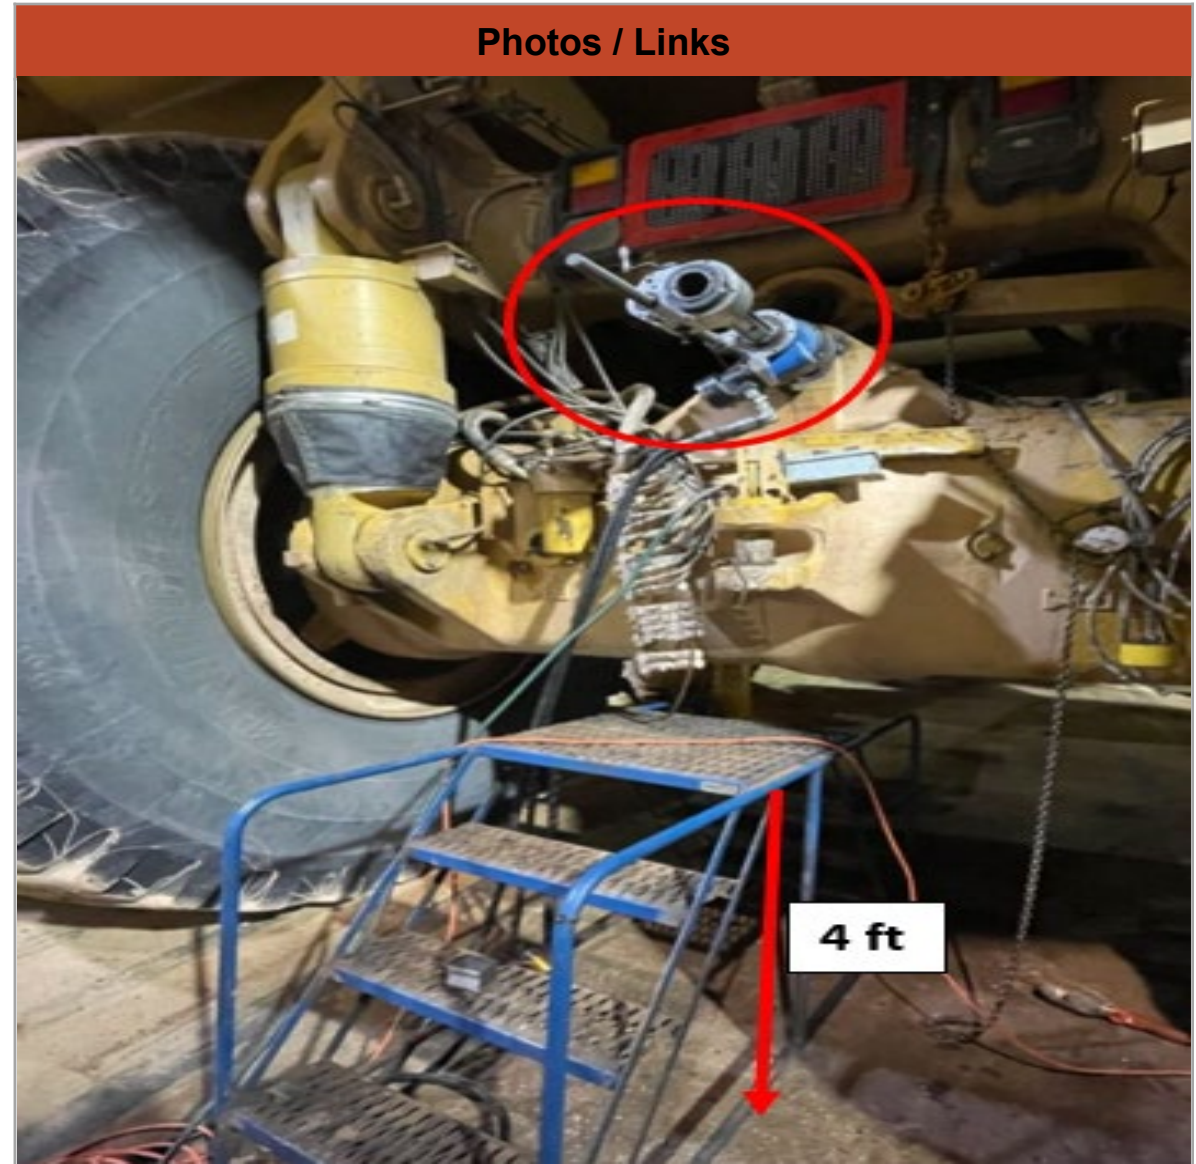
Operation	Morenci
Date / Time	November 2, 2023 / 10:40 p.m.
Type	Injury
Summary	An employee fell off a 4-foot ladder platform while machine boring behind a haul truck. The employee sustained a head injury.
Fatal Risk	Fall from Heights
Risk Category	Monitor
Pre / Post Rating	Significant (3) Possible (2) <b>NOT A PFE</b>
Absent / Insufficient Controls	<ul style="list-style-type: none"><li>• Failure to use correct working platform for the specific task</li></ul>
Applicable Policies / Procedures	<ul style="list-style-type: none"><li>• Working at Heights Policy</li></ul>
Employee Condition	After the fall, the employee was unconscious for about a minute, then came too but was not fully coherent. The employee was transported to the local health clinic and later to the regional medical center for further care. The employee sustained a bruise to the back of the head.
Contact	Willie Biggs, Superintendent-Mine Maintenance

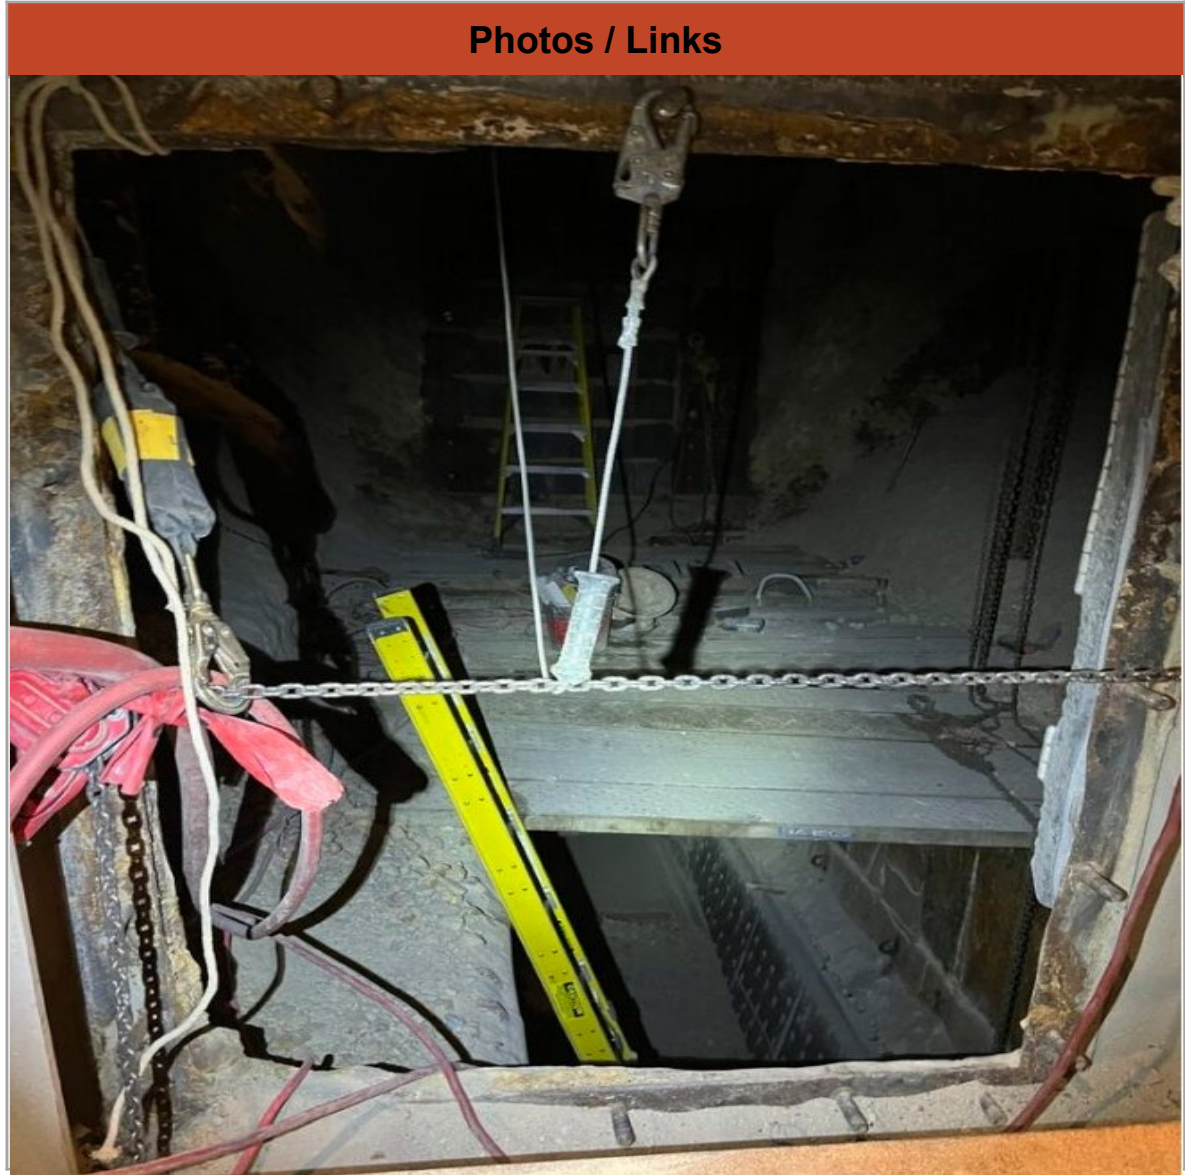
Incident Details	
Operation	Morenci
Date / Time	November 8, 2023 / 10:00 p.m.
Type	Near Miss
Summary	Contract were working in the 8a and 8b feeders. The employee above was on an 8-foot A frame ladder that was leaning on the wall and employee was tied off cutting the liner with a grinder. As the employee was cutting the liner, it fell off the wall towards them and deflected off their hard hat, face shield and left hand of the employee. The ladder tipped back, causing the employee to fall and their harness to catch them. The liner fell through a small opening to the lower level ~10ft below where the other employee was working on the opposite side of the bin approximately 20ft away.
Fatal Risk	Fall from Heights, Falling Objects
Risk Category	Monitor
Pre / Post Rating	Significant (3) Possible (2) <b>NOT A PFE</b>
Absent / Insufficient Controls	<ul style="list-style-type: none"><li>Scaffolding-Ladder inappropriate due to the nature of the work</li></ul>

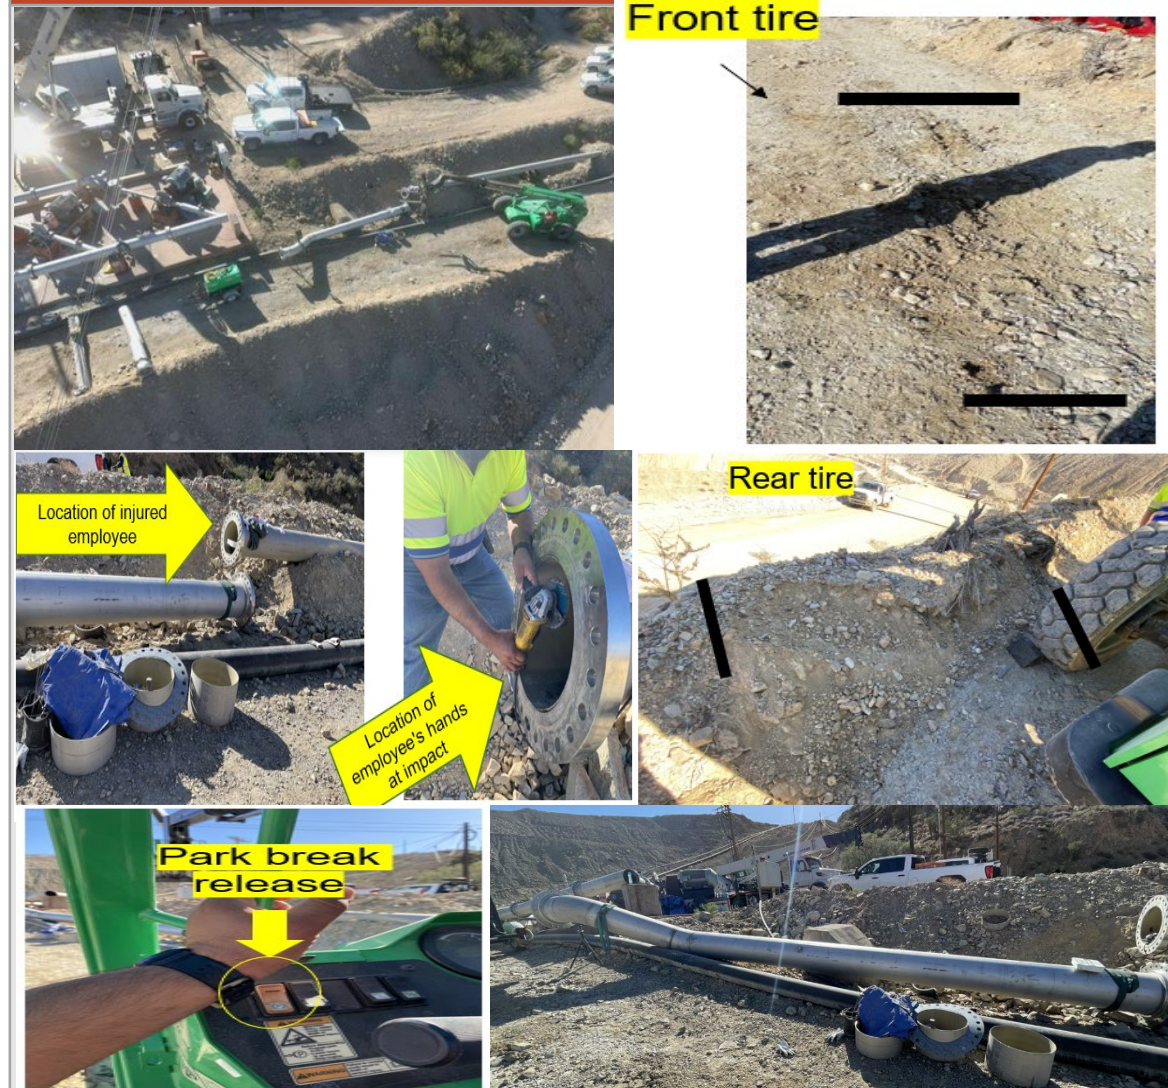
Operation	Bagdad
Date / Time	November 9, 2023 / 1:00 p.m.
Type	Injury
Summary	Employee was fitting connection from the intake pipe to new intake manifold. The pipe was put in place and the flange was adjusted. They moved the pipe away with the crane and tele-handler and rested it on pipe stands. The second operator inadvertently released the park brake. The original operator then jumped into the tele-handler to step on the brake. The tele-handler had rolled back several feet into the berm, pulling the pipe into the welder performing the pipe fitting. The welder was grinding on intake pipe and connector's flange impacted their hands.
Fatal Risk	Uncontrolled Release of Energy
Risk Category	Monitor
Pre / Post Rating	Significant (3) Possible (2) <b>NOT A PFE</b>
Absent / Insufficient Controls	<ul style="list-style-type: none"> <li>Employee in the forklift dismantled without setting the suspended load on the ground</li> </ul>

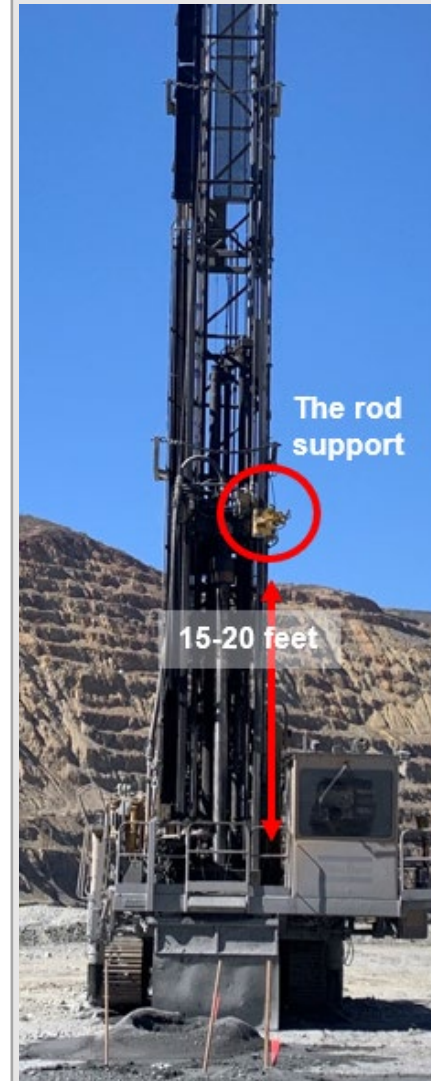
<b>Operation</b>	Sierrita
<b>Date / Time</b>	October 21, 2023 / 3:20 a.m.
<b>Type</b>	Property Damage
<b>Summary</b>	A drill operator was in position to start a new hole and stepped out of the cab onto the platform. As the employee was looking away, the rod support mechanism – estimated to weigh approximately 500 pounds – fell 15 to 20 feet and landed on the deck about four feet away. The operator was struck on the shoulder with a hydraulic hose attached to the rod support.
<b>Fatal Risk</b>	Falling Objects
<b>Risk Category</b>	Actionable
<b>Pre / Post Rating</b>	Significant (3) Likely (3)
<b>Findings / Missing Controls</b>	<ul style="list-style-type: none"><li>• Operator competency</li><li>• Safety cable failed</li></ul>
<b>Applicable Policies / Procedures</b>	<ul style="list-style-type: none"><li>• Drill SOP</li></ul>
<b>Employee Condition</b>	No Injury
<b>Contact</b>	Allen Bruce Kinney, Superintendent-Mine Operations

The rod support

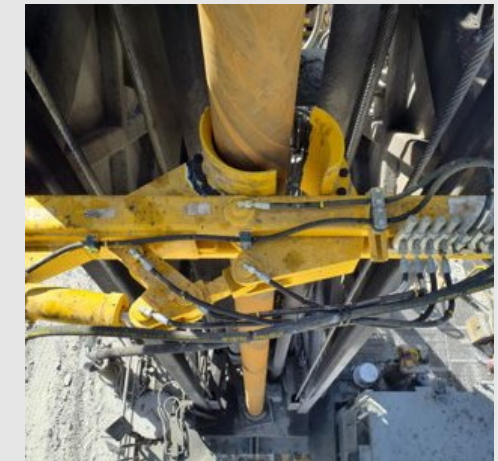
The rod support in place around the drill shaft.

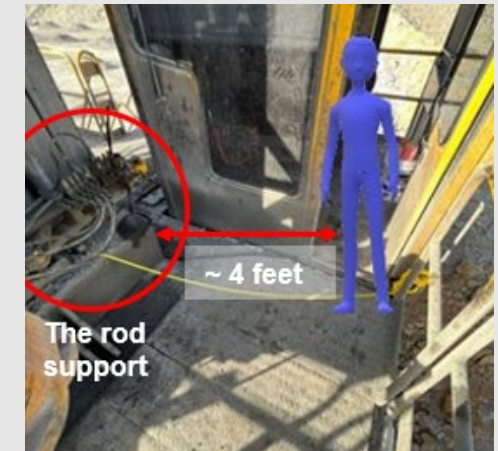
The employee's position when the rod support fell.

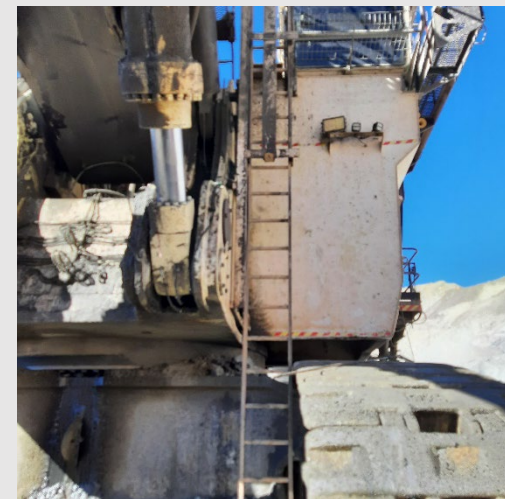
*Ladder Extended*

<b>Operation</b>	Climax
<b>Date / Time</b>	October 25, 2023 / 11:30 a.m.
<b>Type</b>	Injury
<b>Summary</b>	<p>A contractor employee used the emergency egress ladder to access the track below the operator's cab to clean the front of the shovel. After cleaning, the employee began to ascend the ladder, which had retracted. While part way up the ladder, it descended, causing the contractor to fall an estimated 5 to 10 feet below onto the tracks.</p>
<b>Fatal Risk</b>	Fall From Heights
<b>Risk Category</b>	Monitor
<b>Pre / Post Rating</b>	Significant (3) Possible (2)
<b>Findings / Missing Controls</b>	<ul style="list-style-type: none"><li>• Contractor fall protection was not connected</li><li>• Onsite personnel lift was in use on the other side, so not used for this task</li><li>• Job walk was not performed prior to starting task</li></ul>
<b>Applicable Policies / Procedures</b>	<ul style="list-style-type: none"><li>• <a href="#">Working at Heights</a></li></ul>

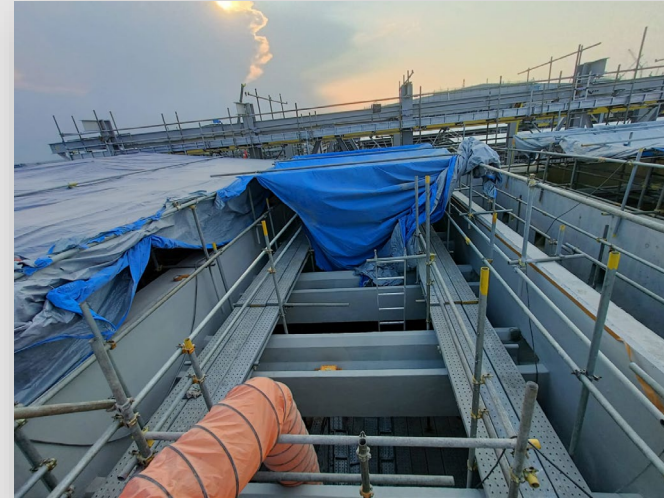
<b>Operation</b>	Manyar Smelter – Desalination Plant
<b>Date / Time</b>	October 31, 2024 / 3:30 p.m.
<b>Type</b>	Injury
<b>Summary</b>	A subcontractor employee was applying coating on a tank from scaffolding and was reminded to tie off by a Health and Safety specialist. While attempting to stand up to tie off, the employee lost balance and fell through the gap about 4 meters (13 feet) to the ground.
<b>Fatal Risk</b>	Fall from Heights
<b>Risk Category</b>	Monitor
<b>Risk Rating</b>	Significant (3) Possible (2)
<b>Findings / Missing Controls</b>	<ul style="list-style-type: none"><li>Employee was not tied off</li></ul>
<b>Applicable Policies / Procedures</b>	<ul style="list-style-type: none"><li><a href="#">Working at Heights policy</a></li><li>Work procedures and training</li></ul>
<b>Employee Condition</b>	The employee received a laceration requiring eight stitches above the right eye and was cleared to return to work.

*The scaffolding where the worker fell.*

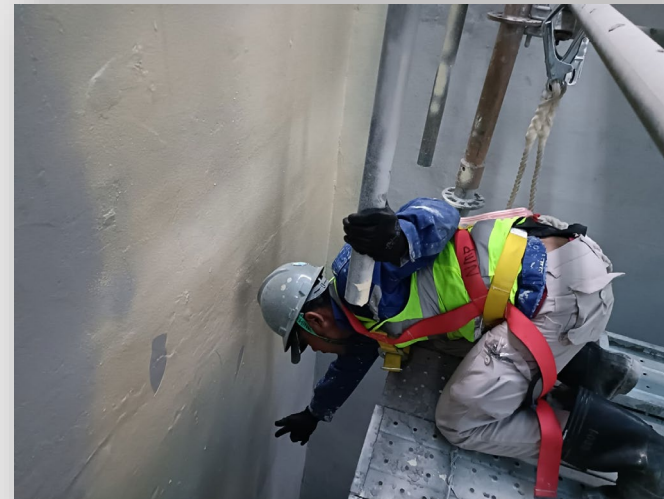
*Reenactment – The worker fell about four meters to the ground.*

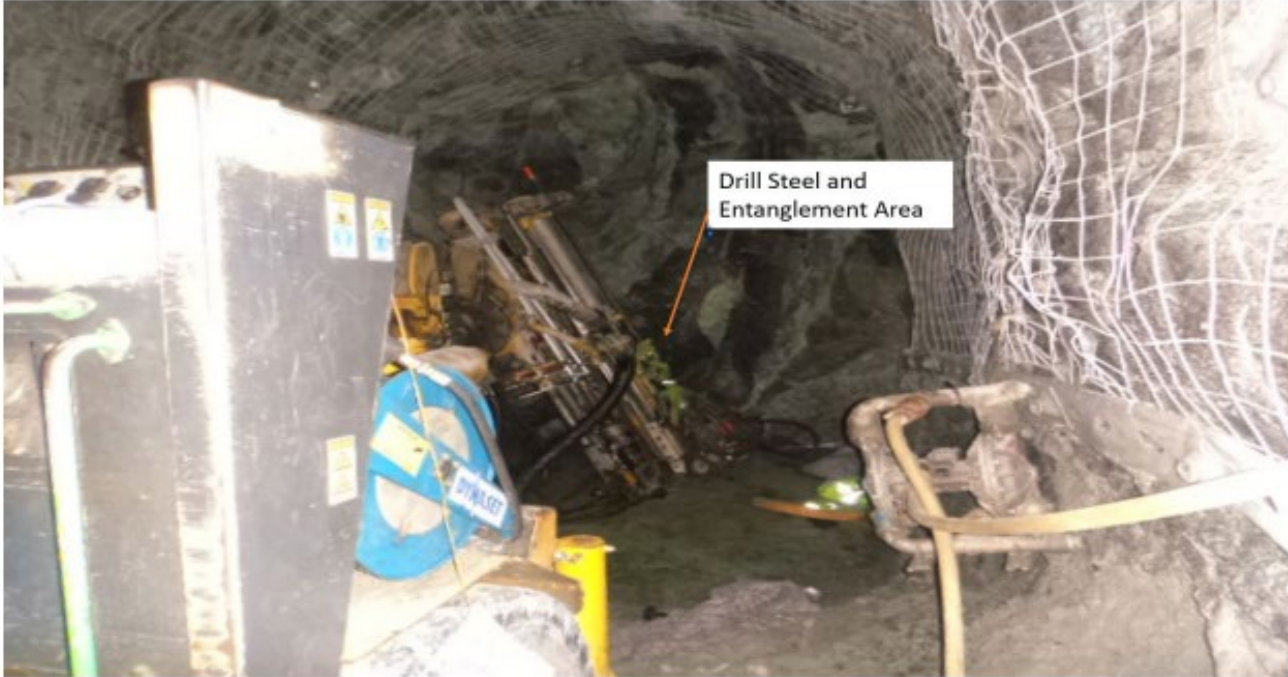
**MINE FATALITY** – On November 13, 2023, a rotating drill steel of a roof bolting machine entangled a miner, causing fatal injuries.

- Always follow manufacturer recommendations when conducting maintenance on equipment, including:
  - Turn off or de-energize the machine.
  - Secure the equipment against hazardous motion.
- Never touch or hold the drill steel, wrench, or bolt while it is rotating.
- Do not wear loose-fitting or bulky clothing when working around any machinery with rotating parts.
