FCX Monthly Safety Content

FCX Safety Updates

February 2024

FCX Safety Incidents, Successes, & Alerts

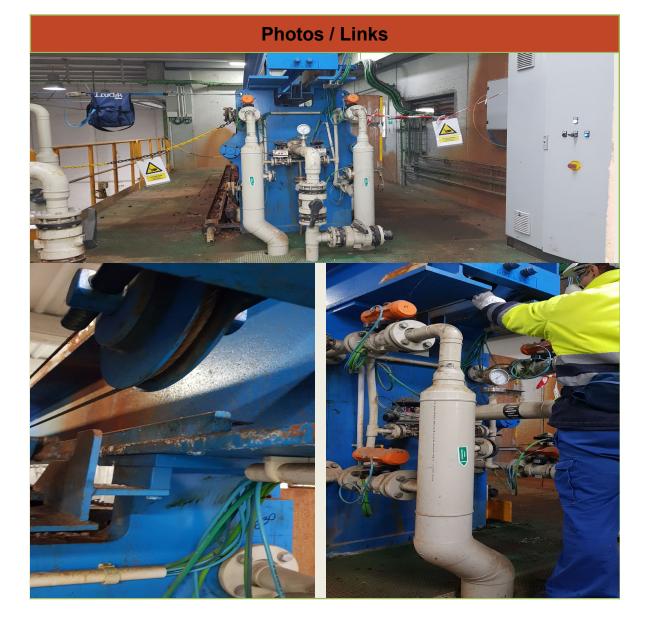
| E-V FREEPORT- | McMoRan |
|---|---|
| Event ID # 20012570 | SAFE PRODUCTION MATTERS |

| Incident Details | |
|---|---|
| Summary | When an operator was carrying out the cake discharger operation from the overhead filter presses, he detected a failure in the plate system. While looking for possible causes, the employee tried to check the pulley of the plate transport system. During the inspection, he |
| | tripped and rested his right hand between the pulley and cable of the transport system, which trapped his fingers, resulting in amputation of the 2 nd and 3 rd fingers on his right hand. |
| Absent / Insufficient Controls | Engineering Controls: Moving Machinery not guarded |
| Employee Condition | Amputation of 2 nd and 3 rd fingers on employee's right hand |

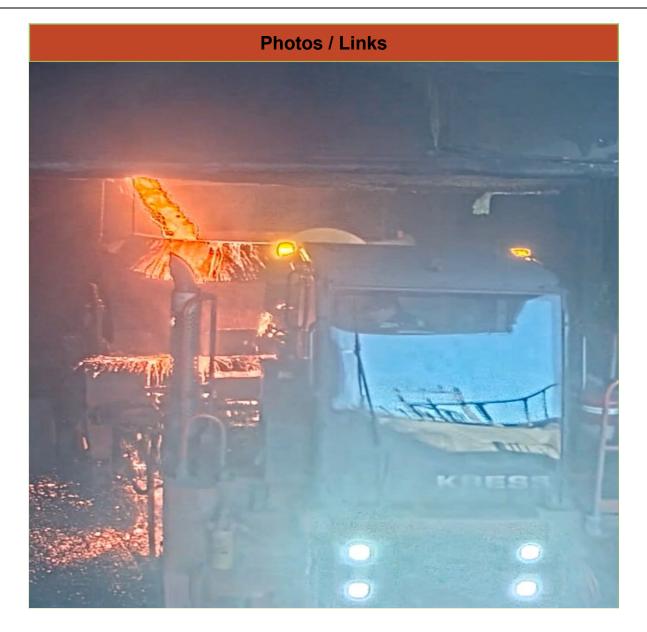
| E-V FREEPORT-M | cMoRan |
|---|---|
| Event ID # 20012772 | SAFE PRODUCTION MATTERS |

| Incident Details | |
|---|---|
| Summary | Smelter Operator Trainee gave clearance to the slag hauler operator to set the pot in place to receive slag from the east slag launder. Without confirming that the pot was in place, the operator opened the launder and it spilled on the ground and slag hauler. The slag hauler operator quickly moved the hauler and pot away from the pouring slag. No damage to the hauler was reported. |
| Absent / Insufficient Controls | Communication between slag skimmer and hauler operator Visual verification |

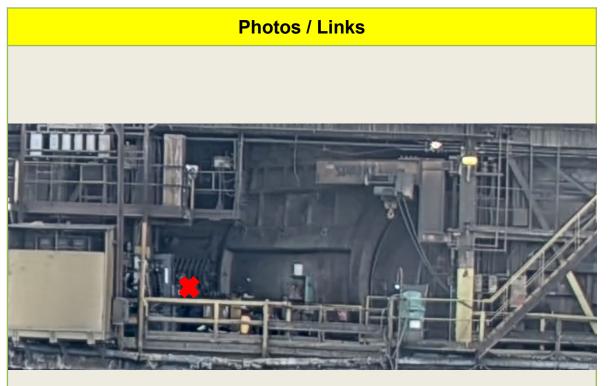
| Preliminary Incident Details | |
|--|---|
| Summary | An employee stepped from behind a converter into an aisle and was struck by a forklift. The employee was knocked to the ground. |
| Findings / Missing Controls | Forklift operator did not sound horn when traveling past openings in structure Pedestrian did not yield when entering roadway Operating speed |

The red X marks where the forklift struck the employee.

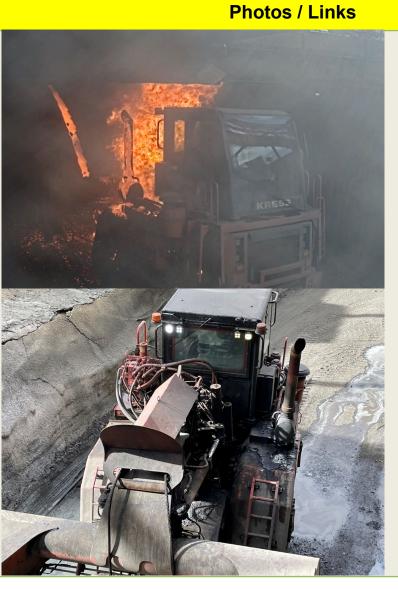
| Preliminary Incident Details | |
|---|--|
| Summary | An employee who was opening the slag tap hole requested the slag hauler operator move the pot from the east hole to the west hole. While the hauler operator was picking up the pot from the east hole, the tapper, thinking the pot was already in place, opened the west hole. Molten material flowed out onto the slag hauler. The operator moved the slag hauler forward away from the slag and immediately pulled the pin to activate the fire suppression system, and safely escaped without injury. The slag hauler caught fire and was damaged. |
| Findings / Missing Controls | Failure to follow SOPLack of communication between operators |

The slag hauler caught fire after molten material flowed onto it.

Damage to the slag hauler.

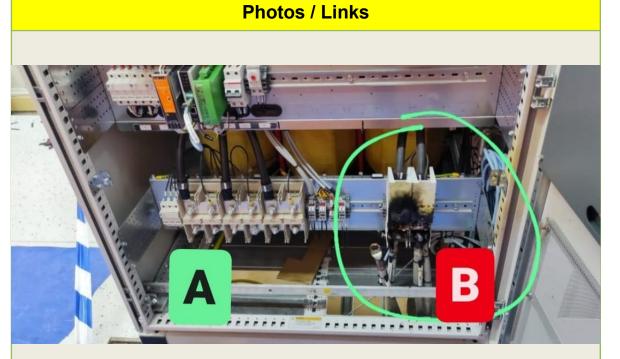
| | Preliminary Incident Details |
|---|--|
| Summary | Contractors were working on the left side of an electrical panel, which had been de-energized. Without testing for current, a worker removed a 400-volt cable from the right side, which remained energized, and contacted another cable, causing a spark. |
| Findings / Missing Controls | Failure to isolate energy with LOTOTO procedure Wrong tool for the job Inadequate training; worker was not authorized to perform this work |

The de-energized portion of the panel (A) and the energized portion (B), which shows damage.

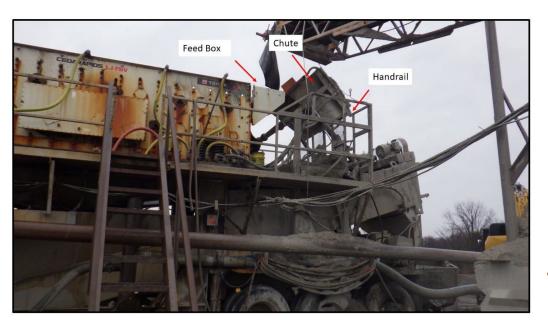
MSHA Fatality Alert – Bison No.1

MINE FATALITY – On December 14, 2023, a miner died while preparing to repair flanges on the feed box. In the process of lowering the chute into the maintenance position, the chute pinned the miner between the chute and the handrail.

- Block machinery components against motion before beginning maintenance or repairs and verify miners are in a safe location before moving equipment and components.
- Examine work areas during the shift for hazards that could be created while performing the work.
- When conducting a non-routine task, review safe procedures before starting work and ensure all safety components are in place.
- Do not work under suspended loads.

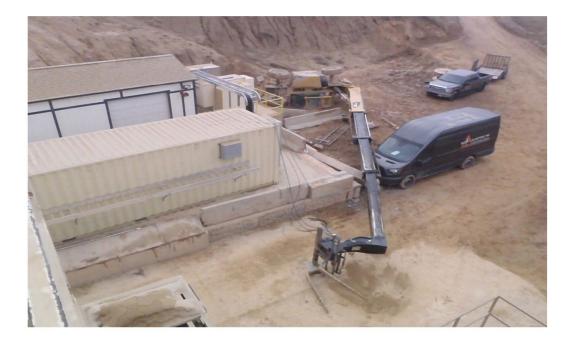
MSHA Fatality Alert – Beck Street

MINE FATALITY – On December 14, 2023, a contractor died while delivering parts to the mine when an all-terrain telehandler pulling cable, tipped over, striking him.

- Do not exceed the load radius and load limits of lifting equipment.
- Ensure miners position themselves in a safe manner while working around equipment.
- Barricade and sign affected areas in case equipment or loads fail or tip.
- Ensure visitors entering the mine receive site specific hazard awareness training.
- Maintain good communication between co-workers.
