FCX Monthly Safety Content

FCX Safety Updates

January 2024

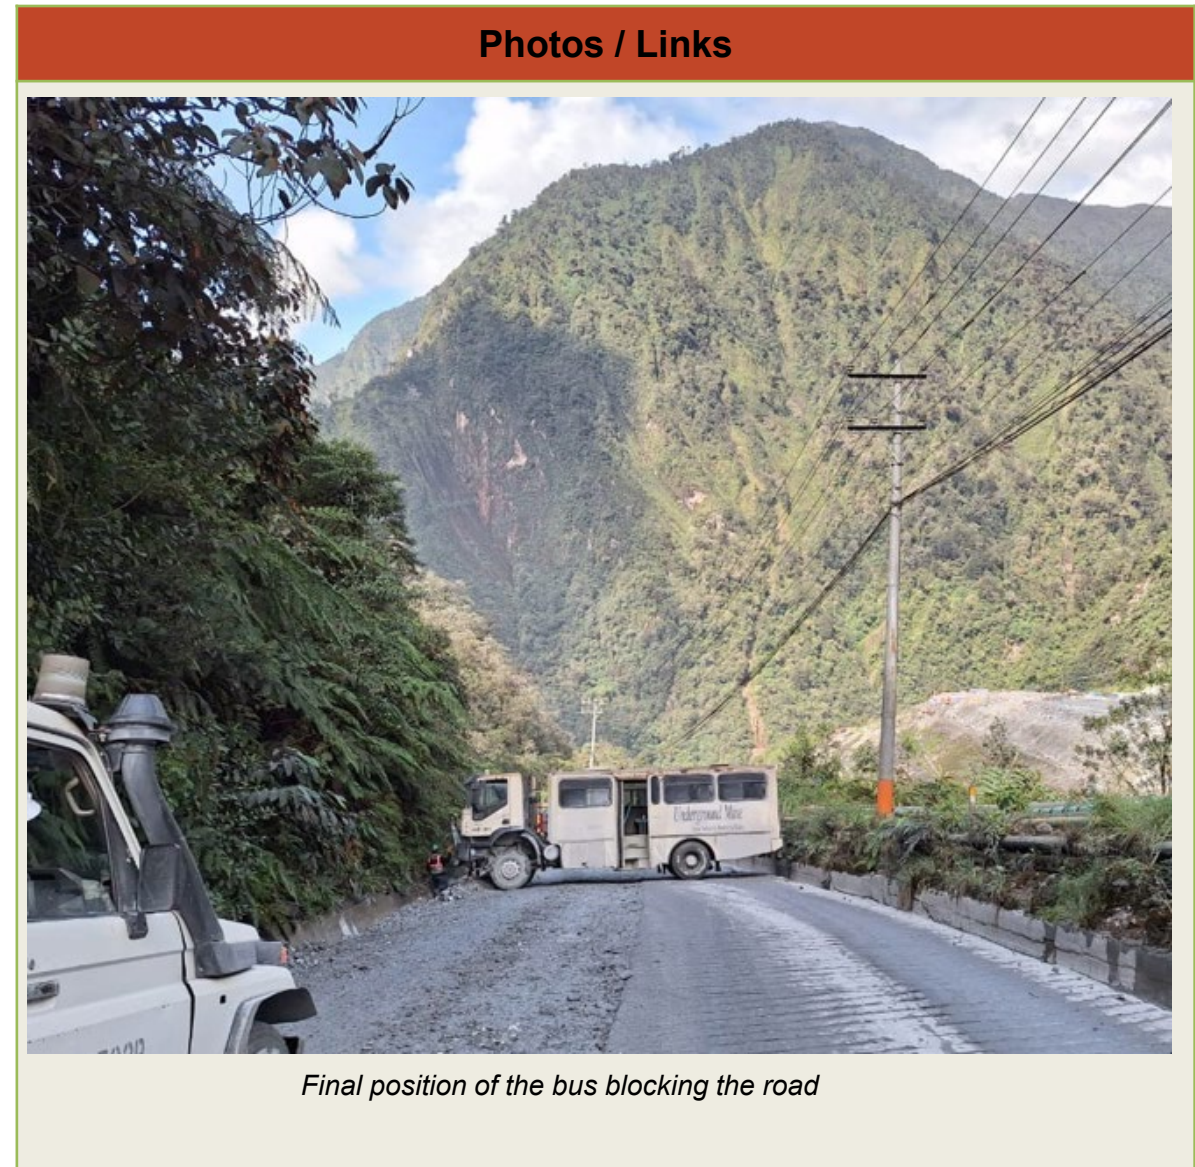
High Risk Event: PTFI Bus Near Miss

Incident Details	
Operation	PT Freeport Indonesia
Date / Time	December 1, 2023 / 10:15 a.m.
Type	Near Miss
Summary	A bus traveling down MP74 about 100 meters (330 feet) from Davey Tunnel moved onto a section of concrete road to allow an excavator traveling uphill to be on a concrete-free section. The bus tires slipped on the slick concrete, causing the bus to skid and block the access road.
Fatal Risk	Vehicle Collision or Rollover
Risk Category	Actionable
Pre / Post Rating	Catastrophic (4) Possible (2)
Absent / Insufficient Controls	<ul style="list-style-type: none">operator not using the proper gear when going down the road incline.
Applicable Policies / Procedures	<ul style="list-style-type: none">Low speedsBermsGPS Tracking SystemsOperational Safety Mobile Assets.
Employee Condition	N/A
Contact	Andri Abdullah, UG Health and Safety Manager

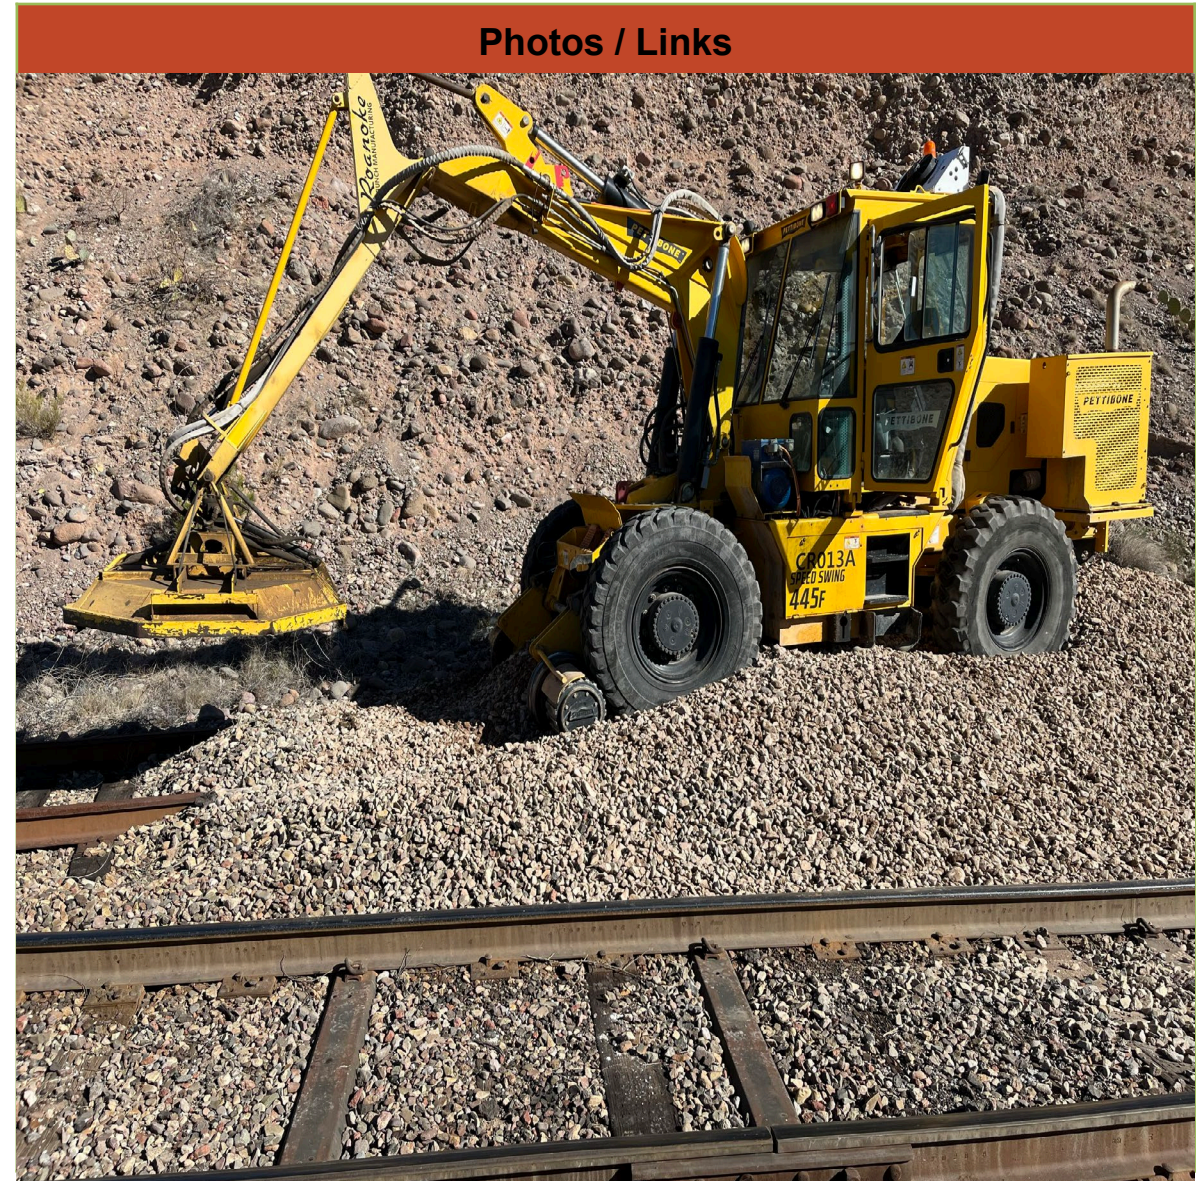
High Risk Event: Morenci Railroad Near Miss

Operation	FM Americas: Morenci
Date / Time	December 28,2023 / 9:00 am
Type	Near Miss
Summary	<p>A Railroad employee was using a rail mounted piece of equipment (Petty Bone) to trim vegetation along the Railroad when he stopped at the Columbine Gate crossing to dismount the rail. He stopped and was getting ready to disengage the wheels when he felt the Petty Bone rolling away. He couldn't stop it with the brake system, so he dismounted the equipment and the equipment continued down the track approximately 1.76 miles coming to a stop at the derailer.</p>
Fatal Risk	Railroad Collision
Risk Category	Actionable
Pre / Post Rating	Significant (3), Likely (3)
Absent / Insufficient Controls	
Applicable Policies / Procedures	
Employee Condition	N/A
Contact	Rassie Ras, Health & Safety Manager

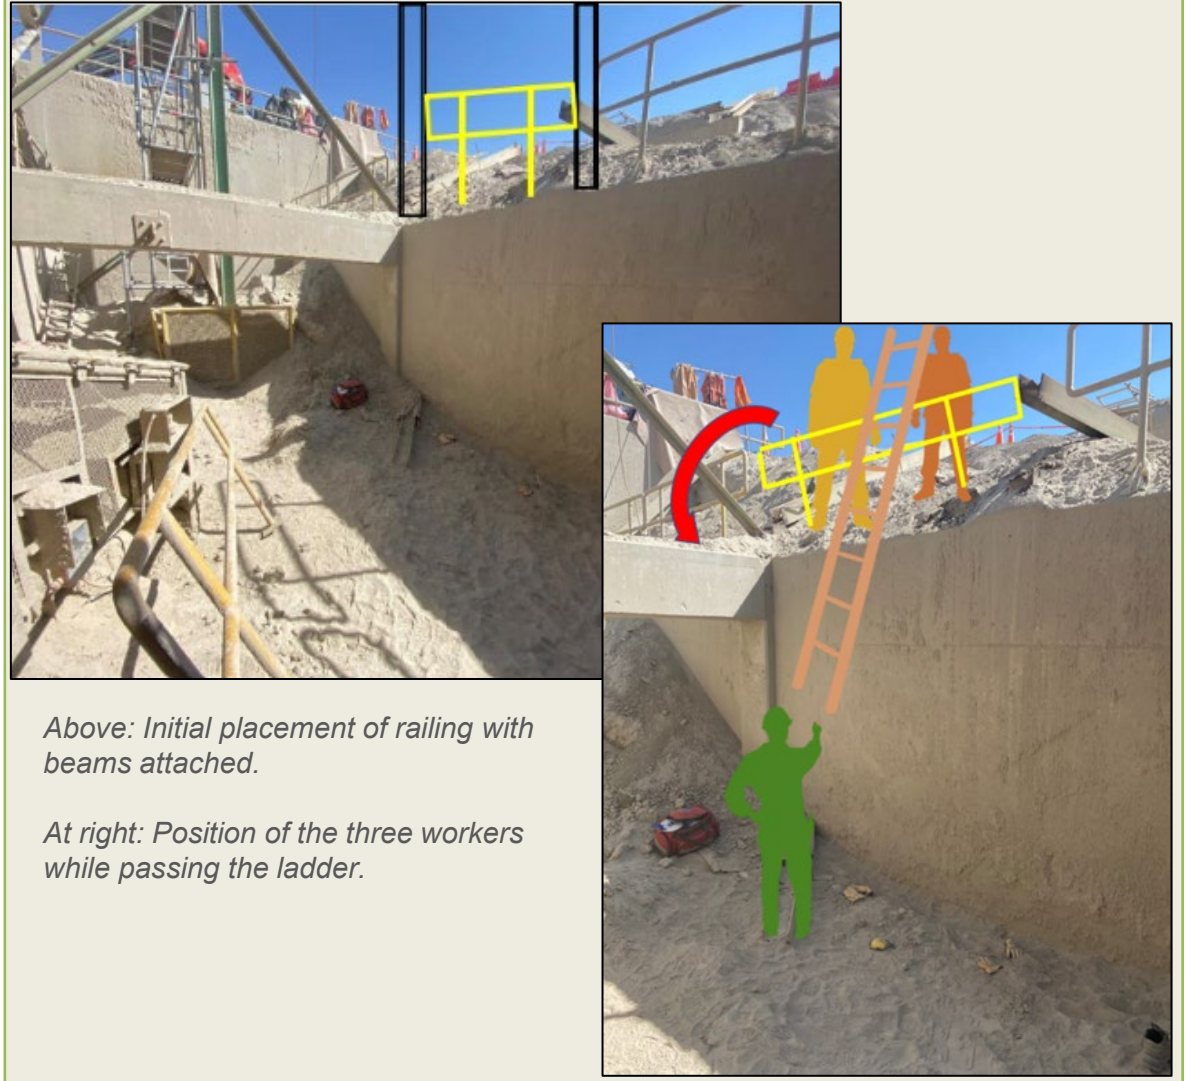
Operation	Cerro Verde
Date / Time	November 27, 2023 / 2 p.m.
Type	Injury
Summary	Two workers were trying to pass a ladder from a platform to a coworker approximately 3 meters (9 feet) below. They rested the ladder on the railing, which gave way. The two workers and the ladder fell onto the coworker below. Earlier that day, the three workers had cut/removed two beams used to support the railing as part of demolition activities.
Fatal Risk	Fall from Heights
Risk Category	Actionable
Risk Rating	Significant (3) Likely (3)
Findings / Missing Controls	<ul style="list-style-type: none">After removing the primary support structures, no new inspection was conducted to check the integrity of the handrails.
Applicable Policies / Procedures	<ul style="list-style-type: none">Working at Heights Policy / StandardWorkplace inspections
Employee Condition	The three workers sustained several contusions.
Contact	Jorge Chavez Rivera, Mine, Tailings and Water Project Manager

Above: Initial placement of railing with beams attached.

At right: Position of the three workers while passing the ladder.

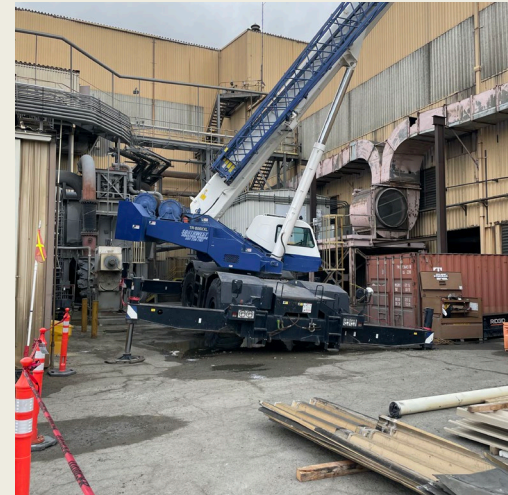
Operation	Chino
Date / Time	December 1, 2023 / 10:00 am
Type	Property Damage
Summary	A crane was lifting roof panels to be installed on the roof of the mill when a void opened under the left front outrigger, causing the crane to tip forward and hit the building. There were four employees working on the roof installing the roof panels – three were standing about 25 feet away as the load was being flown in and one was guiding the load with a tag line. When the crane tipped forward into the building, the load swung and came within 4-5 feet of hitting the employee holding the tag line.
Fatal Risk	Lifting Operations
Risk Category	Monitor
Pre / Post Rating	Significant (3) Likely (2)
Findings / Missing Controls	<ul style="list-style-type: none">• The drainage system was not identified when setting the crane up.• The drainage system does not show on the prints of the area.
Applicable Policies / Procedures	<ul style="list-style-type: none">• Crane and Rigging Policy• Crane and Rigging Critical Lift TS

Position of the crane after the event

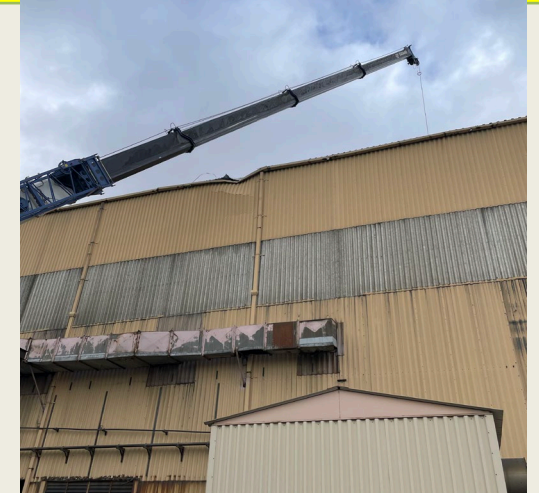
Location of where the crane hit the roof

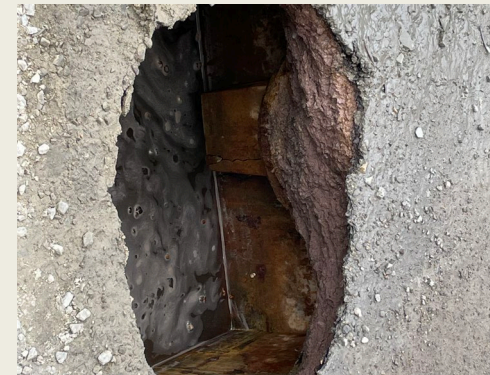
Cavity that the outrigger fell into

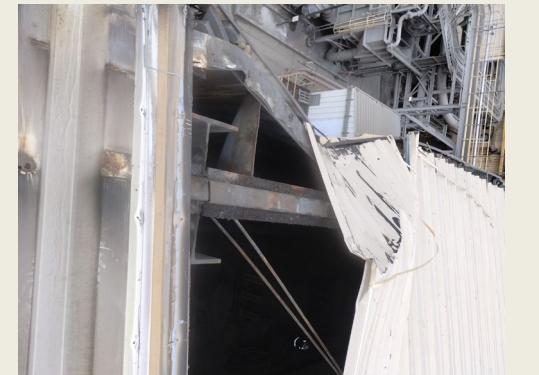
Damage to the roof

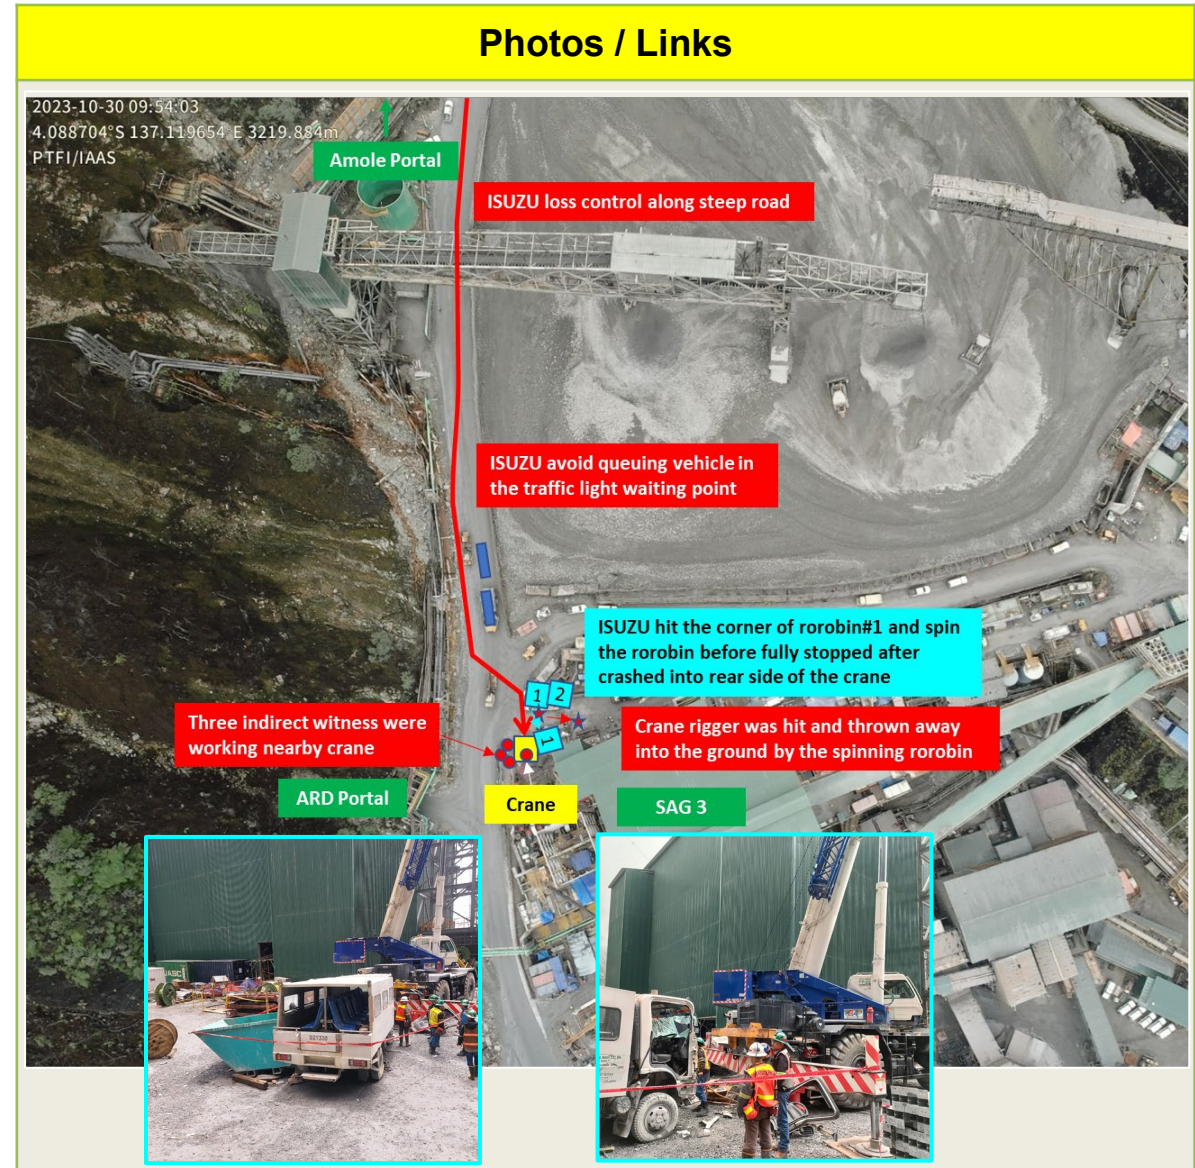
Potential Fatal Event: Manhaul Truck Collided with Crane

Preliminary Incident Details	
Operation	PT Freeport Indonesia
Date / Time	December 4, 2023 / 11:30 a.m.
Type	Injury
Summary	An Isuzu passenger transport truck was heading to Kasuang when the driver lost control along a steep downhill road segment. The vehicle hit a trash bin, causing it to spin, before striking a crane and coming to a stop. The trash bin struck a rigger who was standing nearby, resulting in injury. The truck operator's foot was pinched inside the cabin, requiring extraction to be released from the vehicle.
Fatal Risk	Vehicle Collision or Rollover
Risk Category	Actionable
Pre / Post Rating	Significant (3) Likely (3)
Findings / Missing Controls	<ul style="list-style-type: none">• Incorrect or unsuccessful use of proper gear selection• Failure to operate vehicle according to road conditions• Failure to secure control of the vehicle
Applicable Policies / Procedures	SOP-6.01-UGMO03 Operating Procedure Truck Isuzu NPS-75 Type Manhaul, Boom Crane and Rescue Truck in the Underground Mine and Surface Area

Employee Condition	Truck operator received first aid. Rigger sustained chest and hand injuries and is under observation.
Contact	Matthew Sullivan, Sr. Vice President-Underground Mine Division

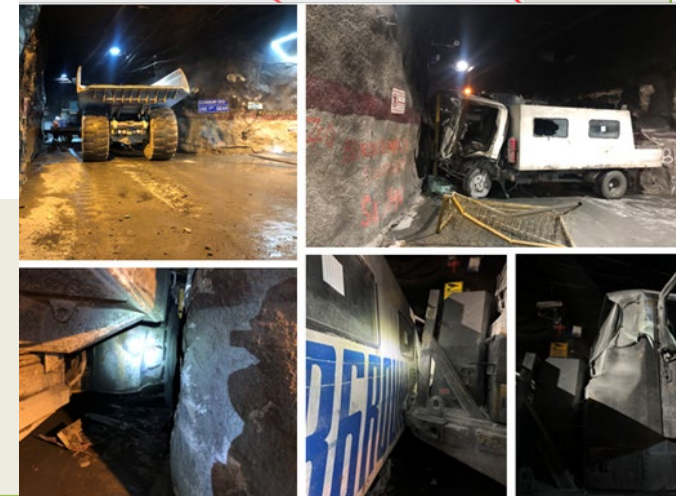
Operation	PT Freeport Indonesia
Date / Time	December 20, 2023 / 6:30 a.m.
Type	Injury
Summary	The operator of an AD60 haul truck lost control of the vehicle and accelerated into an Isuzu man haul unit coming from the opposite direction. The haul truck collided with the man haul's front cabin structure, pushing the Isuzu backward ~10 meters (30 feet) before turning it ~90 degrees. The man haul driver and five passengers were able to exit the vehicle without emergency team assistance.
Fatal Risk	Vehicle Collision or Rollover
Risk Category	Monitor
Pre / Post Rating	Significant (3) Possible (2)
Findings / Missing Controls	Failure to operate equipment properly – Prior to hitting the man haul, the haul truck accelerated toward the rib. The operator tried to apply the service brake with the left foot while still applying the throttle. The haul truck hit the rib and articulated right. The sudden change in direction caused the operator's left foot to come off the brake and right foot to apply full throttle.

Right: Photos of damage to the man haul
