# THE VALUE OF COPPER

## Freeport Safety Updates

July 2024

(Incidents and Communications from June 2024)

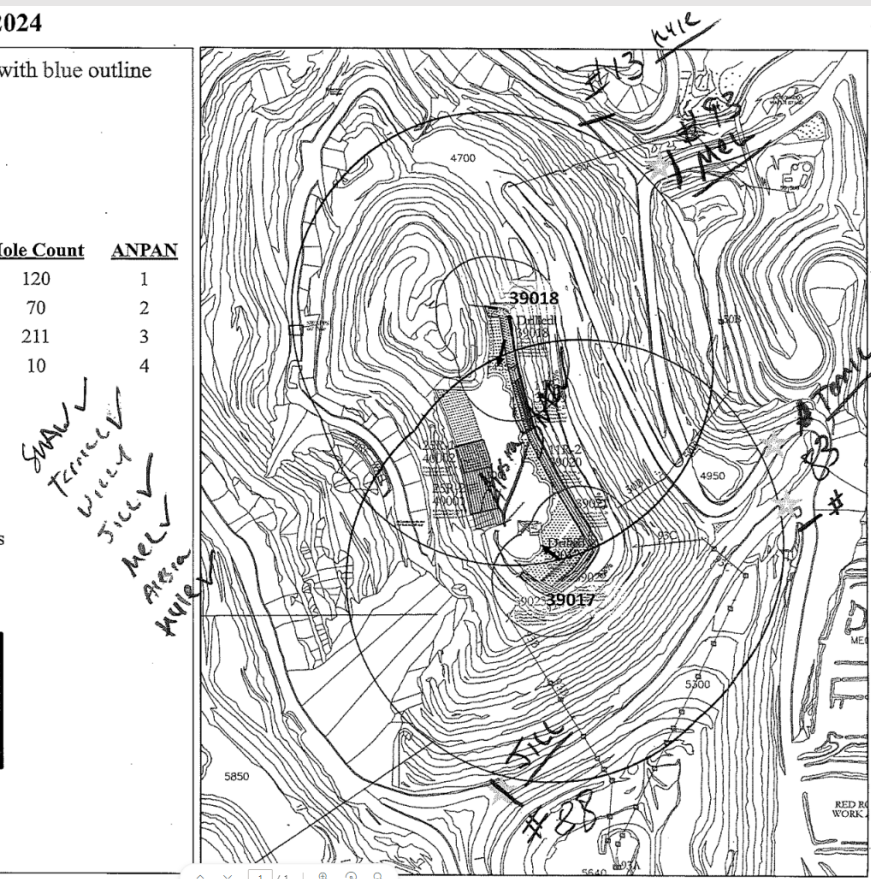
<b>Operation</b>	Morenci
<b>Date / Time</b>	June 13, 2024 / 2 p.m.
<b>Event Type</b>	Near Miss
<b>Summary</b>	<p>A drill operator was not cleared during the sweeping process for a planned blast in the Coronado pit. The drill was outside the required 400-foot blasting radius for equipment, but the operator was not clear from the required 1500-foot blasting radius for personnel.</p> <p>The operator reported hearing a radio announcement for the blast and assumed it was the 45-minute reminder because no one came by to pick them up. The operator continued to drill when the blast was initiated. At the end of the day shift, the operator reported they were not cleared for the blast.</p>
<b>Risk Category</b>	Actionable – Significant (3) Likely (3)
<b>Findings / Missing Controls</b>	<ul style="list-style-type: none"> <li>Failure to properly clear blast zone – employee was never picked up.</li> </ul>
<b>Applicable Policies / Procedures</b>	<ul style="list-style-type: none"> <li><a href="#">FCX - HS15 Surface Blasting Policy - 2021</a></li> </ul>

Clearing map from June 13, 2024.

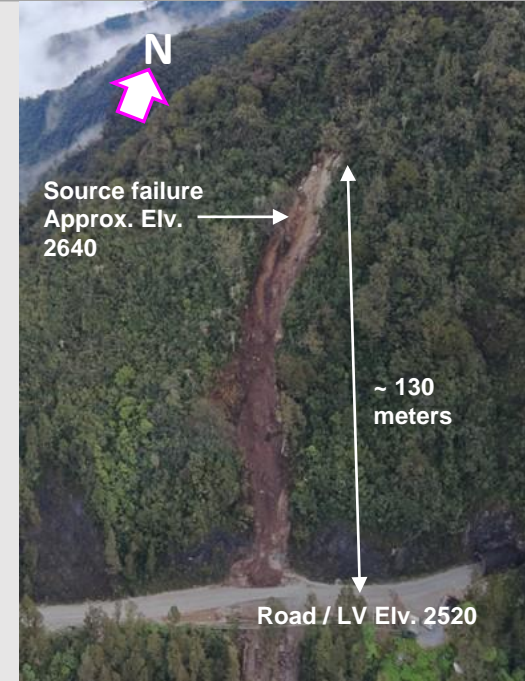
<b>Operation</b>	PTFI – Road Maintenance and GeoEngineering
<b>Date / Time</b>	June 11, 2024 / 1:58 a.m.
<b>Event Type</b>	Property Damage
<b>Summary</b>	A light vehicle was escorting a cargo convoy on the Mine Supply Route (MSR). The vehicle was hit by landslide material, damaging the vehicle’s hood and left front end. A driver and three passengers were in the vehicle and sustained no injuries. The landslide came from hanging material on the upper slope, which was residual hazard from a landslide on June 3, 2024.
<b>Risk Category</b>	Actionable – Significant (3) Possible (3)
<b>Findings / Missing Controls</b>	<ul style="list-style-type: none"> <li>A Trigger Action Response Plan (TARP) was in place at the time of the incident. <ul style="list-style-type: none"> <li>It triggered an inspection of the previous landslide area approximately two hours before the new slide but did not require a road closure.</li> </ul> </li> <li>A newly developed TARP was in the review process the night of the incident. <ul style="list-style-type: none"> <li>The new process proposed a road closure trigger, which was implemented the next day (June 12).</li> </ul> </li> </ul>

Source of the landslide came from upper slope. Consisted of topsoil, vegetation and boulders.

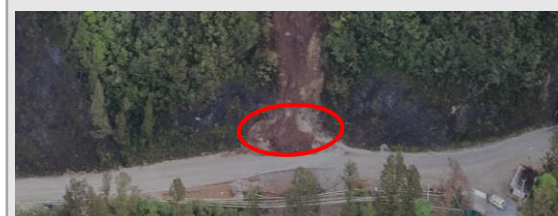
Small material retained inside the temporary berm.

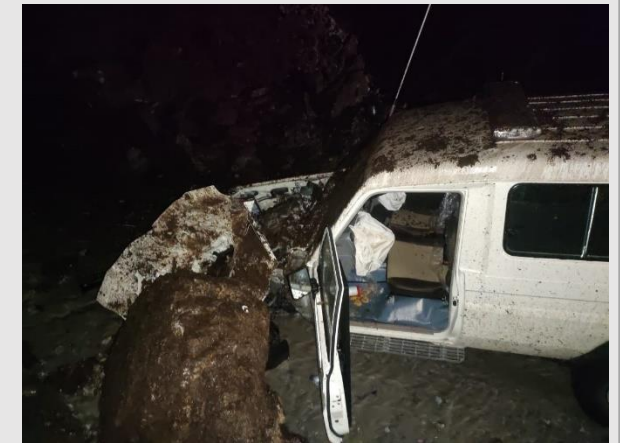
Boulder from the landslide struck light vehicle after passing through a tunnel.

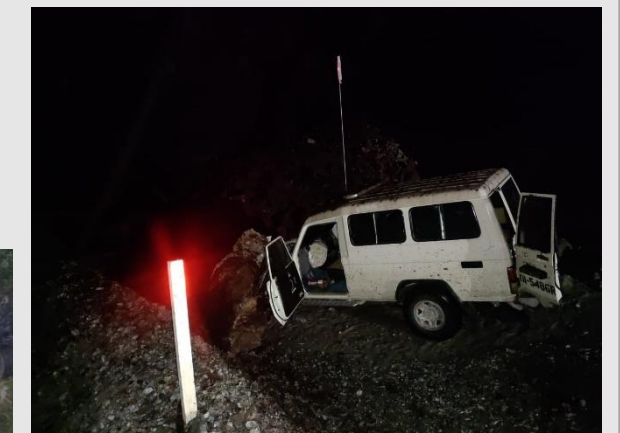
Front and rear passengers were able to exit the vehicle uninjured.

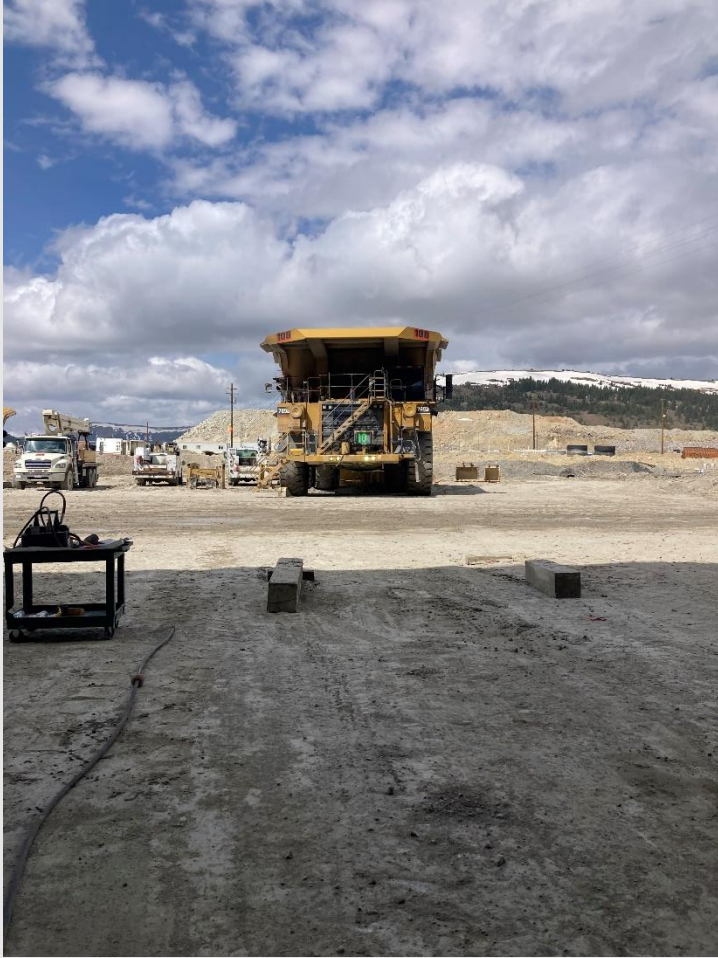
<b>Operation</b>	Climax
<b>Date / Time</b>	June 19, 2024 / 10:25 a.m.
<b>Event Type</b>	Near Miss
<b>Summary</b>	As part of routine maintenance activities, an employee set up a haul truck on wood planks in front of a bay at the shop to remove both outer tires. The employee noticed the truck wasn't properly centered and went to move it, but it wouldn't start. The employee called over two other technicians, who went under the truck and behind the front left tire to air start it. When air was applied, the truck started and rolled backward, missing the two technicians underneath. The truck traveled about 25 yards in reverse across the road before coming to a stop against a berm. Initial review indicates the park brake was not set and only one chock was set.
<b>Risk Category</b>	Actionable – Significant (3) Likely (3)
<b>Findings / Missing Controls</b>	<ul style="list-style-type: none"> <li>• Failure to follow proper protocols</li> <li>• Park brake was not set</li> <li>• Only one chock was placed to prevent movement</li> </ul>

*A view of the haul truck after it rolled off the wood planks and crossed the road in reverse before coming to a stop against a berm.*

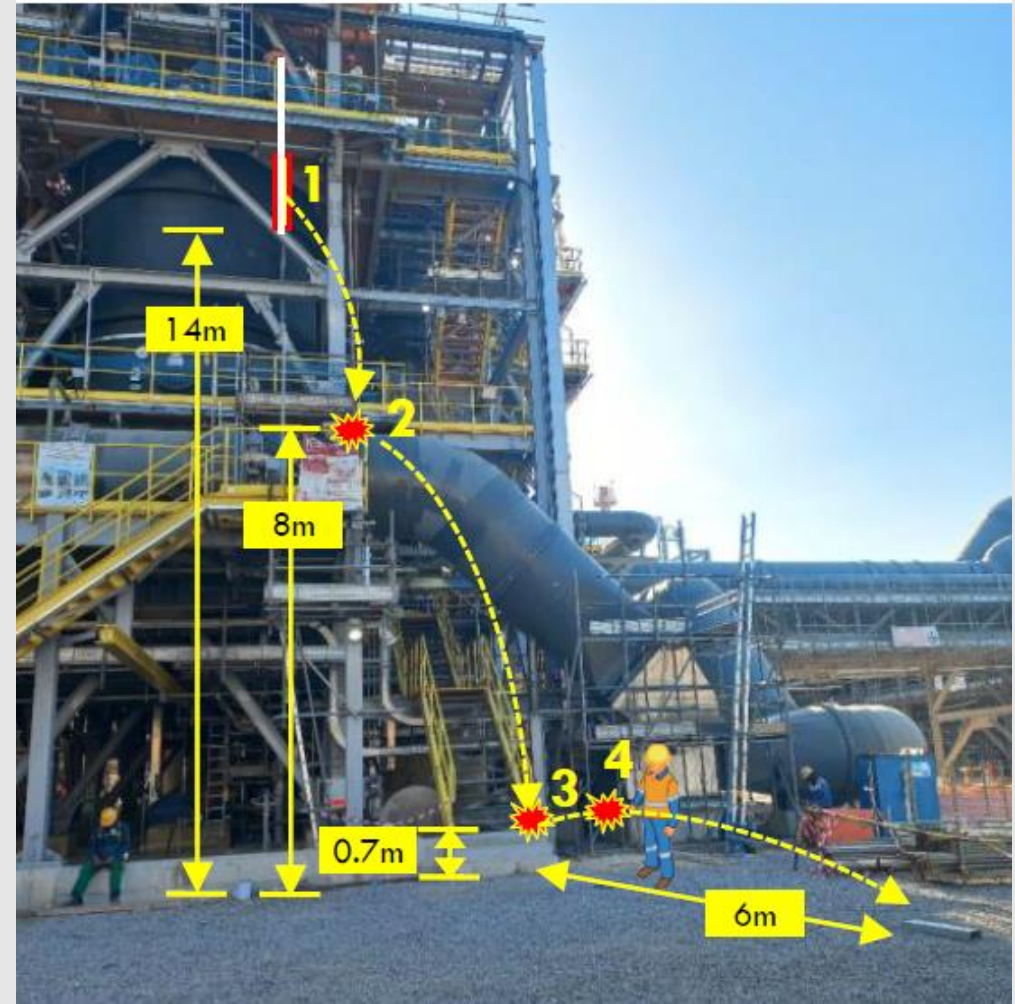
<b>Operation</b>	Manyar Smelter Project
<b>Date / Time</b>	June 20, 2024 / 1:30 p.m.
<b>Event Type</b>	Injury - Medical Treatment
<b>Summary</b>	While performing housekeeping activities, a C-channel (approximately 25 lbs) was hoisted with a 12-mm nylon rope from the third to the second level of the structure. While being hoisted, the C-channel beam became untied and fell. It bounced off the structure three times and struck the right hand of an employee who was walking before landing on the ground.
<b>Risk Category</b>	Monitor – Significant (3) Likely (2)
<b>Findings / Missing Controls</b>	<ul style="list-style-type: none"> <li>The area immediately below the structure was barricaded, but the beam bounced outside the exclusion zone.</li> </ul>
<b>Applicable Policies / Procedures</b>	<ul style="list-style-type: none"> <li>Site Dropped Object Prevention Plan</li> <li>Site Permit to Work procedures</li> <li><a href="#">Flagging and Barricading Policy</a></li> </ul>

<b>Employee Condition</b>	<ul style="list-style-type: none"> <li>Employee suffered a contusion on the hand and a fractured finger.</li> </ul>
<b>Contact</b>	<ul style="list-style-type: none"> <li>Zachary Scrivner, Manager-Corporate Project Engineering Safety</li> </ul>

Diagram of the dropped channel path, contact points and elevations.
