## Freeport Safety Updates

June 2024

(Incidents and Communications from May 2024)

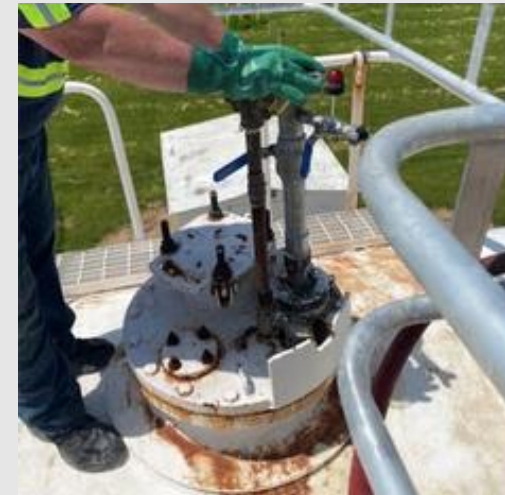
<b>Operation</b>	Fort Madison
<b>Date / Time</b>	May 13, 2024 / 12:10 pm
<b>Event Type</b>	Injury – Medical Treatment
<b>Summary</b>	A contractor was depressurizing an acid railcar. While attempting to check the low side pressure valve tree, the employee was unable to maintain a tight seal on the valve and was sprayed with 93% sulfuric acid. The contractor was wearing chemical gloves, a suit, boots, face shield and goggles.
<b>Risk Category</b>	Actionable – Significant (3) Likely (3)
<b>Findings / Missing Controls</b>	<ul style="list-style-type: none"> <li>Acid tank was not properly depressurized. <ul style="list-style-type: none"> <li>Operator deviated from depressurizing procedures.</li> <li>Improper depressurizing training.</li> </ul> </li> <li>Missing and improperly worn personal protection equipment.</li> <li>Failure to conduct periodic monitoring and assessment of contractor transload operations.</li> </ul>

Re-enactment of valve assembly.

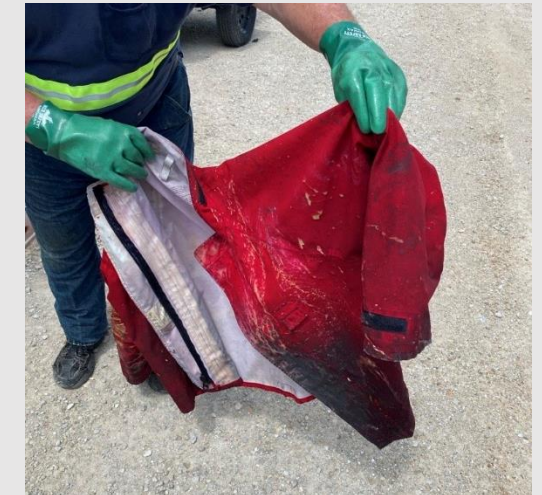
<b>Applicable Policies / Procedures</b>	<ul style="list-style-type: none"> <li><a href="#">FCX-HS28 – Sulfuric Acid Bulk Handling Policy</a></li> <li><a href="#">FCX-HS01 Administration Requirements Policy</a></li> </ul>
<b>Employee Condition</b>	<ul style="list-style-type: none"> <li>Contractor sustained second-degree burns.</li> </ul>
<b>Contact</b>	<ul style="list-style-type: none"> <li>Michael Alsbrook, Manager-Health and Safety</li> <li>Sarah Johnson, Manager-Moly Operations</li> </ul>

Contractor suit following acid exposure.

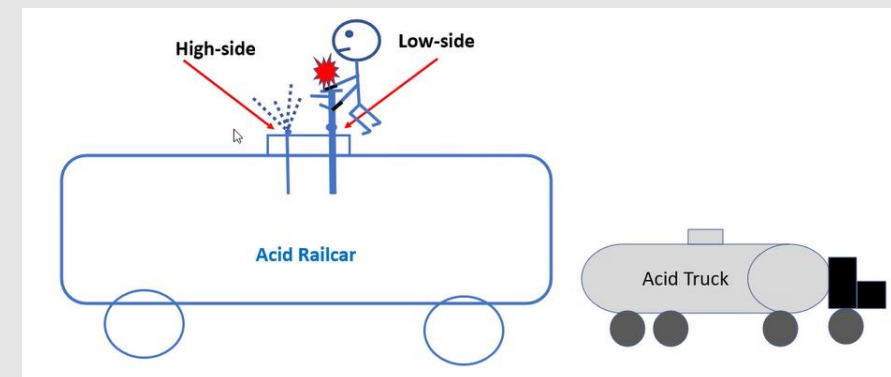
Railcar tank set up.

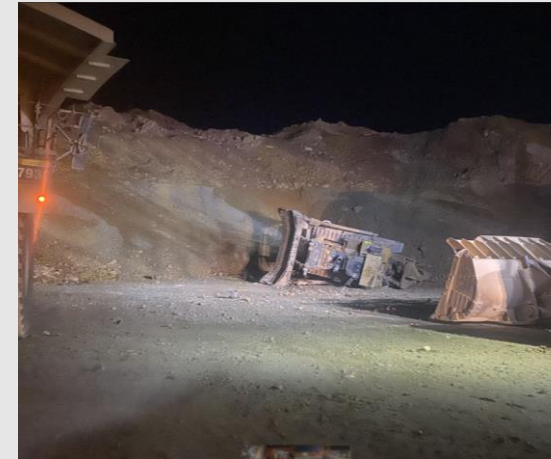
<b>Operation</b>	Cerro Verde
<b>Date / Time</b>	May 25, 2024 / 11:17 p.m.
<b>Event Type</b>	Injury – First Aid
<b>Summary</b>	A dozer was tasked with pushing down a corniced overhang in fill material to two loaders below. The dozer used an existing ramp to access the top and decided to move a small windrow in the access; which wasn't part of the job. While doing so, the operator moved too close to the corniced crest and rolled one-and-a-quarter times down an 8-meter bank before stopping. A loader operator immediately issued a Mayday.
<b>Risk Category</b>	Actionable – Significant (3) Likely (3)
<b>Findings / Missing Controls</b>	<ul style="list-style-type: none"> <li>• Dozer operator expanded access on the upper mining face.</li> <li>• The dozer was working parallel to the corniced ridge.</li> <li>• The weight of the dozer was not supported.</li> </ul>
<b>Applicable Policies / Procedures</b>	<ul style="list-style-type: none"> <li>• Site-specific standard operating procedures.</li> </ul>

• A CAT truck was leaving the loading front when the dozer fell. The loader operator activated the emergency button and activities were stopped.

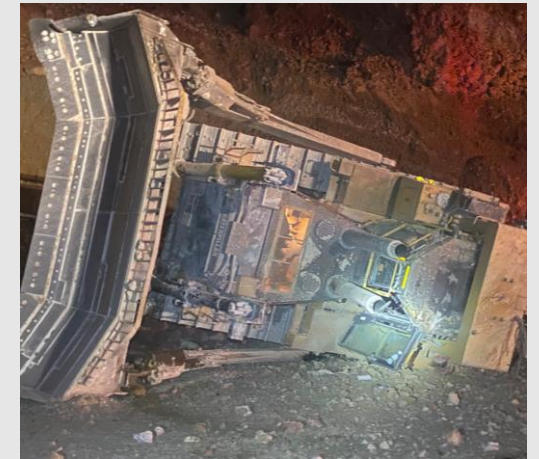
• Dozer position following the roll. The operator exited the machine without assistance.

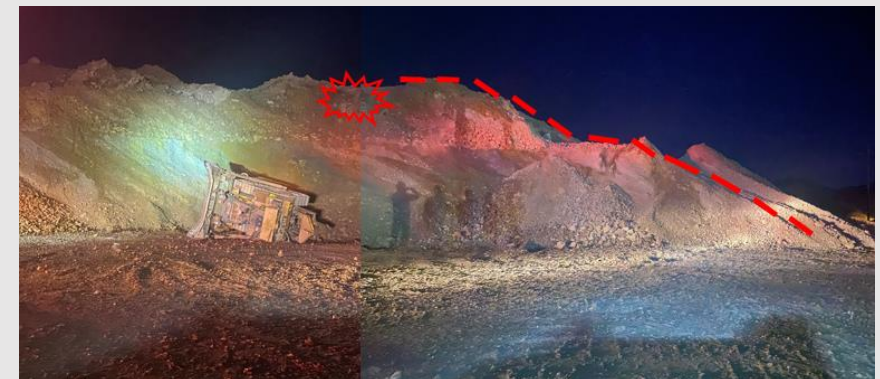
• Trajectory of the tractor, to the point where it slid and rolled down an 8-meter bank.

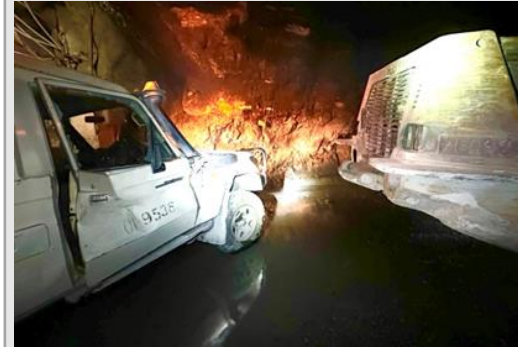
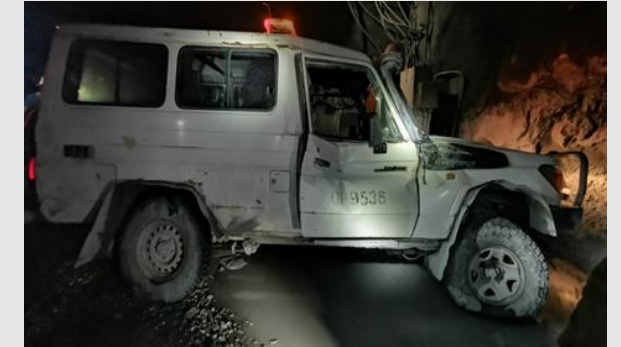
<b>Operation</b>	PTFI – Underground Mines Division, GBC Mine
<b>Date / Time</b>	May 8, 2024 / 2:55 a.m.
<b>Event Type</b>	Property Damage
<b>Summary</b>	A loader (LHD) was travelling up a ramp in reverse toward an intersection to turn left. Before entering the intersection, the operator stopped, sounded the horn four times and flashed the lights. A light vehicle (LV) – unaware of the LHD and stop sign – approached the intersection in third gear, slowed and sounded the horn about 4 meters before entering the area. Upon doing so, the LV was struck by the LHD’s rear tow hook and cabin side wings. The LV was pushed into the rib and then back about 4.4 meters, resulting in significant damage to the driver's side door and front, righthand-side quarter panel. In addition, the driver's side window and windshield were broken, and both tires on the passenger side were pulled off the rim.
<b>Risk Category</b>	Actionable – Significant (3) Likely (3)

<b>Findings / Missing Controls</b>	<ul style="list-style-type: none"> <li>• Failure by LV to follow procedure for approaching and safely passing through intersection.</li> <li>• Failure by LHD to follow the Traffic Management Plan – the area is listed as one-way.</li> <li>• The reverse camera was not functioning, which increased the LHD blind-spot while reversing.</li> <li>• The reverse camera is a critical component on pre-start inspection, but the operator used an outdated pre-start checklist without the camera listed.</li> </ul>
<b>Applicable Policies / Procedures</b>	<ul style="list-style-type: none"> <li>• SOP-6.01-UG-J01 LHD Operation Procedure</li> <li>• SOP-4.04-PTFI-002 Light Vehicle Operation</li> </ul>
<b>Employee Condition</b>	<ul style="list-style-type: none"> <li>• No employees were injured.</li> </ul>
<b>Contact</b>	<ul style="list-style-type: none"> <li>• Anthony Hall, Manager-GBC Development</li> <li>• Andri Abdullah, Manager-Health &amp; Safety UG Division</li> </ul>

Damage to light vehicle.

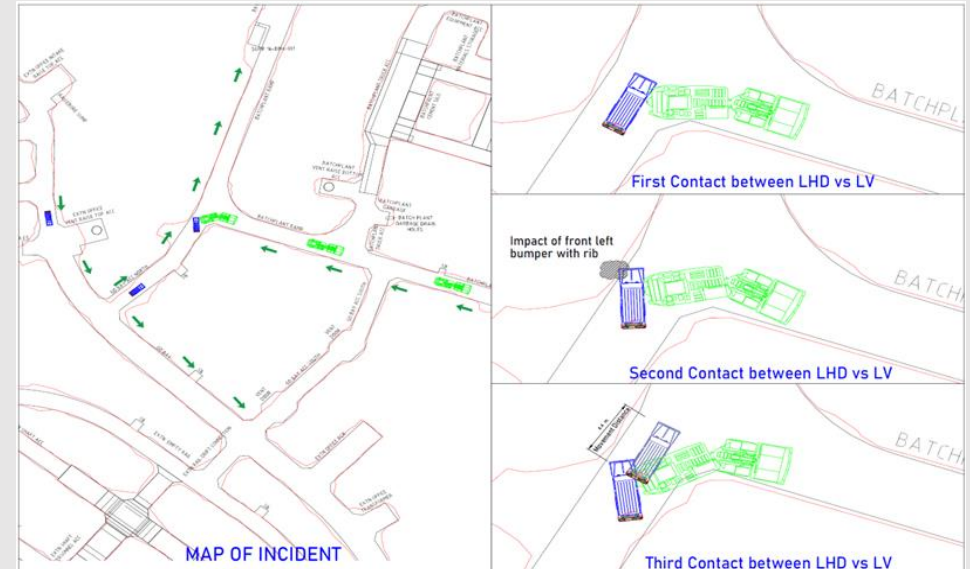
Incident sketch.

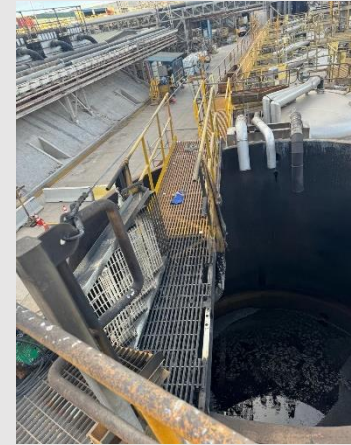
<b>Operation</b>	El Abra
<b>Date / Time</b>	May 13, 2024 / 4:05 p.m.
<b>Event Type</b>	Injury – First Aid
<b>Summary</b>	Three contractors were performing hot work on a platform at the tank farm. A failure in the undersized extension cord caused a fire at the welding machine, which subsequently spread to the fire blanket. One employee who was tied-off was unable to get free from the harness until the lanyard was completely burned through by the fire. The other employee attempted to suppress the fire with a portable fire extinguisher but was unsuccessful. The emergency response team was notified and quickly arrived on scene to extinguish the fire.
<b>Risk Category</b>	Actionable – Significant (3) Likely (3)
<b>Findings / Missing Controls</b>	<ul style="list-style-type: none"> <li>• Improper selection of appropriately rated extension cord.</li> <li>• Improper evaluation of fire risk and exposure to electrolyte backwash tank.</li> <li>• Improper use of fire blanket – the blanket was left in place for a week and was subsequently contaminated with organic.</li> <li>• Standard operating procedures was not developed for hot work around the tank farm.</li> </ul>

Platform where fire started.

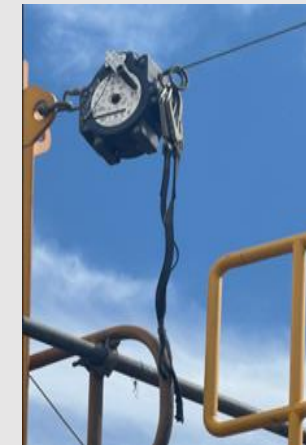
Reactor and burned lanyard.

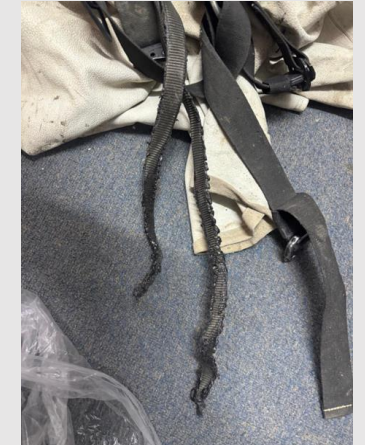
Burned lanyard.

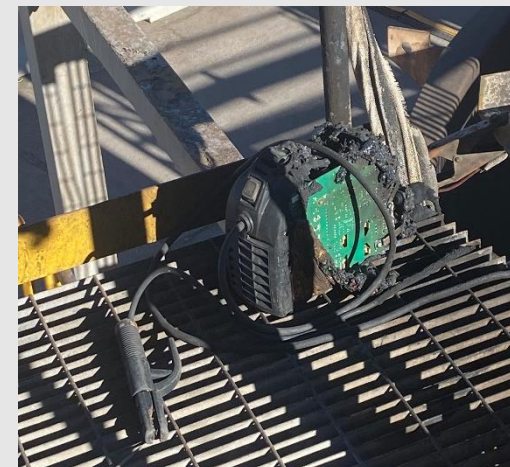
Burned welding machine.

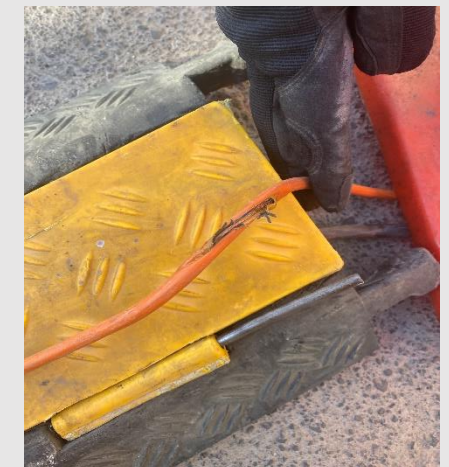
Failed extension cord.

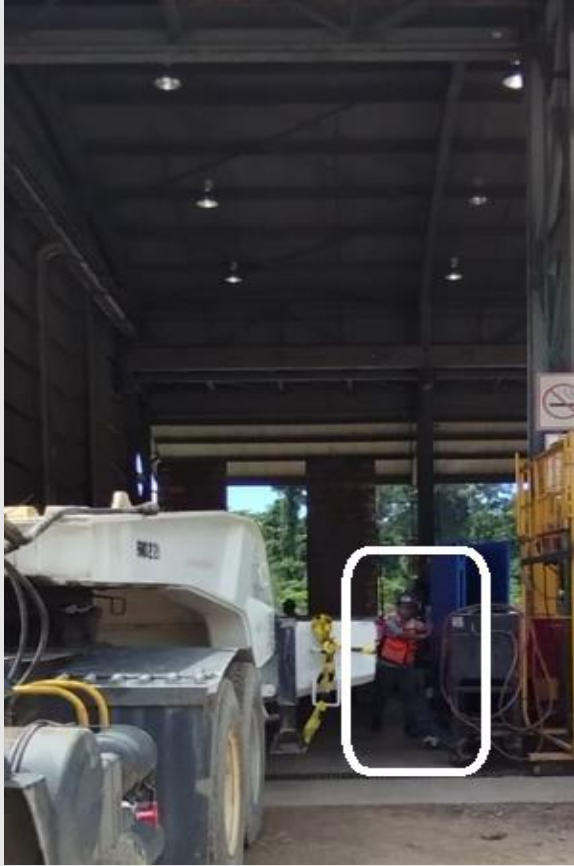
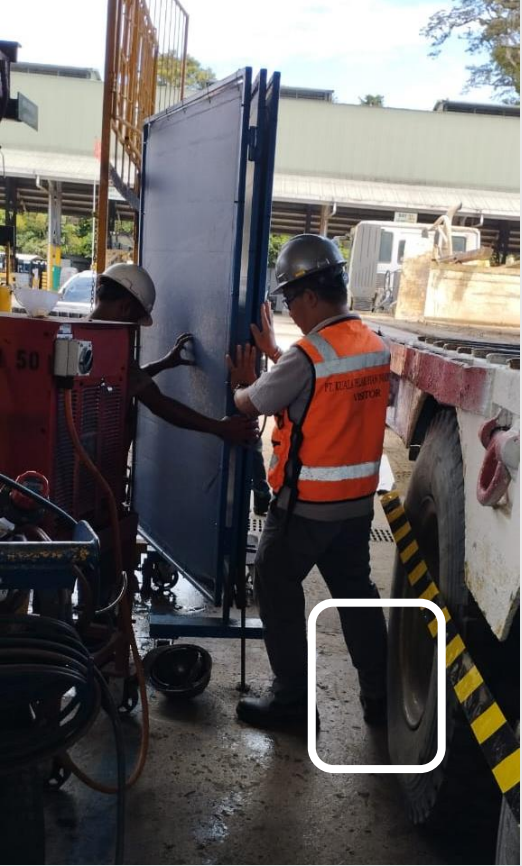
Preliminary Incident Details	
<b>Operation</b>	PTFI Technical Services – Maintenance Support Division
<b>Date / Time</b>	May 29, 2024 / 7:59 a.m.
<b>Event Type</b>	Injury – Medical Treatment
<b>Summary</b>	A lowboy was moving out of the trailer shop at 5km/h (3 mph) with a spotter on the right side. Another employee approached the moving equipment from the left side to move a welding screen that had potential to be hit. The employee was positioned facing the welding screen. The left rear tire of the lowboy ran over the employee's right foot, resulting in major leg and foot injuries.
<b>Risk Category</b>	Actionable – Significant (3) Likely (3)
<b>Findings / Missing Controls</b>	<ul style="list-style-type: none"> <li>• Failure to maintain safe distance from moving vehicles.</li> <li>• Failure to maintain safe visibility (victim unseen by spotter).</li> <li>• Failure to maintain positive communication between operator, spotter and offsideers.</li> </ul>

<ul style="list-style-type: none"> <li>• Incident reenactment. Position of employee to moving equipment.</li> </ul>	<ul style="list-style-type: none"> <li>• Incident reenactment. Position of employee's right foot and the welding screen. The lowboy was moving 5km/h (3 mph).</li> </ul>

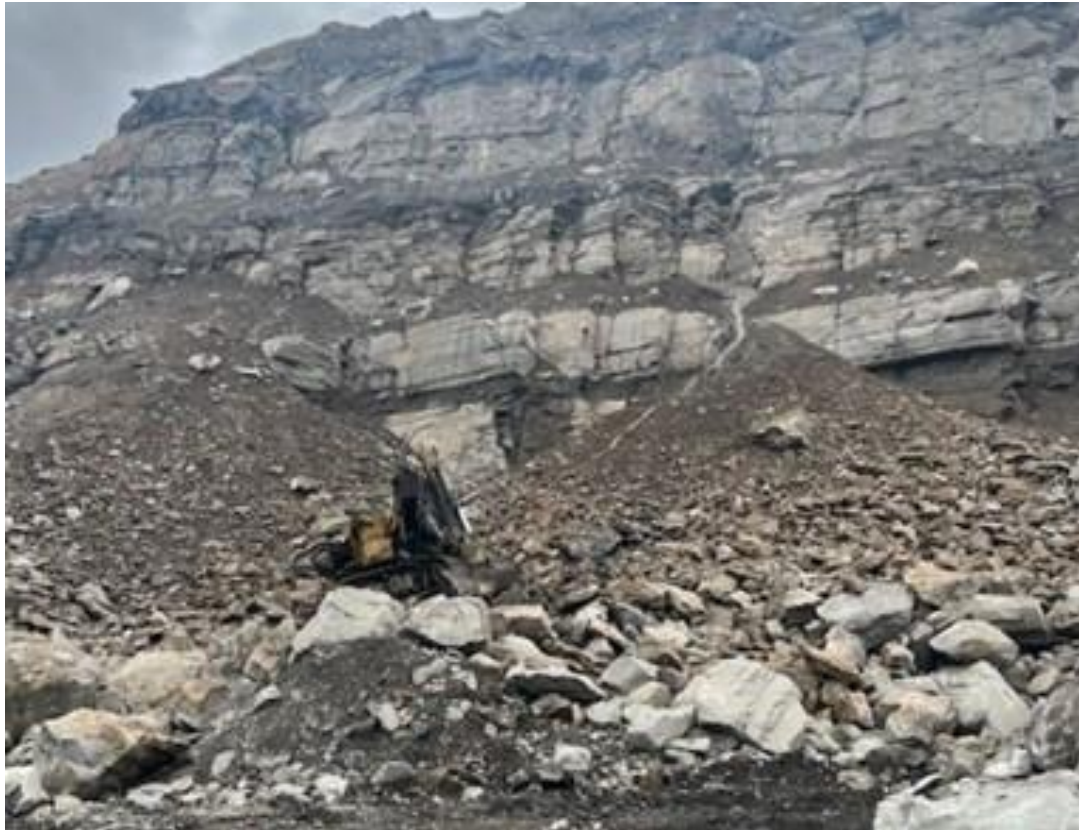
**MINE FATALITY** – On May 16, 2024, a miner died when the excavator he was operating traveled over a 200-foot highwall.

- Reduce fall hazard exposure by limiting the distance equipment can safely operate near the edge of highwalls.
- Examine benches to identify hazards related to insufficient bench width, locations of other equipment, loose material, etc.
- Discuss highwall hazards with miners and train miners to recognize these hazards.
- Address hazards in the mine's Surface Mobile Equipment Safety Program. Include safe work practices for weather conditions (fog, heavy rain, or snow) that could reduce visibility.
