FCX Monthly Safety Content

FCX Safety Updates

November 2023

(Incidents and Communications from October 2023)

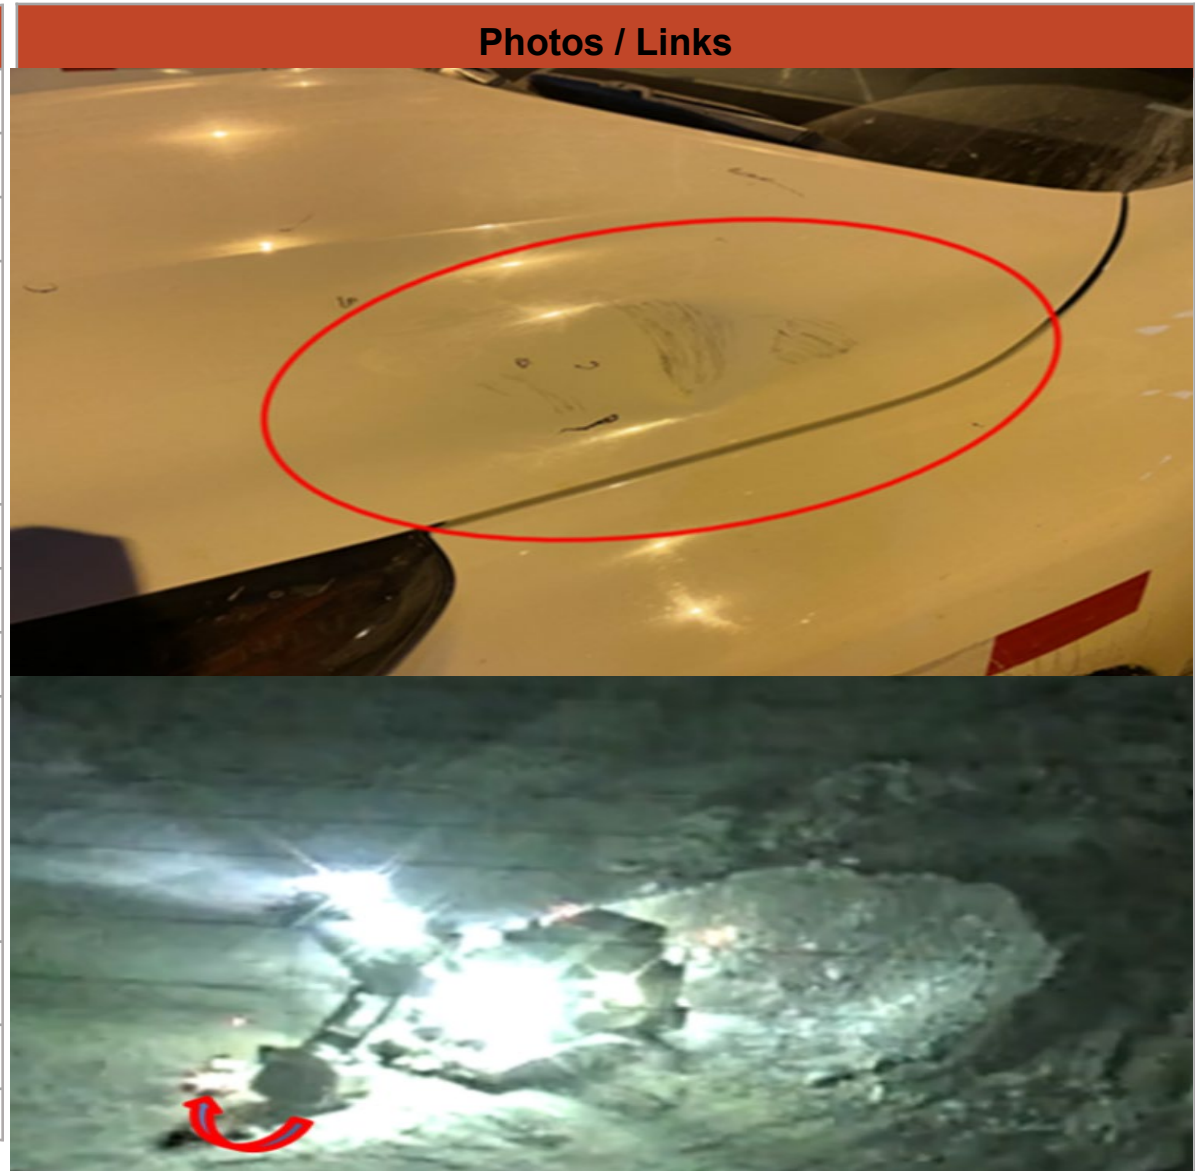
High Risk Event: Shovel Hit a Parked Truck

Incident Details	
Operation	Cerro Verde
Date / Time	September 20, 2023 / 12:30 a.m.
Type	Property Damage
Summary	During a shovel operator change, the outgoing operator placed the bucket on the ground, and the incoming operator parked near the shovel. The bucket began to rotate slowly and hit the hood of the parked vehicle.
Fatal Risk	Vehicle Collision or Rollover
Risk Category	Actionable
Pre / Post Rating	Significant (3) Likely (3) NOT A PFE
Absent / Insufficient Controls	<p>Non-compliance of Procedures:</p> <ul style="list-style-type: none"> Entering and parking within shovel rotation radius without authorization Failure to apply equipment brakes after bucket was placed on the ground
Applicable Policies / Procedures	<ul style="list-style-type: none"> FCX-23 Interaction with Heavy Mobile Equipment
Employee Condition	No Injury
Contact	Frank Tapia, Superintendent – Mine Operations

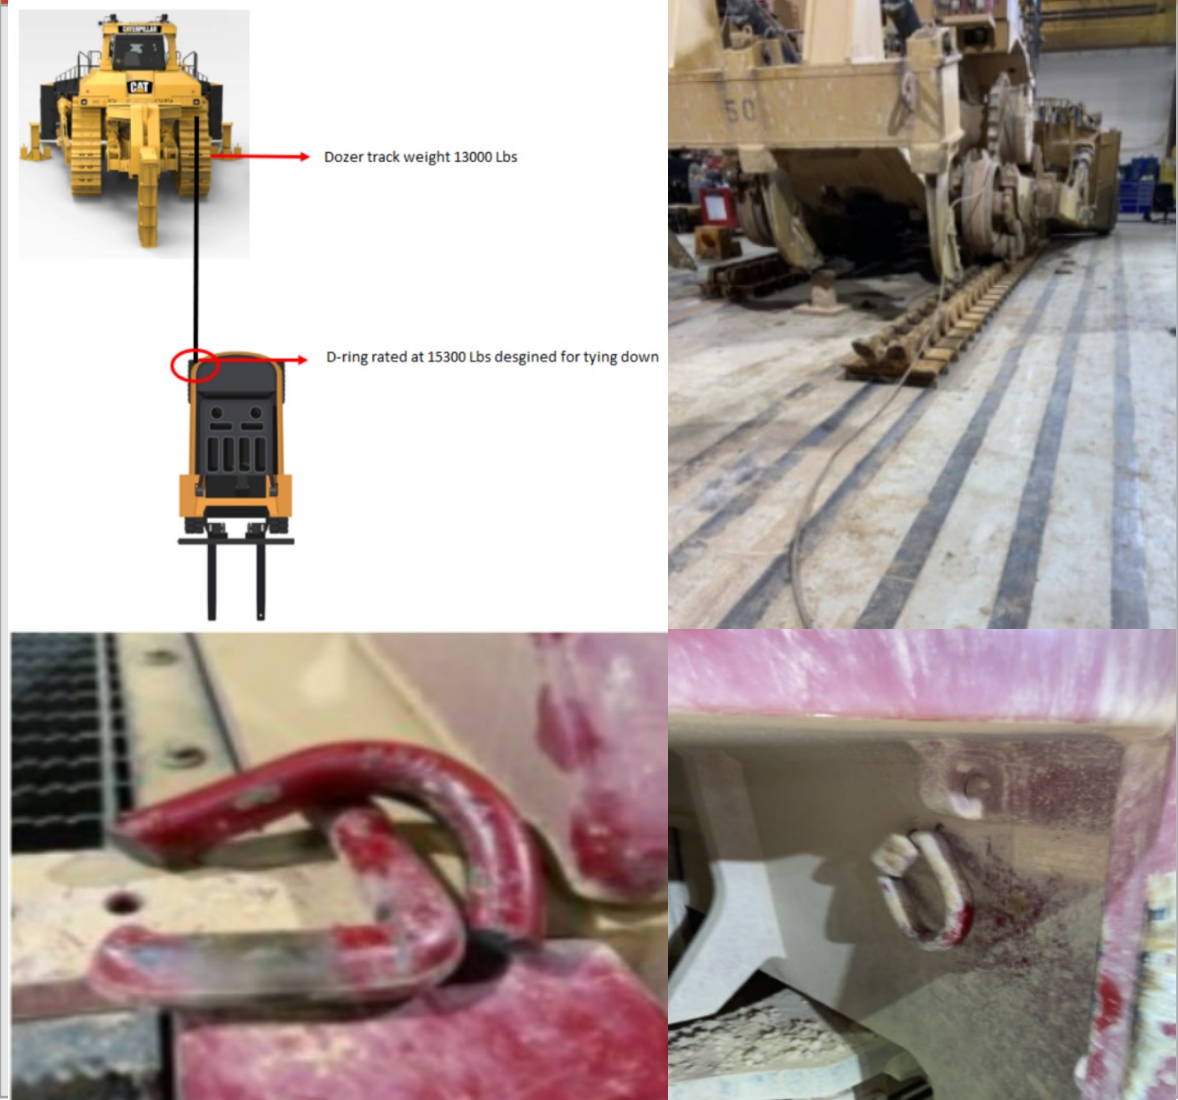
High Risk Event: D-Ring Failure

Operation	Morenci
Date / Time	September 29, 2023 / 10:30 p.m.
Type	Near Miss
Summary	While rigging up the cable to the D-rings on the back of the FL090A Forklift for a track change, the operators put tension to the track for installation of the track and the D-ring on the right side of the forklift failed, causing the ring to break and be projected across the shop area striking a toolbox in its path.
Fatal Risk	Uncontrolled Release of Energy
Risk Category	Monitor
Pre / Post Rating	Significant (3) Possible (2) NOT A PFE
Absent / Insufficient Controls	<ul style="list-style-type: none"> The wire rope sling was connected to the forklift D-ring that is not designed for pulling or lifting.
Applicable Policies / Procedures	<ul style="list-style-type: none"> SOP – Changing a Bulldozer Track
Employee Condition	No Injury
Contact	Joseph Rodriguez, Superintendent Mine Maintenance

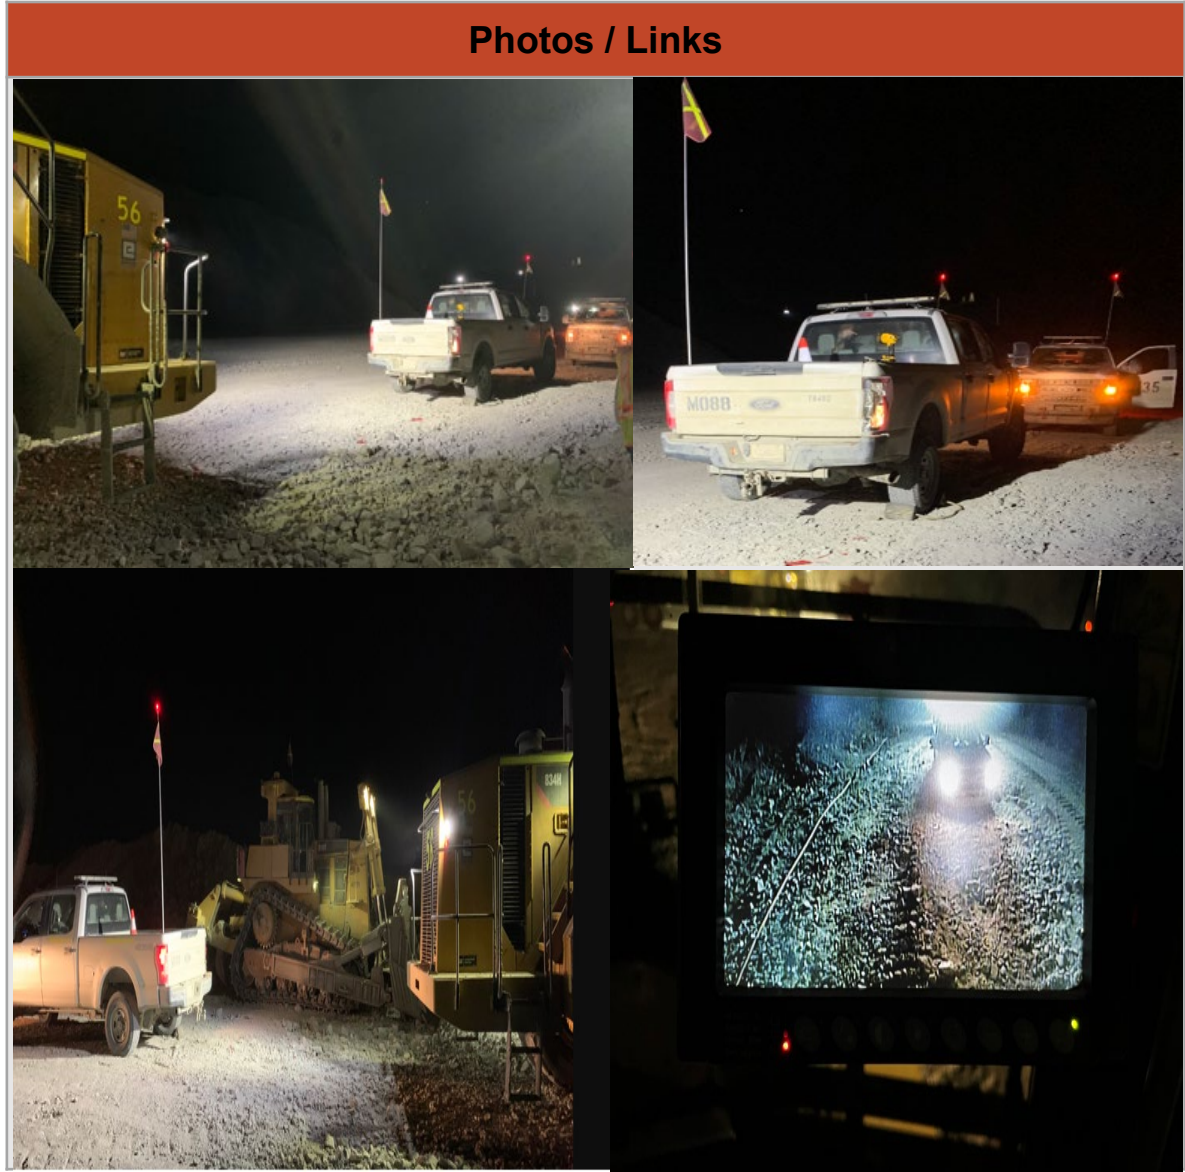
High Risk Event: RTD Backed into Light Vehicle

Incident Details	
Operation	Sierrita
Date / Time	October 3, 2023 / 10:10 p.m.
Type	Property Damage
Summary	Rubber tire operator backed his rubber tire into the rear tailgate area of the oiler's pickup, which was parked approx. 15ft from the rear of the rubber tire. This caused damage to the MO88's right rear taillight.
Fatal Risk	Vehicle Collision or Rollover
Risk Category	Monitor
Pre / Post Rating	Significant (3) Possible (2) NOT A PFE
Absent / Insufficient Controls	<ul style="list-style-type: none"> Failure to Utilize Mirrors/Cameras on Equipment Standard of work or SOP being reviewed with crews on parking distance between light Vehicles and Heavy Equipment
Applicable Policies / Procedures	<ul style="list-style-type: none"> Interaction with Heavy Mobile Equipment- Surface Road Design, Light vehicle & Ground Personnel Policy
Employee Condition	No Injury
Contact	Allen Bruce Kinney, Mine Superintendent

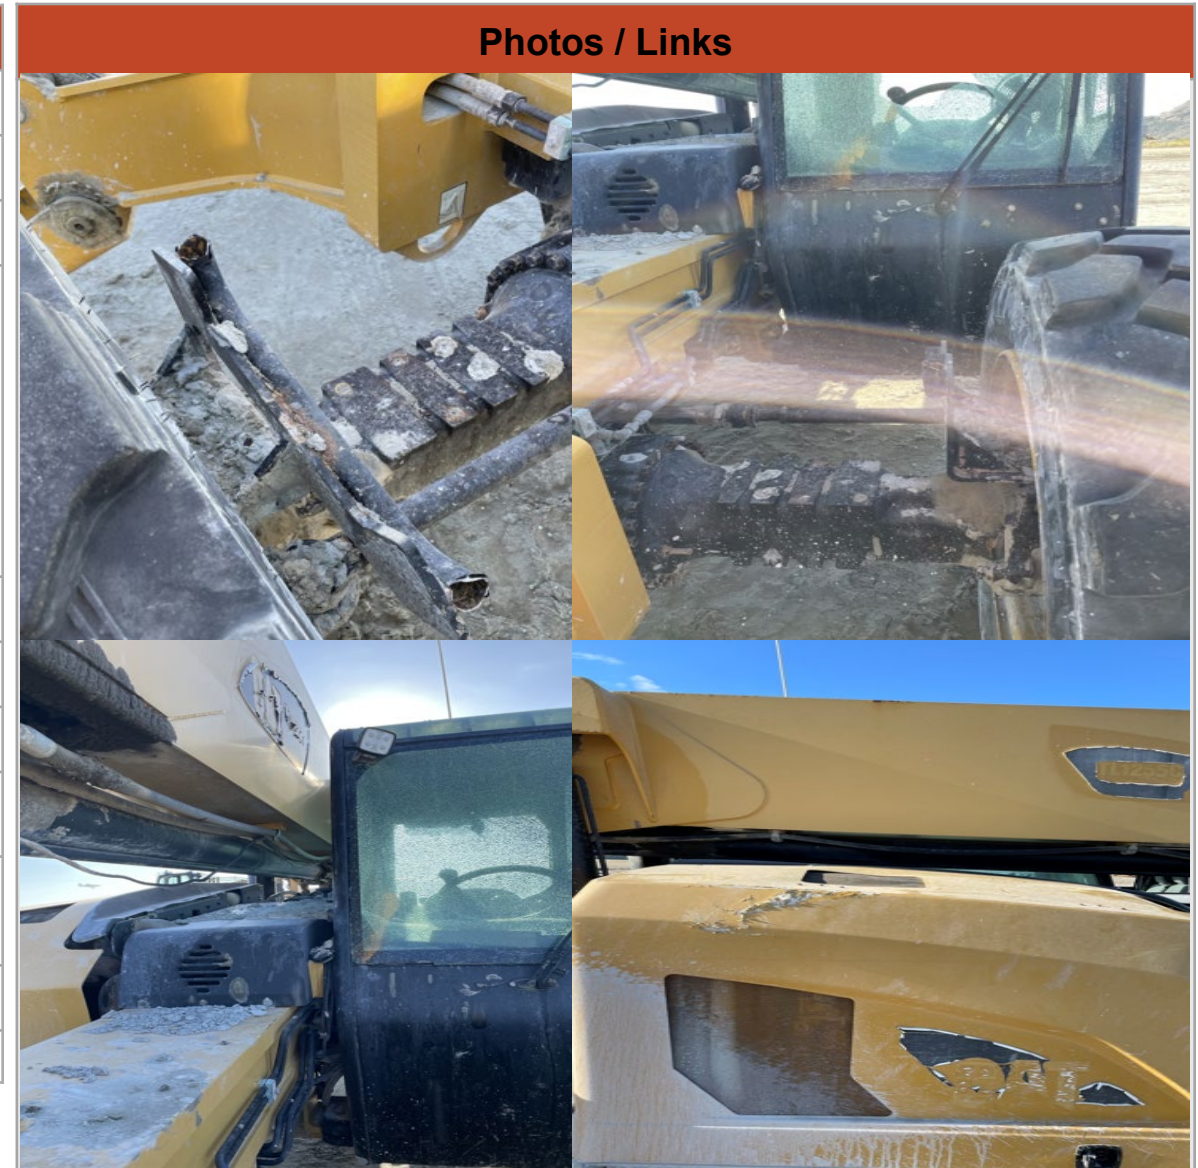
High Risk Event: Discharge Line Struck Reach Fork

Incident Details	
Operation	Sierrita
Date / Time	October 11, 2023 / 7:40 a.m.
Type	Property Damage
Summary	While working to relocate the berm builder discharge line, the pipe became stuck on the impoundment berm. In the process of repositioning the reach fork to free the line, the pipe fell off the forks and struck the reach fork, breaking the fender, mirror, and windshield.
Fatal Risk	Uncontrolled Release of Energy
Risk Category	Actionable
Pre / Post Rating	Significant (3) Likely (3) NOT A PFE
Absent / Insufficient Controls	<ul style="list-style-type: none"> No specific SOP
Applicable Policies / Procedures	<ul style="list-style-type: none"> Develop standard of work and train employees HDPE Pipe Handling Policy
Employee Condition	No Injury
Contact	Chris Fiedler, Tailing Superintendent

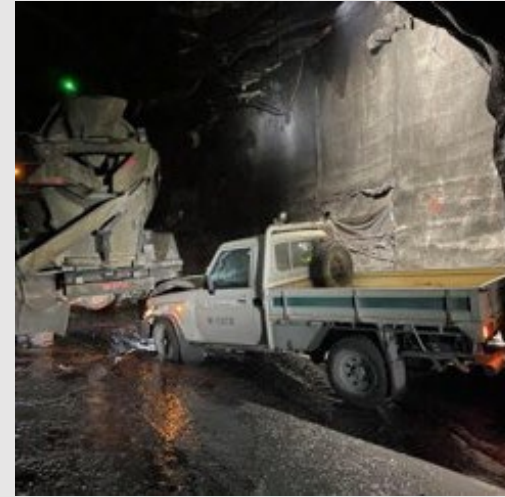
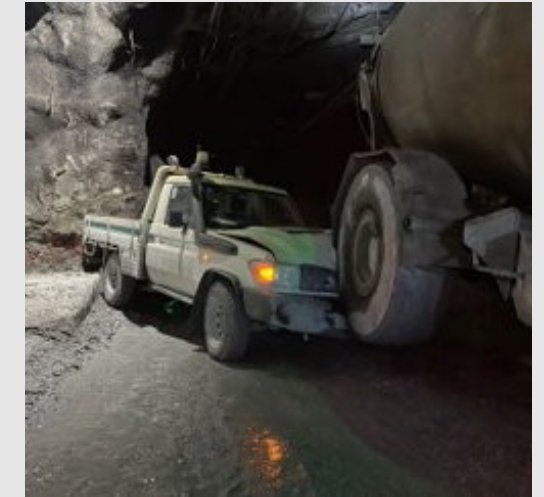
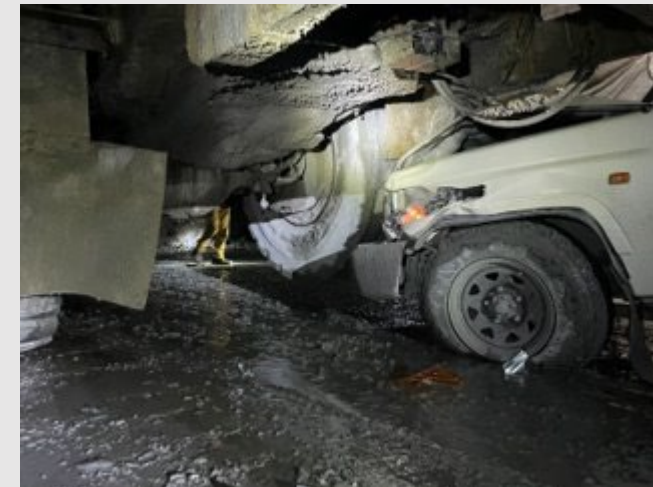
Potential Fatal Event: SVS Mixer Contacts Light Vehicle

Operation	PT Freeport Indonesia
Date / Time	September 12, 2023 / 2:25 p.m.
Type	Property Damage
Summary	A light vehicle was traveling along a drift to the crane bay shop and came up behind an SVS mixer that was stopped behind a line of vehicles blocked by a Jumbo drill. The LV along with other vehicles began to reverse to seek alternative access. The LV stopped when the truck behind it stopped, but the SVS mixer kept reversing. The LV driver sounded the horn. The SVS mixer continued to reverse and contacted the LV, pushing it into the rib. The front left tire burst, damaging the front end and hood. No one was injured.
Fatal Risk	Vehicle Collision or Rollover
Risk Category	Actionable
Pre / Post Rating	Significant (3) Likely (3)
Findings / Missing Controls	<ul style="list-style-type: none"> • Failure to initiate correct action – SVS mixer lost visual of the LV and continued to reverse • Competing sounds made the LV horn inaudible

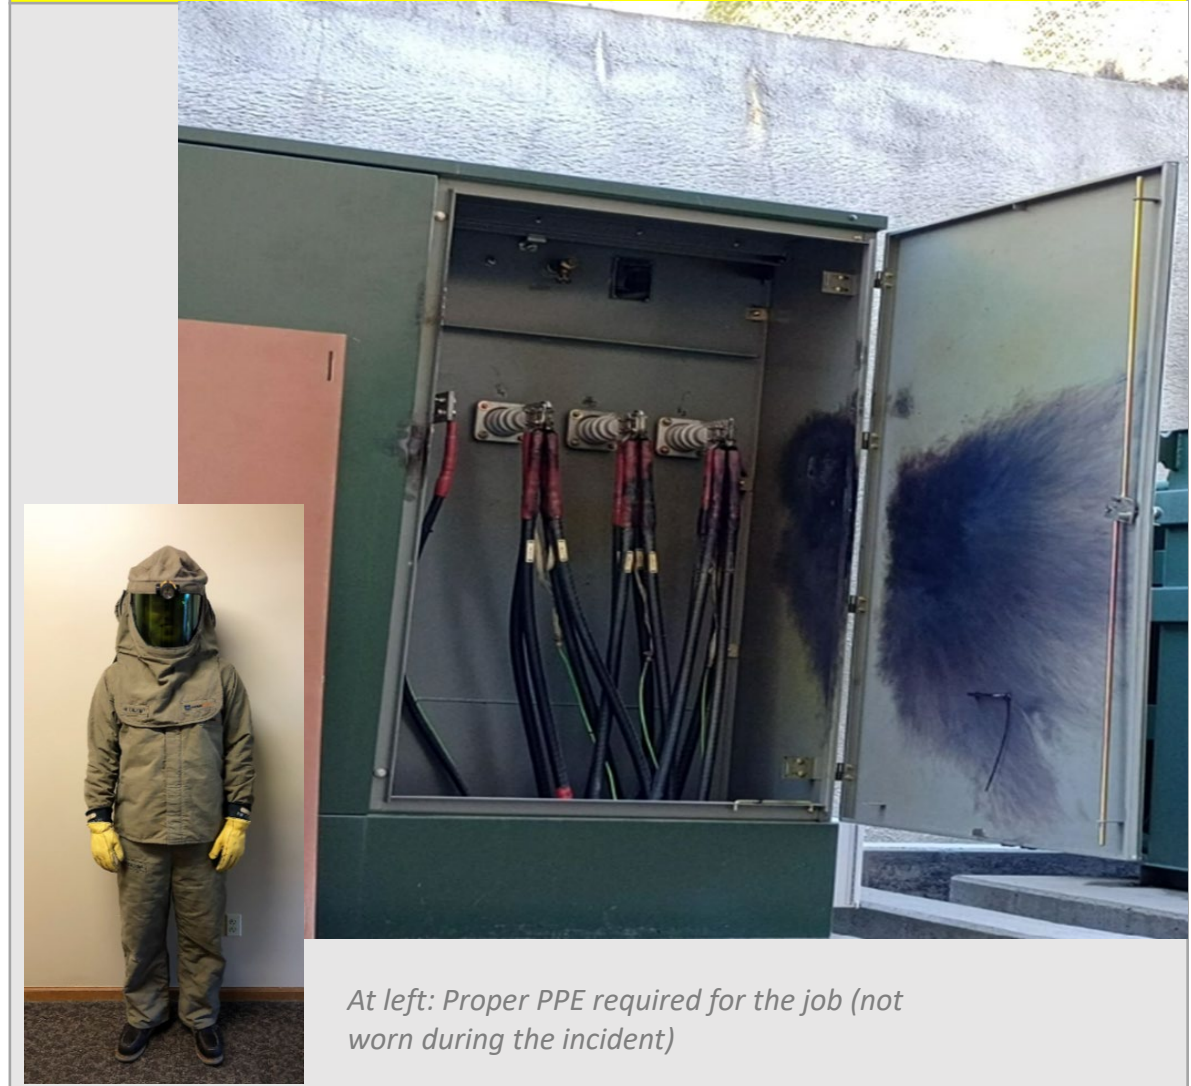
Operation	Climax
Date / Time	September 30, 2023 / 8:10 a.m.
Type	Injury
Summary	<p>Two electrical subcontractors involved in rerouting a power line for the new water treatment plant under construction at Climax were preparing to check the phase rotation of a 4160-volt transformer that had not been de-energized. When they attempted to attach the meter, an arc flash occurred.</p> <p>The workers were not wearing the proper PPE, and both sustained burns to the face. One was treated at the hospital and released while the other was hospitalized with second-degree burns.</p>
Fatal Risk	Exposure to Electrical Hazards
Risk Category	Monitor
Pre / Post Rating	Significant (3) Possible (2)
Findings / Missing Controls	<ul style="list-style-type: none">Contractors were not using appropriate PPEInstrumentation was rated for 600 volts
Applicable Policies / Procedures	FCX-HS03 Electrical Safety Policy
Employee Condition	Both workers sustained first- and second-degree burns to the face.

At left: Proper PPE required for the job (not worn during the incident)

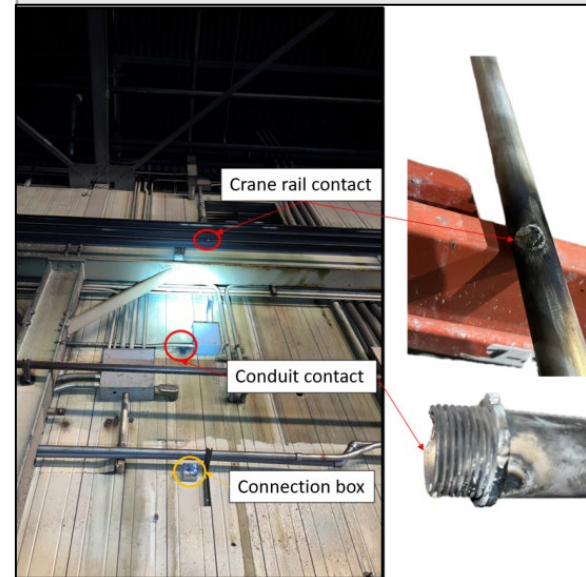
Overhead crane rail and wall

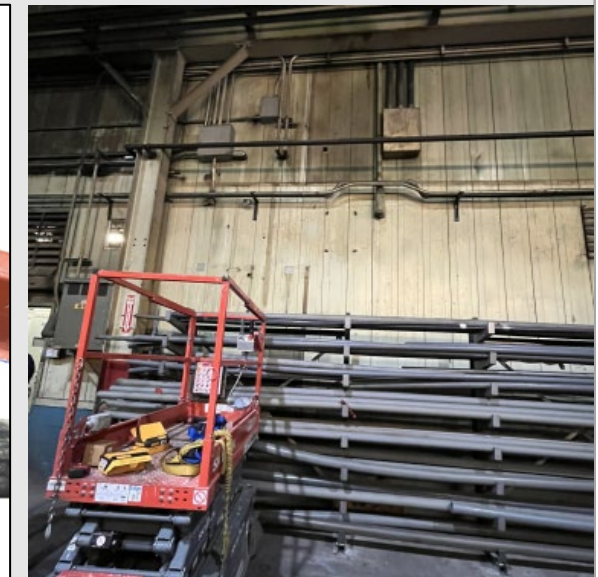
Contractors were installing conduit using scissor lift

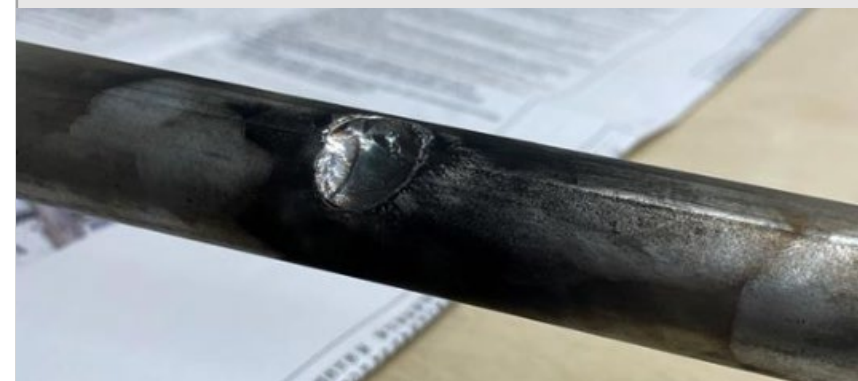
Operation	El Paso Rod Mill
Date / Time	October 3, 2023 / 3 p.m.
Type	Near Miss
Summary	Electrical contractors installing communication line conduit inside of a motor control center got ahead of schedule and began installing the conduit on the wall outside of the MCC near an overhead crane rail. Unaware the crane was energized, one of the workers contacted the rail's 480-volt power line, causing a short and arc to ground. No injuries were sustained, and power to the overhead crane tripped off.
Fatal Risk	Exposure to Electrical Hazard
Risk Category	Monitor
Pre / Post Rating	Significant (3) Possible (2)
Findings / Missing Controls	<ul style="list-style-type: none">Contractors proceeded with work in an area outside the original scope of work and did not lockout, assuming the crane rail was de-energized.
Applicable Policies / Procedures	<ul style="list-style-type: none">FCX – HS04 Control of Hazardous Energy/Job Risk Assessment

Conduit that contacted the 480v line

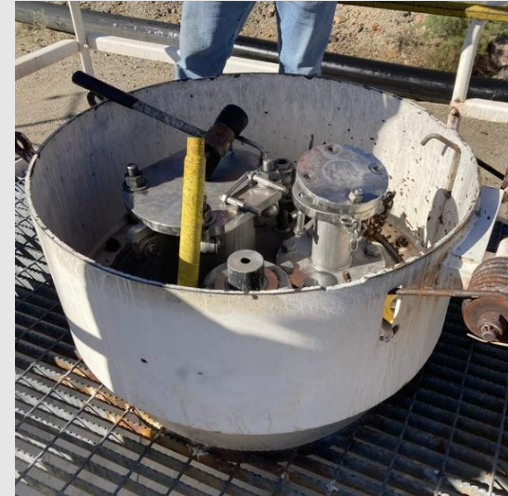
Operation	Chino
Date / Time	October 4, 2023 / 8:27 a.m.
Type	Injury
Summary	A mechanic was cutting the bolts off the flange of a depressurized acid tank car when there was a sudden and unexpected burst of pressurization, causing acid to spray into the air. The employee was wearing a face shield but not other personal protective equipment. A small amount of acid got on the neck of the employee, who immediately rinsed off at the nearby safety shower.
Fatal Risk	Fire
Risk Category	Actionable
Pre / Post Rating	Significant (3) Likely (3)
Findings / Missing Controls	<ul style="list-style-type: none"> • Wrong tool for the job – angle grinder used to cut bolt created a spark that ignited hydrogen buildup in the tank • Failure to monitor lower explosive limit before performing hot work • Failure to wear proper acid suit
Applicable Policies / Procedures	<ul style="list-style-type: none"> • FCX-HS06 Hot Work Policy

Flange where bolt was cut.

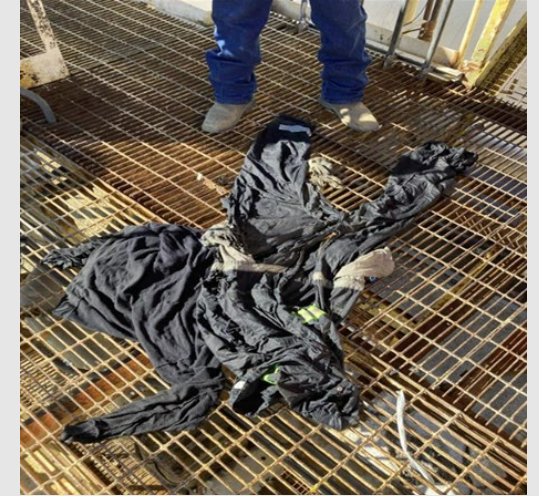
Condition of overalls after exposure to acid.

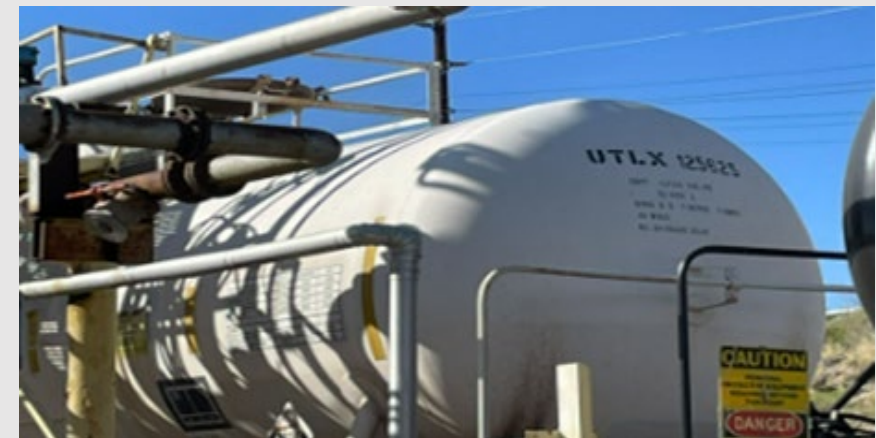
Work platform above the acid tanker car.

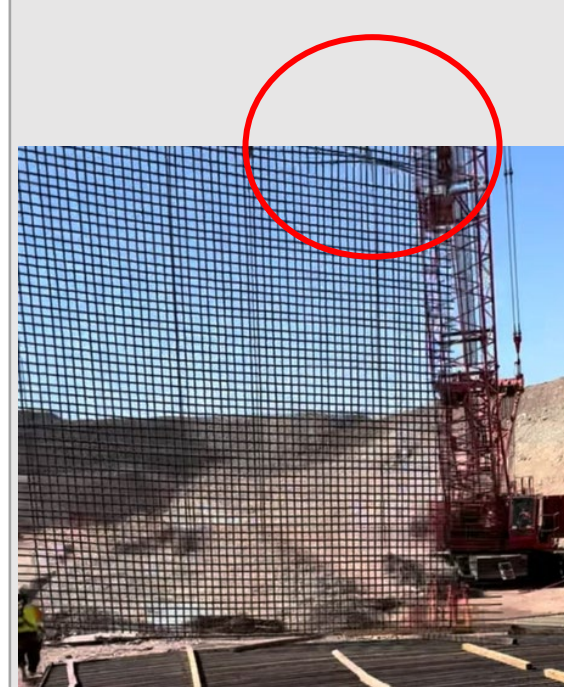
Operation	Safford
Date / Time	October 16, 2023 / 1:45 p.m.
Type	Lost-Time Injury
Summary	A contractor crew was preparing to lift a rebar mat into place to form a reclaim chamber wall at the fine ore stockpile construction site. The mat was 36 feet tall (66 rebar sticks) by 35 feet wide (57 rebar sticks). Upon reaching the vertical position, the rebar ties towards the top began to fail, causing the rebar to fall to the ground. Two individuals were in the area manning taglines. One of them ran away unharmed while the other (foreman) was struck by falling rebar, resulting in a broken right elbow and dislocated left wrist.
Fatal Risk	Falling Objects
Risk Category	Actionable
Pre / Post Rating	Significant (3) Likely (3)
Findings / Missing Controls	<ul style="list-style-type: none">• Insufficient rebar ties• Inadequate rigging
Applicable Policies / Procedures	<ul style="list-style-type: none">• Rigging/Signaling• Strength calculations for load prior to lift

Circled in red is the area where the rebar ties first began to fail.

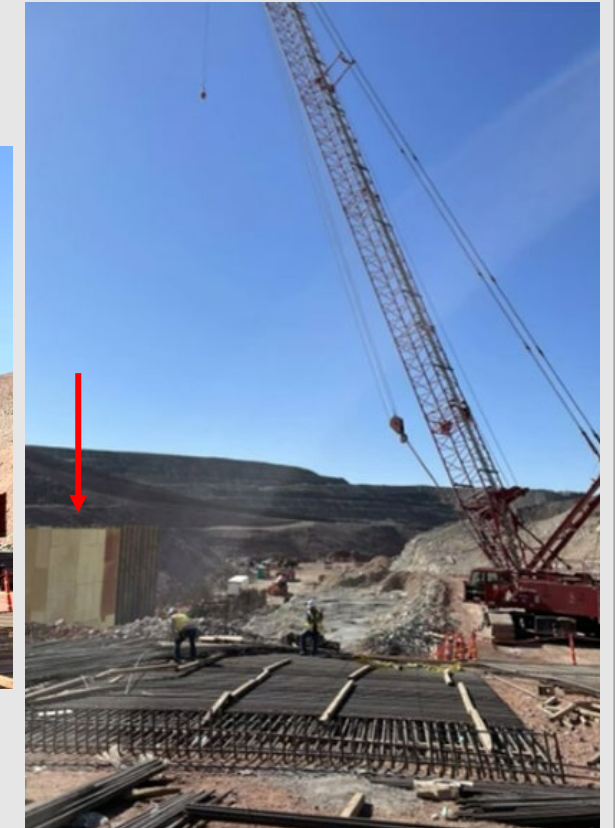
The incident area after the rebar mat fell. The arrow at left points to the location of the chamber wall where the rebar mat was to be placed.

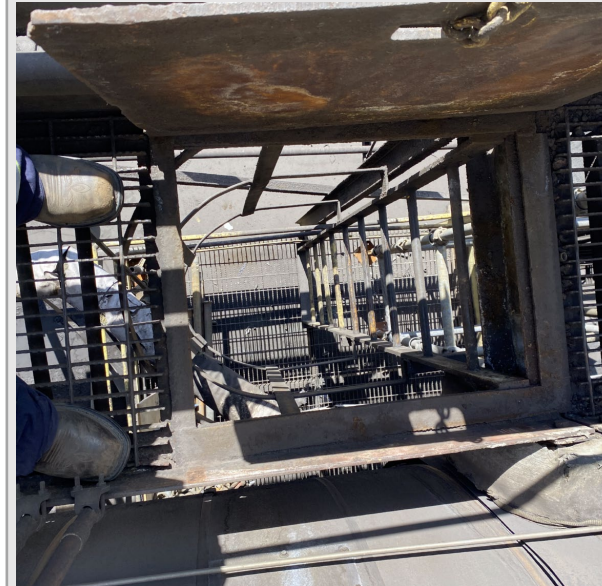
Operation	Miami Smelter
Date / Time	October 25, 2023 / 11:30 a.m.
Type	Injury
Summary	<p>A contractor worker carrying a junction box with both hands in front was following a fellow worker on a catwalk. A hatch door was open in the catwalk to provide access to a lower platform. The first worker stepped over the open hatch. The second worker, who was carrying the junction box, could not see the open hatch. Without warning, the worker fell through and dropped approximately nine feet before hitting the platform below, sustaining minor injuries.</p>
Fatal Risk	Fall From Heights
Risk Category	Monitor
Pre / Post Rating	Significant (3) Possible (2)
Findings / Missing Controls	<ul style="list-style-type: none">• Chain guards not used• Hard barricade and flagging not used• Failure to initiate correct action to close hatch door before proceeding
Applicable Policies / Procedures	<ul style="list-style-type: none">• FCX-HS02 Working at Heights

The open hatch the worker fell through and platform below (looking top down).

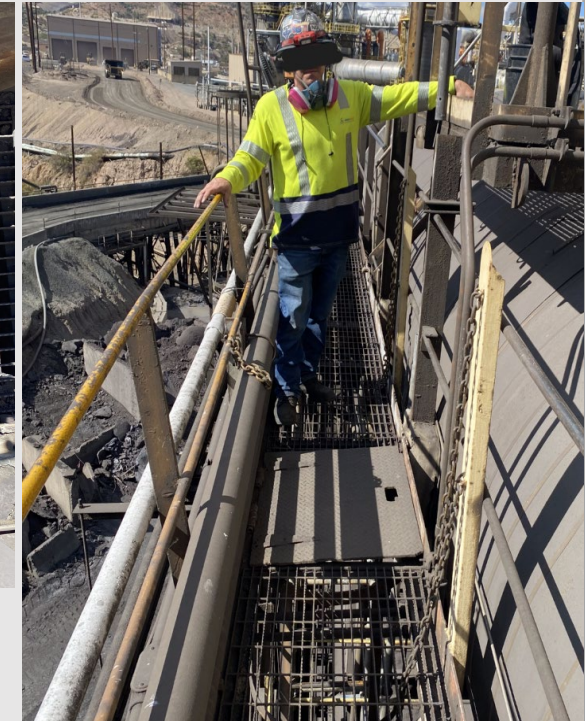
An example of how the catwalk with hatch and chains are to be used when the hatch is open.

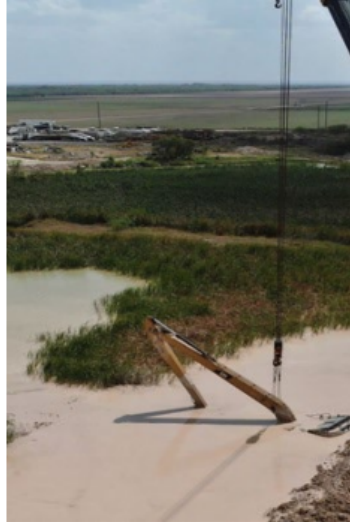
Long Reach Excavator in water.

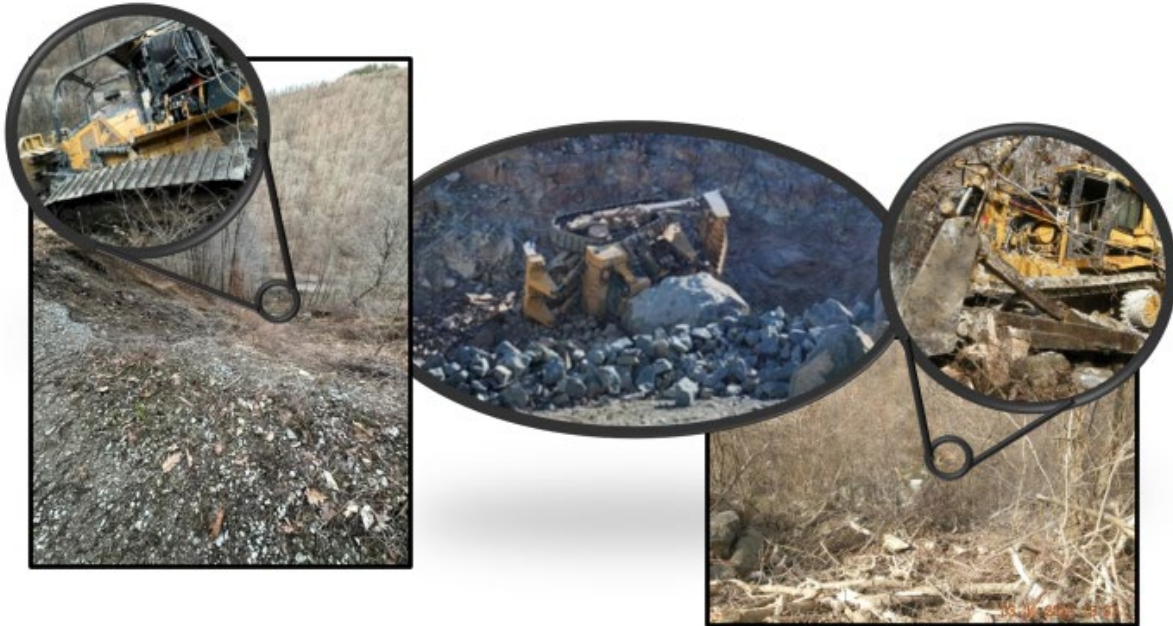
A bulldozer operator was fatally injured when the bulldozer he was operating rolled down a 375 feet embankment. A second bulldozer operator was fatally injured when the bulldozer he was operating rolled down a 300 feet embankment. A third bulldozer operator was fatally injured when the bulldozer backed over the edge of a highwall. In all three accidents the operator was not wearing a seatbelt.

- **Conduct workplace examinations** prior to beginning work.
- **Maintain control and stay alert** when operating mobile equipment.
- **Wear seat belts** when operating equipment.
- **Train Miners** to perform task safely and to recognize potential hazards.

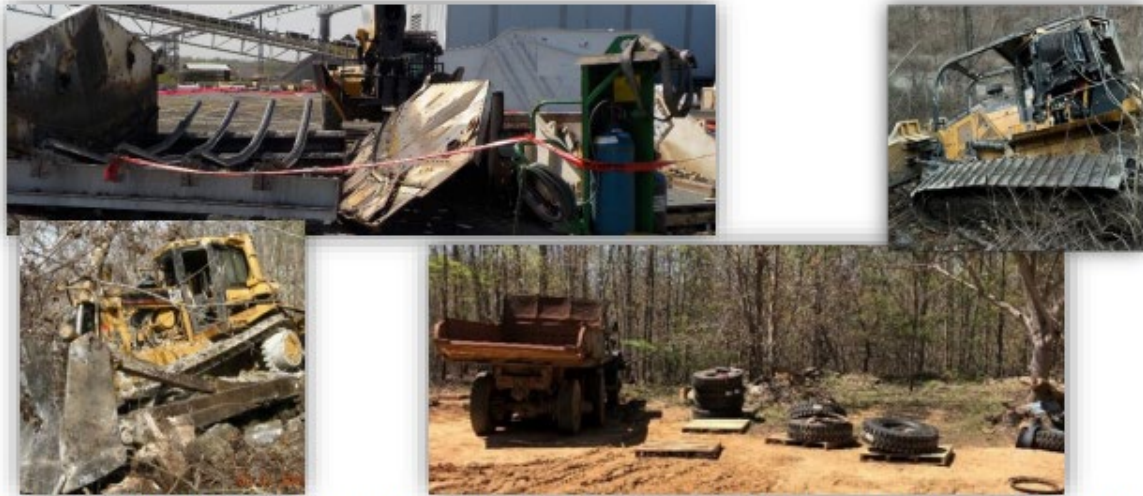
Ten machinery accidents occurred. These fatal accidents involved three bulldozers, a haul truck tire's locking ring that dislodged and struck a miner, and the side plate of a shaker screen that fell during disassembly and struck a miner. It also includes two truck drivers who were fatally struck, and three miners who were struck while equipment lifts were being performed.

(Left to Right) Shaker screen disassembly. Bulldozer rolled down an embankment. Locking Ring dislodged from truck wheel. Bulldozer rolled down an embankment.

- Maintain equipment in safe operating condition.
- Examine work areas prior to beginning work and operating heavy equipment.
- Operate equipment on stable ground and away from hazards.
- Maintain control of equipment and stay alert.
- Always wear seatbelts: remain inside the cab; never attempt to jump clear; consider the use of four-point seat belt systems and new technology that provides early warning of tipping.
- Provide adequate means to prevent locking rings (rims) from creating a hazard. Use tire cages and deflate tires before conducting repairs.
- Train miners to safely perform task.

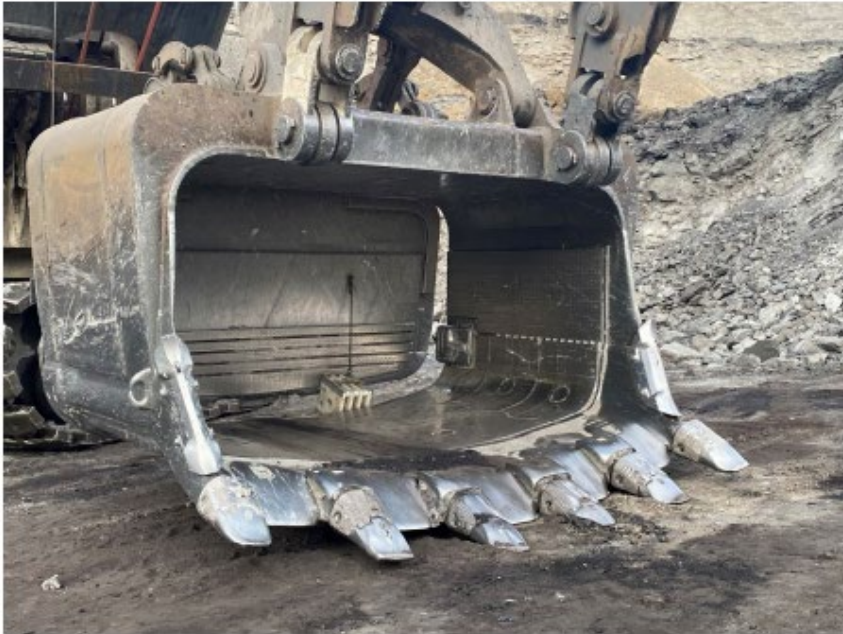
A miner died when a 13-ton steel dipper door he was working on closed, crushing him between the dipper door and the edge of the bucket. Maintenance work on a dipper bucket's door when it is separated from the bucket is dangerous. Make sure to always have a redundant blocking mechanism when performing such work.

- Make sure miners are positioned in a safe location and away from potential pinch point areas.
- Securely block equipment against motion before beginning maintenance or repairs.
- Assure blocking material is substantial and installed correctly to support and stabilize the load.
- Make sure miners conduct repairs according to manufacturer's recommendations.
