ACTIONABLE LESSONS LEARNED: Operator Electrical Shock

Exposure to
Electrical Hazards

Chino, March 6, 2024

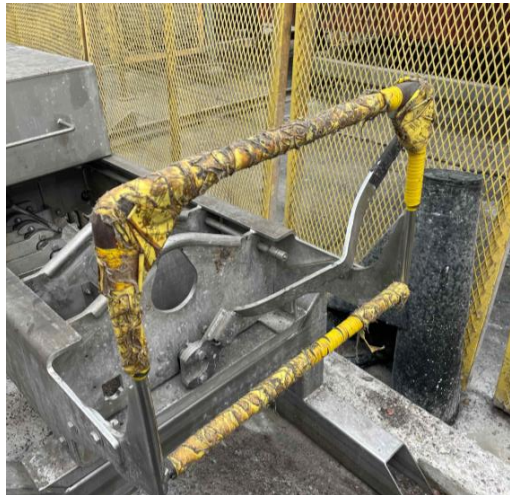
A crane operator was harvesting cathodes from cell 8 inside a jumper frame. The employee was removing the second pull when a wet pantleg came into contact with the jumper frame above the boot. The operator sustained a minor shock.

- The integrity of the crane hook insulator was compromised from excessive grease and moisture.
- The crane hook insulators lacked a weekly Megger Meter check for insulator resistance. Megger readings were not documented per Electrowinning/Electrorefining (EW/ER) policy.

- **Engineering** – Retrofit tank house cranes with non-conductive cables.
- **Substitution** – Replace crane hook grease materials with non-conductive grease. Contractor preventative maintenance reports to be received and reviewed by Freeport site leadership to verify compliance.
- **Administrative** – Create process for crane hook Megger Meter checks at the start of each shift. Meter readings to be conducted by an electrician and reported to leadership. Equipment to be removed from service if insulator fails testing.
- **Administrative** – Corporate Operational Improvement Electrical Subject Matter Expert to inspect tank house and provide recommendations for safety improvements. Will evaluate potential for isolating jumper frame and insulate strongback.

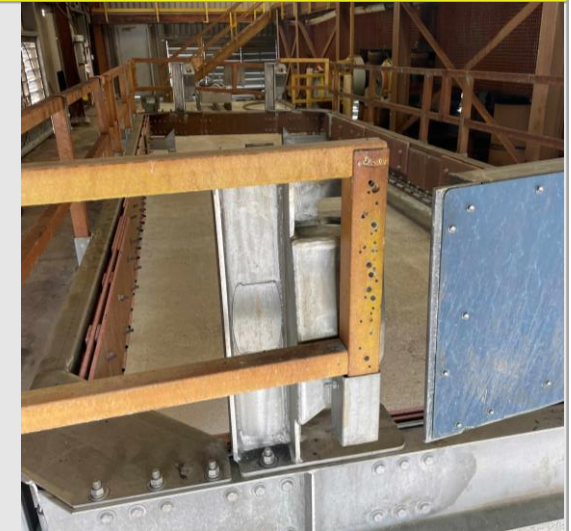
Area the operator's leg contacted the jumper frame

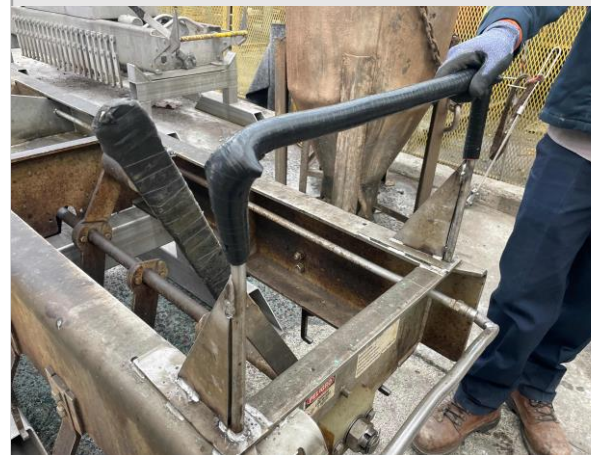
Handle with replaced insulation
