# Potential Fatal Event: Falling Pipe Roller

# Potential Fatal Event Learnings: Falling Pipe Roller

Event ID # 20009681

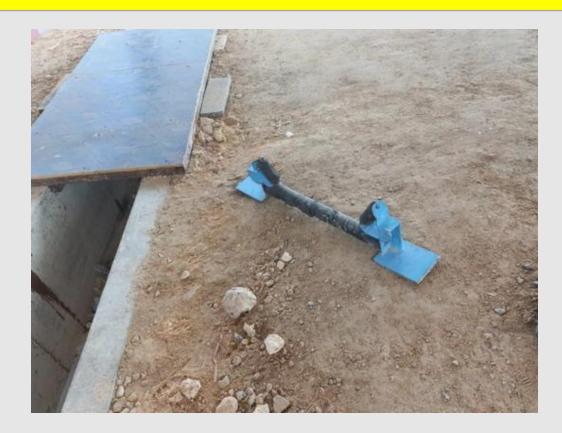
Preliminary Incident Details		
Operation	Manyar Smelter Project	
Date / Time	August 30, 2023 / 2 p.m.	
Туре	Near Miss	
Summary	An employee working on scaffolding at a height of 6 meters (19 feet) knocked a 10 kg (22 lb) pipe roller off the platform. The roller fell to the ground below, landing about 2 meters (6 feet) from a group of employees doing an inspection in the area.	
Fatal Risk	Falling Objects	
Risk Category	Monitor	
Pre / Post Rating	Significant (3) Possible (2)	
Findings / Missing Controls	Missing barricading and toe boards due to scaffold changes	
Applicable Policies / Procedures	FCX-HS19 Flagging and Barricading	
Employee Condition	No injury	
Contact	Zach Scrivner, Manager-Corporate Project Engineering Safety

The 10 kg metal roller

- Preparation falling object protection needs improvement.
- Quality control inspection instructions need improvement.
- Work environment housekeeping needs improvement.

Action Items	Hierarchy of Controls
Walkthrough with health and safety representatives and supervisors to inspect the condition of scaffolding work platforms prior to use. Focus should be placed on toe boards, housekeeping and barricades.	Administrative
Contractors to assess supervisory staffing. Verify adequate resources are available to oversee the quality and thoroughness of scaffolding inspections. Supervisors to confirm erected scaffolding work platforms meet safety requirements including toe boards, flagging and barricading.	Administrative
Daily area simultaneous work (SIMOPS) meetings to include contractors and subcontractors. Discussions regarding known safety issues should be shared between all disciplines.	Administrative

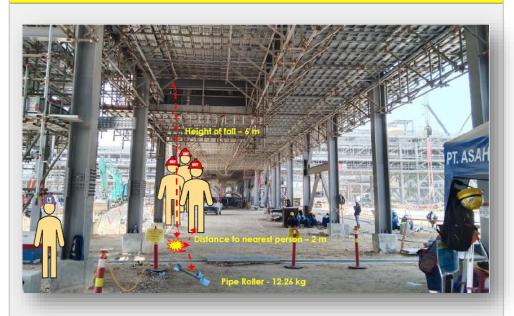
Approximate location of employees when roller fell.
