Potential Fatal Event: Loader Hit Light Vehicle in GBC Mine

Preliminary Incident Details

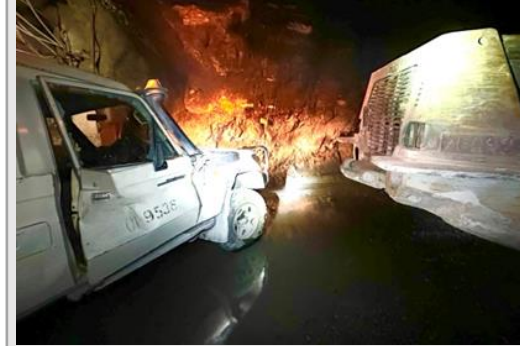
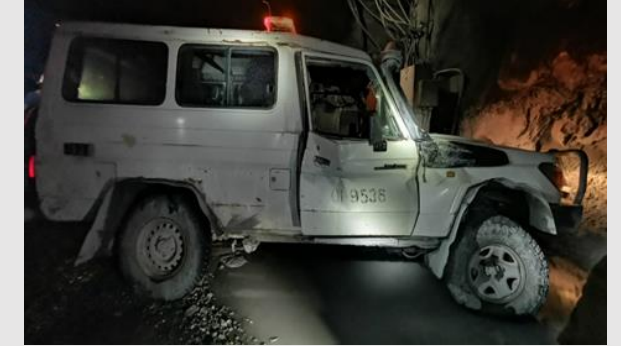
Damage to light vehicle.

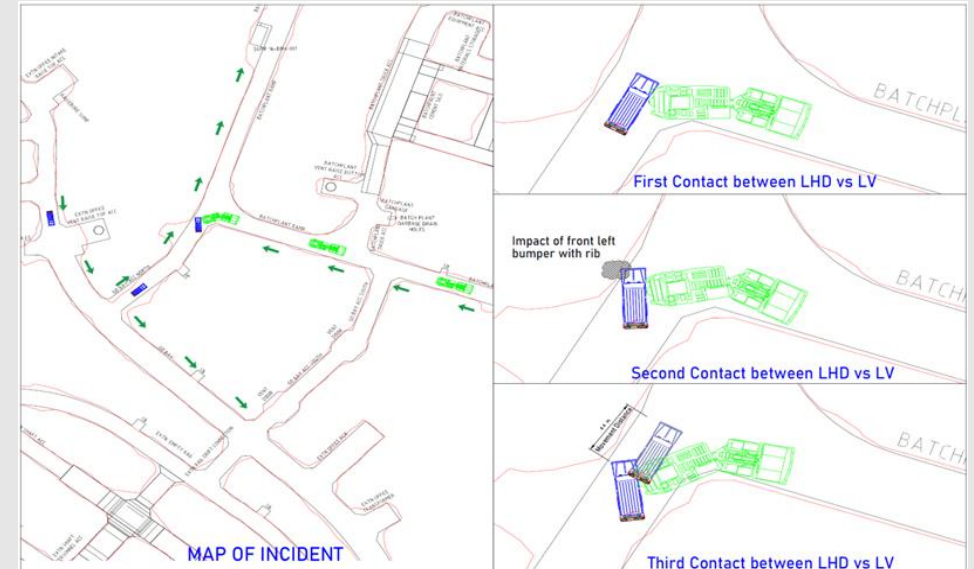
Incident sketch.
