Fire

Incident Overview

El Abra, May 13, 2024

Potential Fatal Event: Hydromet Tank Fire

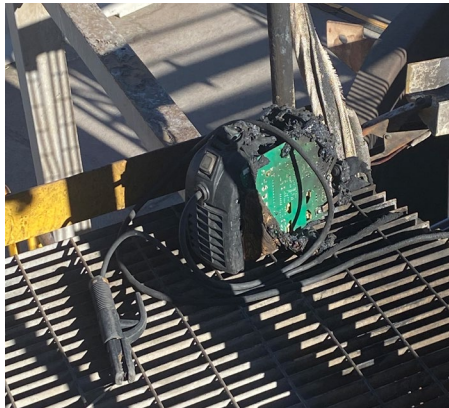
Three contractors were performing hot work on a platform at the tank farm. A failure in the undersized extension cord caused a fire at the welding machine, which subsequently spread to the fire blanket. One employee, who was tied-off, was unable to get free from the harness until the lanyard was completely burned through by the fire. The other employee attempted to suppress the fire with a portable fire extinguisher but was unsuccessful. The emergency response team was notified and quickly arrived on scene to extinguish the fire.

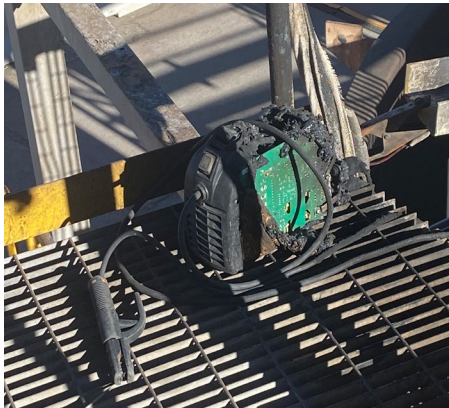
Three contractors were performing hot work on a platform at the tank farm. A failure in the undersized extension cord caused a fire at the welding machine, which subsequently spread to the fire blanket. One employee, who was tied-off, was unable to get free from the harness until the lanyard was completely burned through by the fire. The other employee attempted to suppress the fire with a portable fire extinguisher but was unsuccessful. The emergency response team was notified and quickly arrived on scene to extinguish the fire.

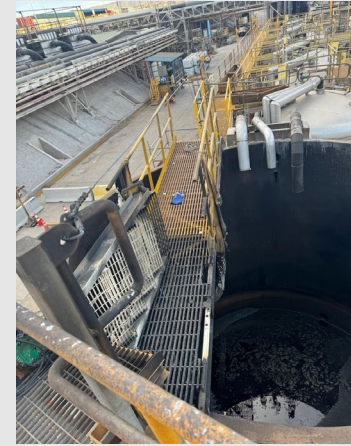
Platform where fire started.

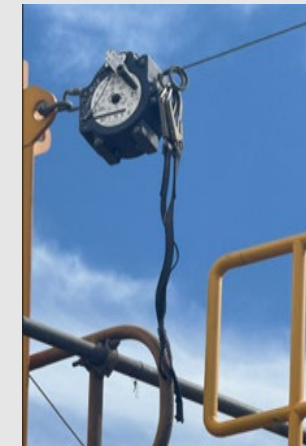
Reactor and burned lanyard.

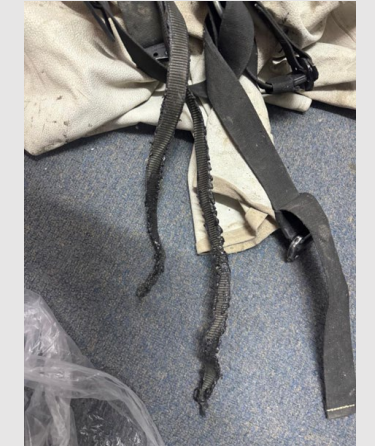
Burned lanyard.

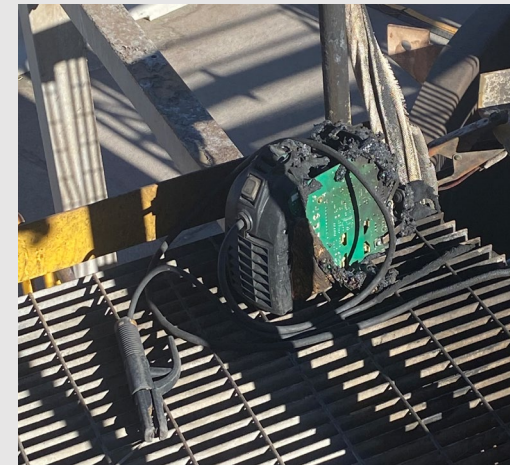
Burned welding machine.

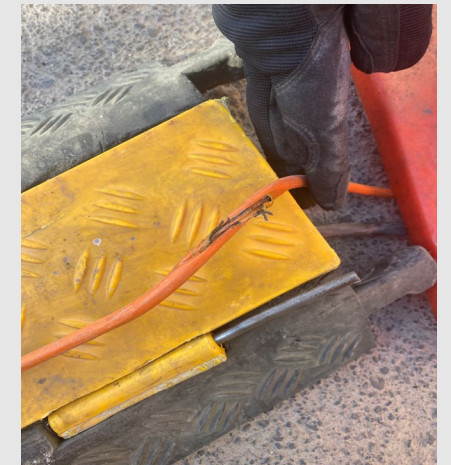
- The contract company modified the extension cord plug from a 10 AMP to a 15 AMP plug, which caused the cord to overheat.
- The area supervisor validated the hot work permit without evaluating the controls/tasks in the field.
- The contractors were unaware the fire blanket was contaminated with flammable organic material from the tank being overfilled the prior day.

Failed extension cord.

- **Substitution** - El Abra certified electricians will review existing extension cords on site. They will remove any modified or non-compliant extension cords. These will be replaced with approved standard extension cords. Extension cords will be audited by site electricians quarterly.
