Rail Impact to Person

Morenci, March 5, 2024

Potential Fatal Event: Rail Impact to Person

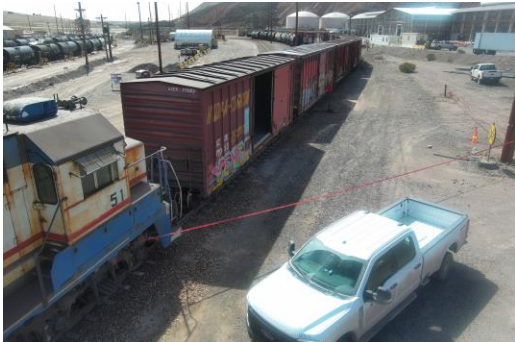
The Industrial Railroad contractor crew was switching out boxcars at the south side of a copper dock. The locomotive operator and a trainee were standing on the engine stairs and leaned out facing away from the direction of travel. While doing so, the operator's body struck a rail switch guard sign. The operator flipped over the handrail, landing face down on the ground. The operator's right arm landed on the track and was run over. A Mayday was called, and emergency services were dispatched to the area.

- Locomotive operator and trainee leaned out from the engine stairs while facing away from the direction of travel.
- Clearance from the rail switch lever to the outside of rail cars was minimal.

- **Administrative Control** – Within 30 days, evaluate the Morenci rail system for unidentified impaired clearance situations (any distance under 30 inches) and high-risk areas (i.e., switches on steep grades).

- **Engineering Control** – Within 60 days, identify impaired distances that can be mitigated by extending switches, lowering switches or clearly marking impaired distances and mapping those switches (i.e., docks and unloading stands).

- **Elimination Control** – Conduct an assessment as outlined in the Freeport Industrial Railroad Policy section 3.4. Determine alternative means to minimizing or eliminating the need for train ground crews to mount/dismount a train in motion.

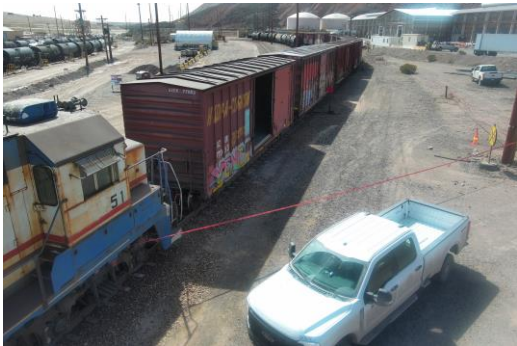
The Industrial Railroad contractor crew was switching out boxcars at the south side of a copper dock. The locomotive operator and a trainee were standing on the engine stairs and leaned out facing away from the direction of travel. While doing so, the operator's body struck a rail switch guard sign. The operator flipped over the handrail, landing face down on the ground. The operator's right arm landed on the track and was run over. A Mayday was called, and emergency services were dispatched to the area.

- Be aware of the Industrial Rail Policy
- Do not ride on train stairs
- Complete site assessment to determine alternate means to minimize or eliminate the need for train ground crews to mount/dismount a train in motion
- Train crew may only ride on the platform of the leading end of railcars, if necessary to perform duties
- Switch personnel may only ride on leading end of railcars for spotting during pushing/shoving operations
- Do not work on or around rail or trains unless trained to do so
