Incident Overview Morenci, March 12, 2024

Lifting Operations

FREEPORT-MCMORAN PFE # 2024-7 Event ID # 20014069

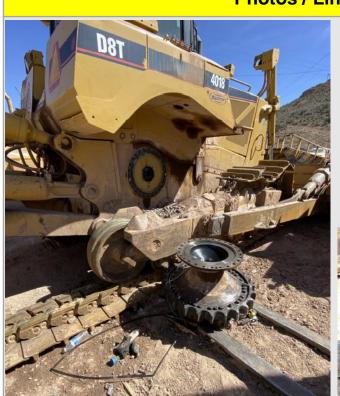
- The c-clamp for replacing the final drive was not on site. A forklift was used instead.
 - There is an Original Equipment Manufacturer (OEM) procedure for this task, including the use of the engineered tool. The OEM was not readily available nor followed.
 - The job safety analysis (JSA) did not address the risks involved.
- The 1600-pound final drive was secured to the forklift with a 500-pound come-along chain. This method prevented backward movement only.
- The forklift was kept in the neutral "inching" position while stopped. The parking brake was not set.

1600-pound final drive on a D8 dozer with the assistance of a forklift. One mechanic was operating the forklift while the other mechanic was greasing the mounting seal. The loaded forklift, positioned 6 to 10 feet behind the mechanic, began to roll forward. The operator applied the brakes which caused the final drive to roll off the forklift. The ground mechanic's leg became pinned between the final drive and the dozer.

Final resting place of final drive after rotating off the forklift

- Engineering Add a smooth pad or work area in the Swapp maintenance yard.
- Administrative Communicate the expectation that Swapp follow OEM maintenance procedures.
 - Verify procedures are followed as outlined by the OEM including tool requirements and the handling of final drives.
 - Expectations will be included in the Maintenance Equipment Reliability Standards v.3 and shared on the Freeport contractor portal.
 Global Action Item
