Potential Fatal Event: SAG Conveyor Holdback Failure

Preliminary Incident Details

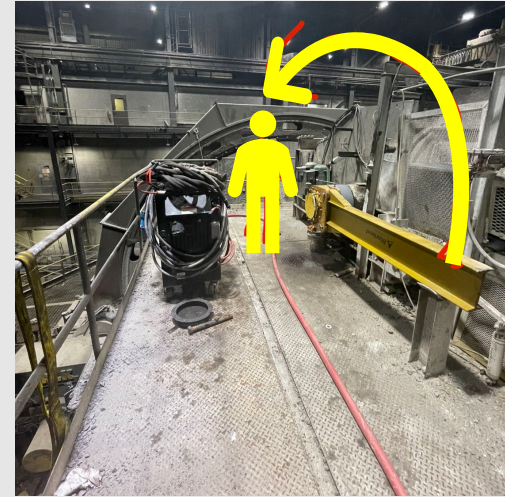
Employee location and direction of travel of the holdback device

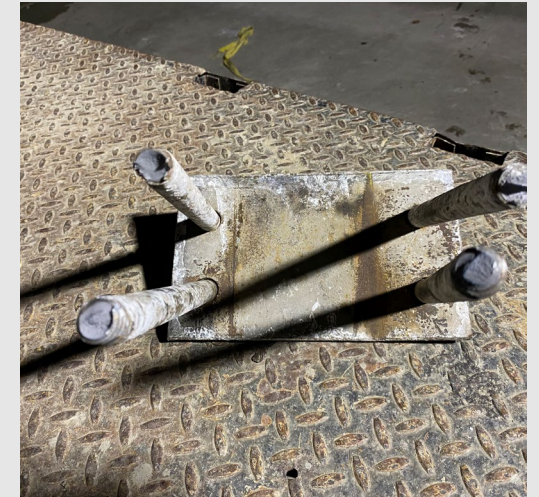
Operation	Chino Mill
Date / Time	September 3, 2023 / 6:30 p.m.
Type	Injury
Summary	A conveyor in the SAG ball mill went down two days after the replacement of a holdback device. While troubleshooting, it was discovered the pullcord bottle was damaged. An electrician repaired it and was waiting for the restart of the mill on the same deck as a conveyor head pulley. When operations restarted, the holdback device failed, and the torque arm swung upwards in the opposite direction of its normal operation. The electrician was struck in the arm and sustained a lost-time injury.
Fatal Risk	Uncontrolled Release of Energy
Risk Category	High
Pre / Post Rating	Actionable
Findings / Missing Controls	<ul style="list-style-type: none"> The holdback replacement part was different than the original part (i.e., size, torque rating) Vendor recommended storage protocol was not followed (i.e., add oil, rotate every two months)

Sheared retaining bolts

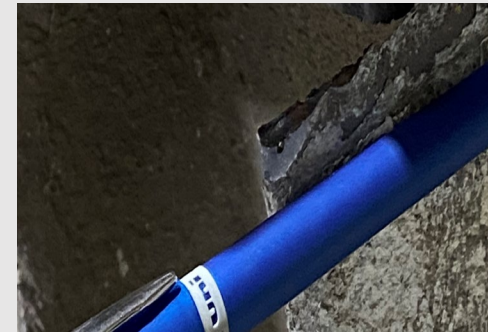
Mounting plate failure

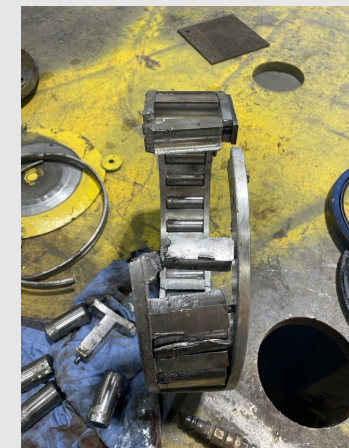
Internal failure
