Potential Fatal Event: Dozer backed into Light Vehicle

Preliminary Incident Details	
Operation	Morenci
Date / Time	September 6, 2023 / 4:05 p.m.
Туре	Injury
Summary	A dozer operator trainee was pushing material to maintain appropriate berm height at a dump. The support equipment lead and dozer mentor pulled up to the dump face in a light vehicle to inspect the berm height. The dozer operator trainee was about 65 feet away and started to back up. The support equipment lead noticed the trainee was headed towards the LV and not stopping. The lead tried to put the LV in reverse. The dozer trainee felt resistance while backing up and discovered they had contacted the LV.
Fatal Risk	Vehicle Collision and Roll Over
Risk Category	Actionable
Risk Rating	Significant (3) Likely (3)
Absent / Insufficient Controls	 Failed to make positive communication Approaching and parking in the blind spot of heavy equipment
Applicable Policies / Procedures	FCX – 23 Interaction with Heavy Mobile Equipment

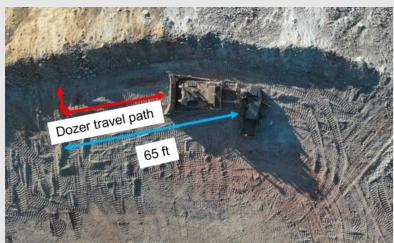
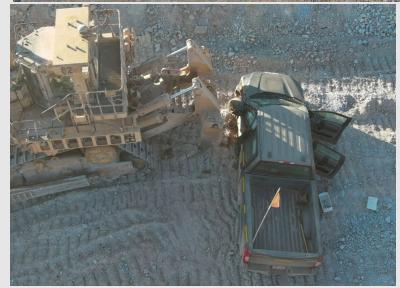
Photos / Links

Employee Condition	Minor abrasion to the left arm of the light vehicle operator
Contact	Haris (Kudir) Kudadiri, Manager-Fragmentation & Loading
