Potential Fatal Event: 4160-Volt Transformer Arc Flash

Preliminary Incident Details

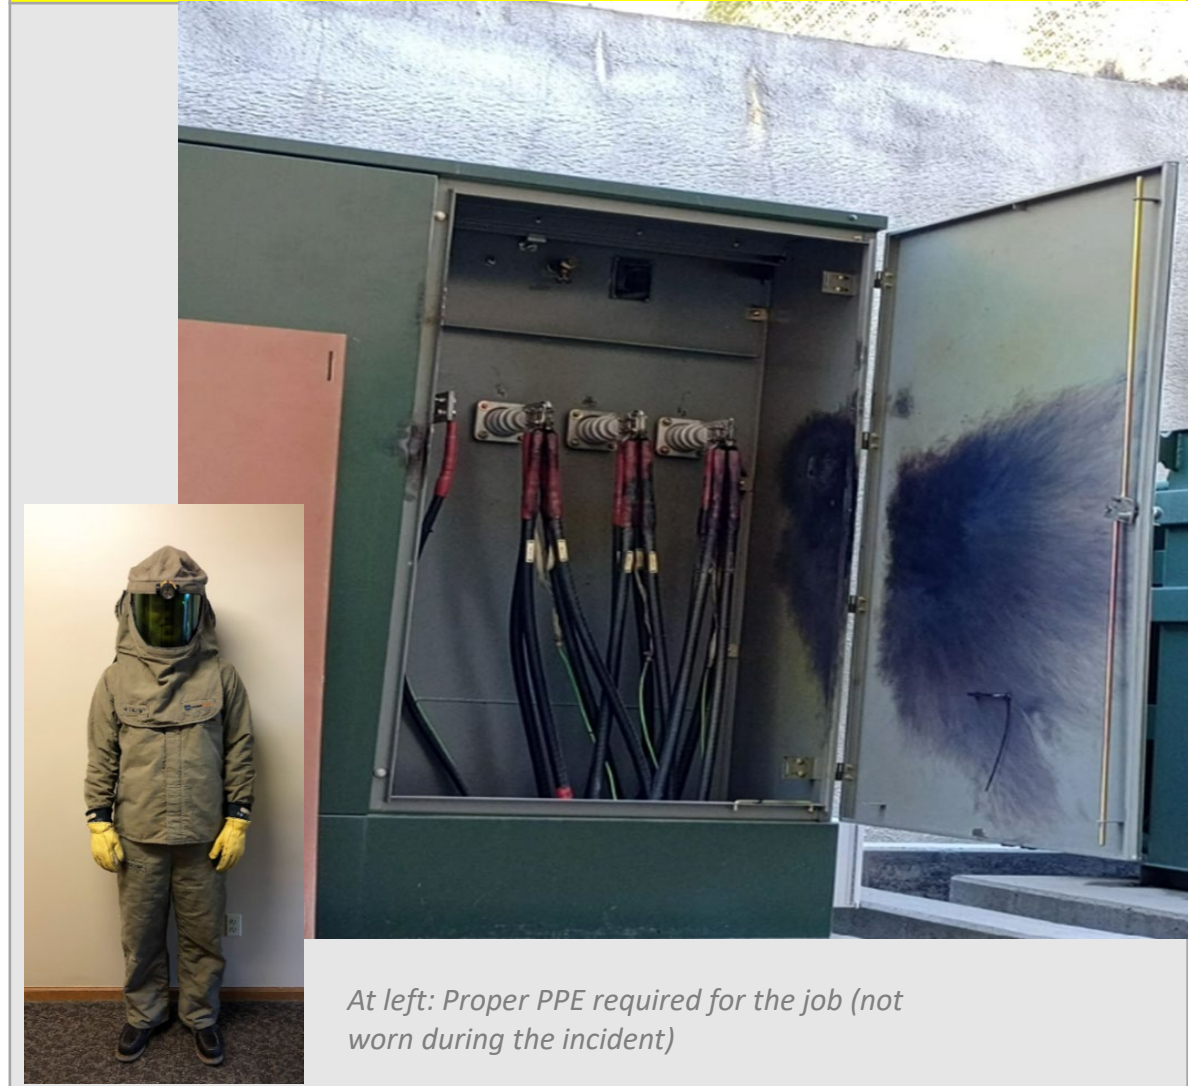
At left: Proper PPE required for the job (not worn during the incident)
