Potential Fatal Event: Falling Rod Support on Drill

Preliminary Incident Details

Operation	Sierrita
Date / Time	October 21, 2023 / 3:20 a.m.
Type	Property Damage
Summary	A drill operator was in position to start a new hole and stepped out of the cab onto the platform. As the employee was looking away, the rod support mechanism – estimated to weigh approximately 500 pounds – fell 15 to 20 feet and landed on the deck about four feet away. The operator was struck on the shoulder with a hydraulic hose attached to the rod support.
Fatal Risk	Falling Objects
Risk Category	Actionable
Pre / Post Rating	Significant (3) Likely (3)
Findings / Missing Controls	<ul style="list-style-type: none">Operator competencySafety cable failed
Applicable Policies / Procedures	<ul style="list-style-type: none">Drill SOP
Employee Condition	No Injury
Contact	Allen Bruce Kinney, Superintendent-Mine Operations

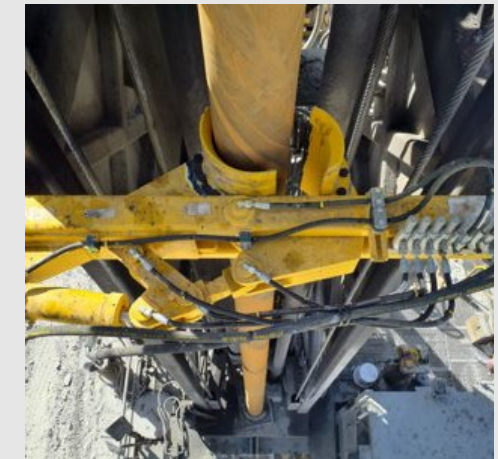
The rod support in place around the drill shaft.
