Potential Fatal Event: Unplanned Drilling Breakthrough

Preliminary Incident Details

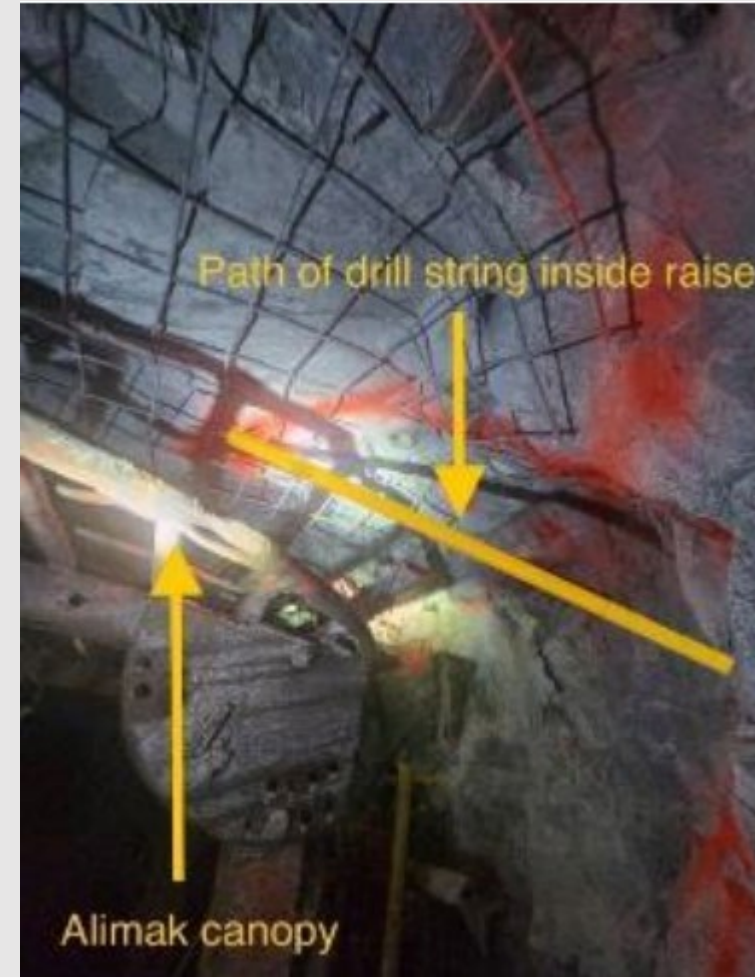
Photo from inside muck raise
