Potential Fatal Event: Haul Truck Collides with Articulated Truck

Preliminary Incident Details

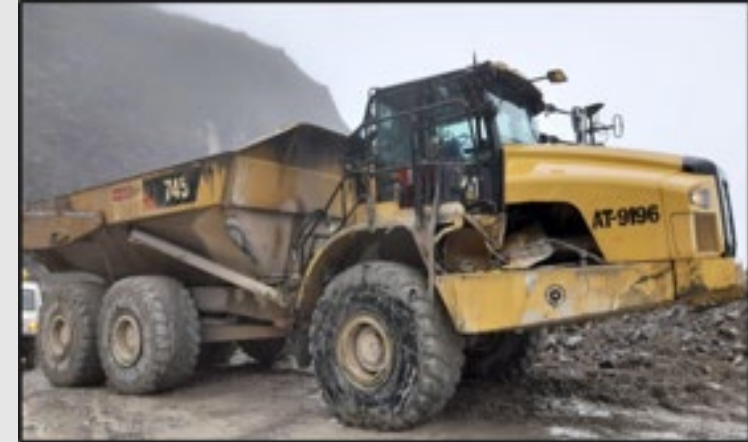
Damage to the right front side of the articulated truck

- Haul truck operator turned too far to the right around the curve in the haulage road.
- Articulated dump truck operator failed to meet safe driving procedures (did not come to a full stop, was cleaning cab window while in motion)
- Lack of traffic management controls at the curve in the road

Action Items	Hierarchy of Controls
• Review and update Standard Operating Procedures for haul truck operations and articulated dump truck operations.	Administrative
• Recommunicate SOPs to appropriate crews. For articulated dump truck operation, this includes the need to stop in a safe position when conducting other activities and to always maintain positive communication (eye contact/radio communication).	Administrative
• Construct traffic segregation berm along the curve of the road	Engineering
• Review road design and ramp entrance	Engineering
• Develop and construct traffic management improvements in the area as well as other areas with narrow access	Engineering

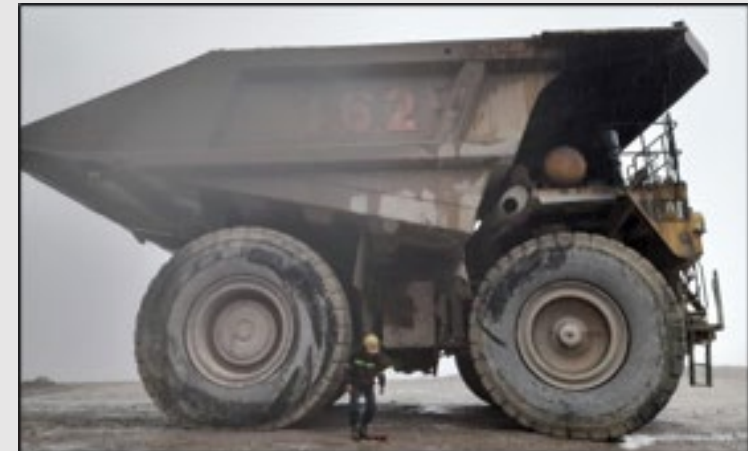
Skid marks visible on outer right wheel of haul truck
