Potential Fatal Event: Lifting Operations

Preliminary Incident Details

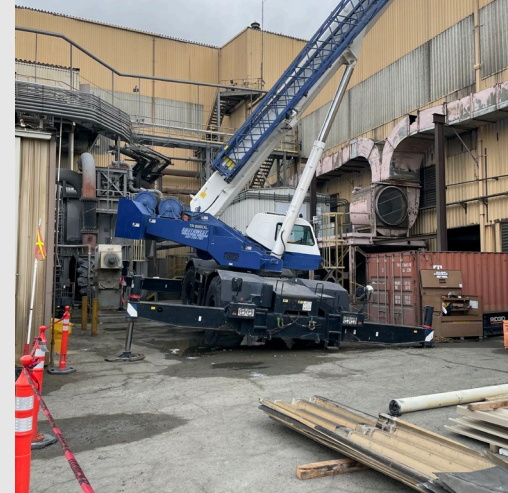
Position of the crane after the event

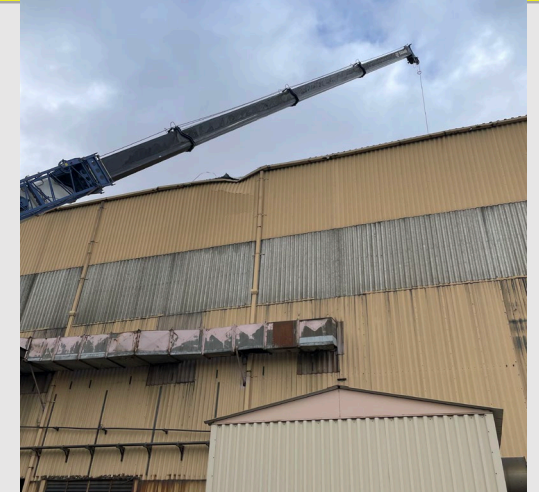
Location of where the crane hit the roof

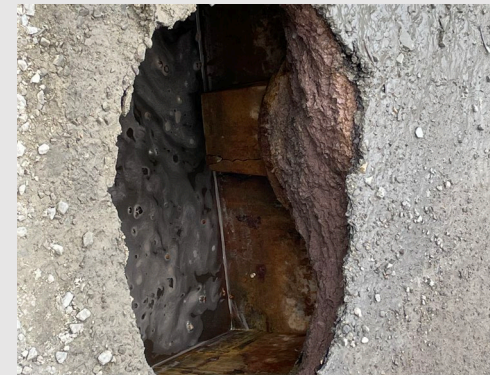
Cavity that the outrigger fell into

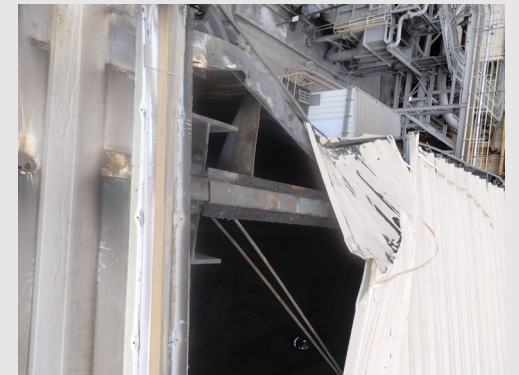
Damage to the roof
