Potential Fatal Event: 50-Foot Highwall Sloughed Off

Preliminary Incident Details

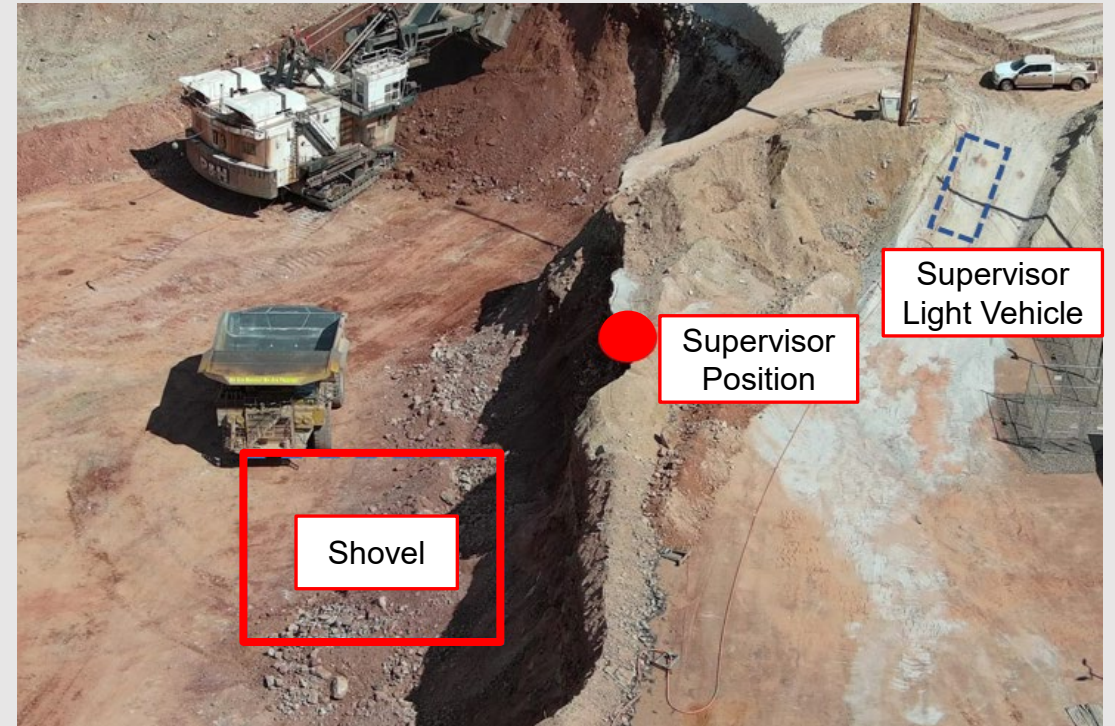
Operation	Morenci
Date / Time	May 15, 2023 / 9 p.m.
Type	Injury
Summary	A supervisor was standing at the edge of a highwall overlook to check on a shovel's progress when the 50-foot highwall sloughed off underneath. The supervisor slid down with the soft material and landed near the shovel. The shovel operator saw the supervisor's flashlight as it slid down and stopped digging. The supervisor received medical care for minor injuries.
Fatal Risk	Ground Failure
Risk Category	Actionable
Pre / Post Risk Rating	Significant (3) Likely (3) / Significant (3) Possible (2)
Absent / Insufficient Controls	<ul style="list-style-type: none"> Missing Crest Indicator (trench) for fill material
Applicable Policies / Procedures	<ul style="list-style-type: none"> HEO-FCX1081C Shovel Operation
Employee Condition	Minor abrasion to the left hand and minor puncture wound on the left palm requiring two stitches.
Contact	Haris (Kudir) Kudadiri, Manager-Fragmentation & Loading

Highwall and location of supervisor and shovel at time of event.

- Mine plan did not include a safety berm to protect personnel and equipment above the active shovel pit crest line
- No designated safe distance between the employee and the crest of the active shovel pit

Dig line will be visible by the shovel runner by having a trench in place	Engineering
When mining fill or tailings material and access to the bench is needed, a safety berm will need to be a minimum of 13 ft (based off a 50' bench) from an active mining crest to keep miners safe from bench failures. If no access is required, access will be restricted. Global Action Item	Engineering
Document the safety berm requirement in administrative controls (i.e., SOP, Site Policy, etc..) and communicate requirement with Mine Operations. No personnel will be allowed access past the safety berm	Administrative
