# Potential Fatal Event: Contact with Energized Cable

Preliminary Incident Details	
Operation	Manyar Smelter Project – Slag Concentrator Substation 2
Date / Time	January 17, 2024 / 10:30 a.m.
Type	Injury
Summary	Contractors were working on the left side of an electrical panel, which had been de-energized. Without testing for current, a worker removed a 400-volt cable from the right side, which remained energized, and contacted another cable, causing a spark.
Fatal Risk	Exposure to Electrical Hazard
Risk Category	Monitor
Risk Rating	Significant (3) Possible (2)
Findings / Missing Controls	<ul style="list-style-type: none"><li>• Failure to isolate energy with LOTOTO procedure</li><li>• Wrong tool for the job</li><li>• Inadequate training; worker was not authorized to perform this work</li></ul>
Applicable Policies / Procedures	<ul style="list-style-type: none"><li>• LOTOTO</li><li>• Isolation/De-Isolation Certification Process</li><li>• Energy Isolation Survey Form</li></ul>

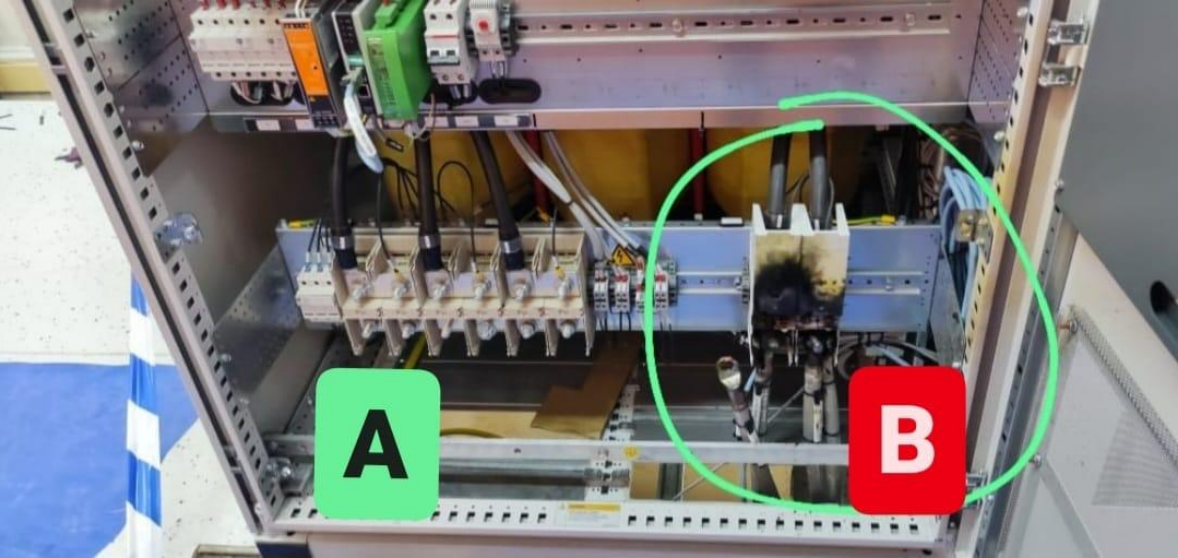
<p>The de-energized portion of the panel (A) and the energized portion (B), which shows damage.</p>
