Lifting Operations

# Potential Fatal Event: 26-ton Boom Truck Tipped Over

## Preliminary Incident Details

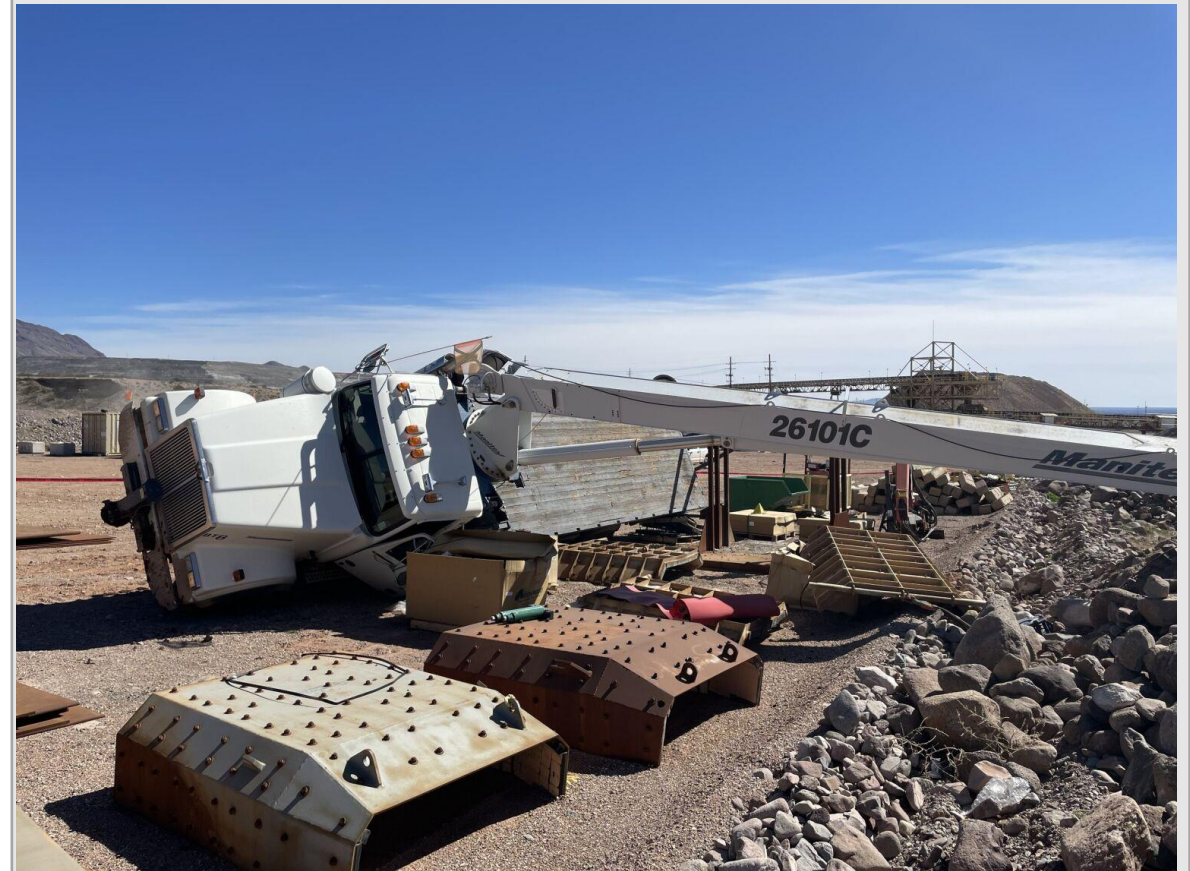
<b>Operation</b>	Safford
<b>Date / Time</b>	February 15, 2024 / 11:55 a.m.
<b>Event Type</b>	First Aid
<b>Summary</b>	Two mechanics and an apprentice were using a 26-ton boom truck to offload a bangboard (feed plate distributor) at the C4 laydown. As the load swung to the driver's side, the truck tipped over. The mechanic operating the boom and another mechanic standing on the bed of the truck jumped out of the way to avoid being in the line of fire. The apprentice was standing on the ground and out of the line of fire.
<b>Risk Category</b>	Actionable – Significant (3) Likely (3)
<b>Findings / Missing Controls</b>	<ul style="list-style-type: none"> <li>• Only the rear stabilizers had been deployed</li> <li>• No footpads were placed under the rear stabilizers</li> <li>• The main outriggers were not used</li> </ul>
<b>Applicable Policies / Procedures</b>	<ul style="list-style-type: none"> <li>• <a href="#">Lifting Operations</a></li> <li>• Mobile Crane/Boom Truck Training</li> </ul>

*The boom truck tipped onto the driver's side when the load swung.*
