2016 February Contractor Safety Meeting

Safety Dashboard 2/7/2016

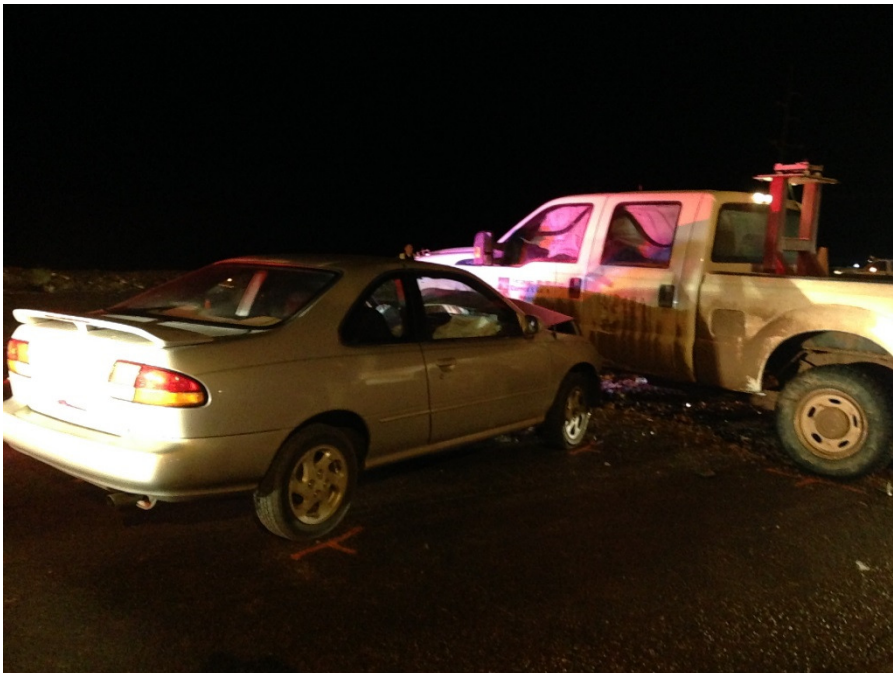
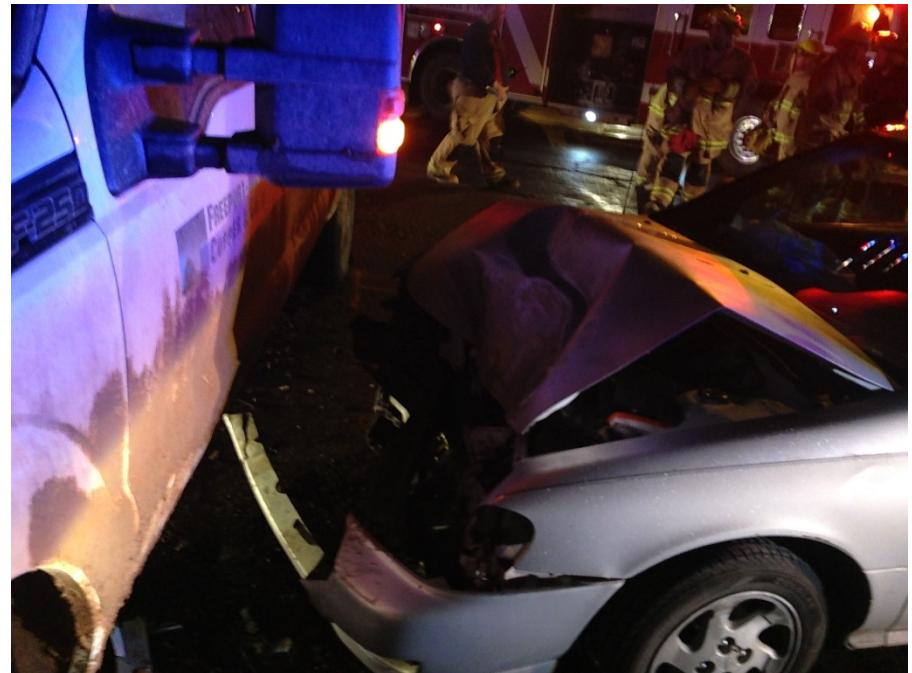
Property Damage			
Date	01.05.2016		
Organization	Administration		
Division	Resource Management		
Potential Risk	3	3	9
	Consequence	Likelihood	Potential Risk
Brief Description	The operator of the LV848A stopped at the first stop sign at the Highway 191 and Acid Gate Rd. intersection. He saw a break in the North bound traffic and pulled out. He was struck by a vehicle in the South bound lane. The employee stated he did not see the car.

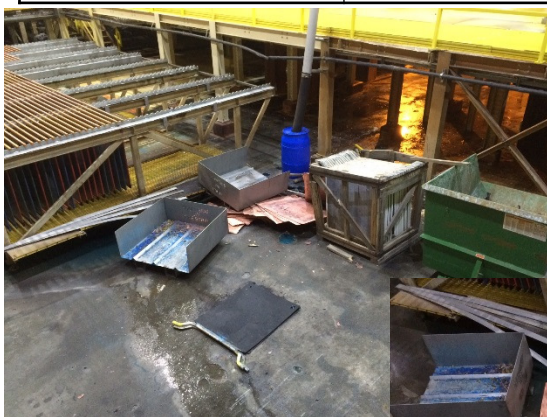
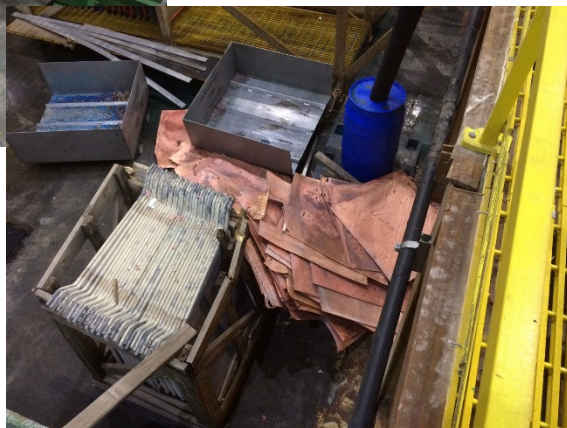
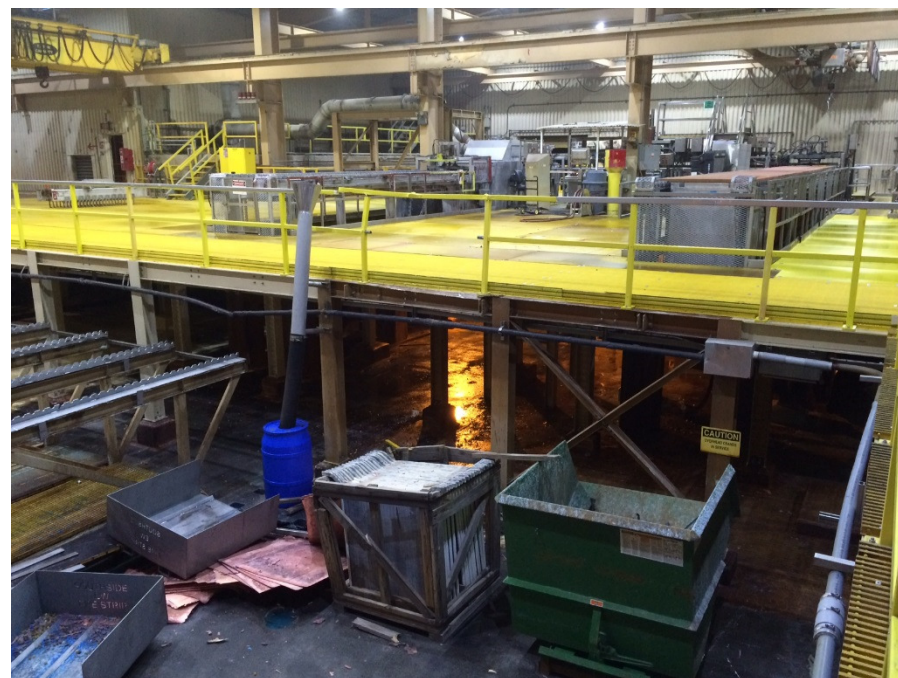
Property Damage			
Date	01.10.2016		
Organization	Processing		
Division	Hydromet		
Potential Risk	3	2	6
	Consequence	Likelihood	Potential Risk
Brief Description	EW Operator was moving the pre-strip bin with the overhead to the Back Bay when the it slid off the strong back. The pre-strip bin went through the top and mid fiberglass Handrails to the lower level. There were no other employees in the Back Bay at the time of the incident.

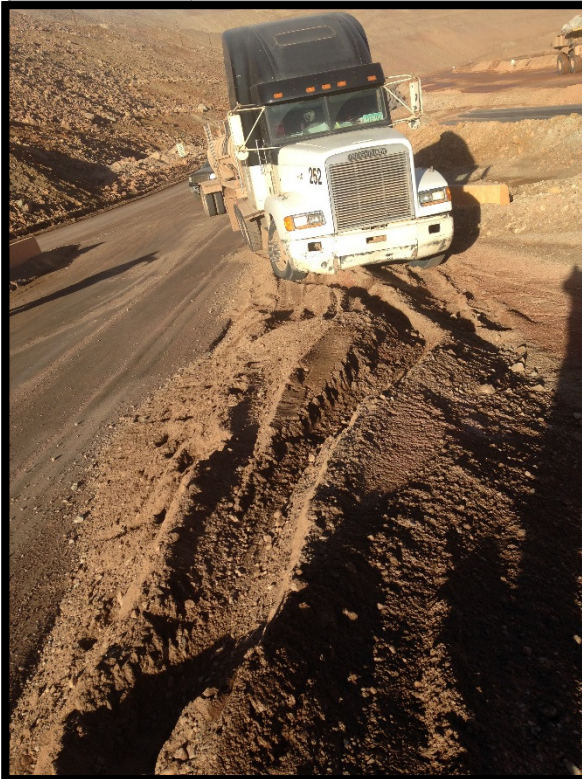
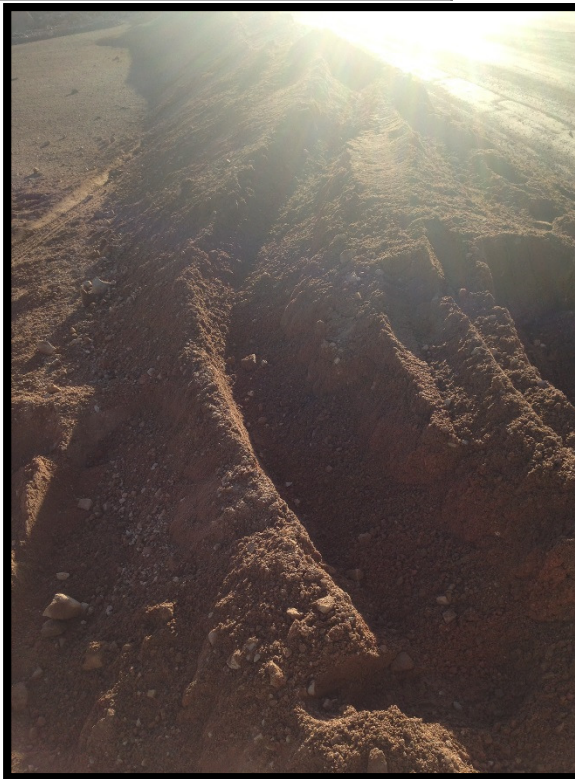
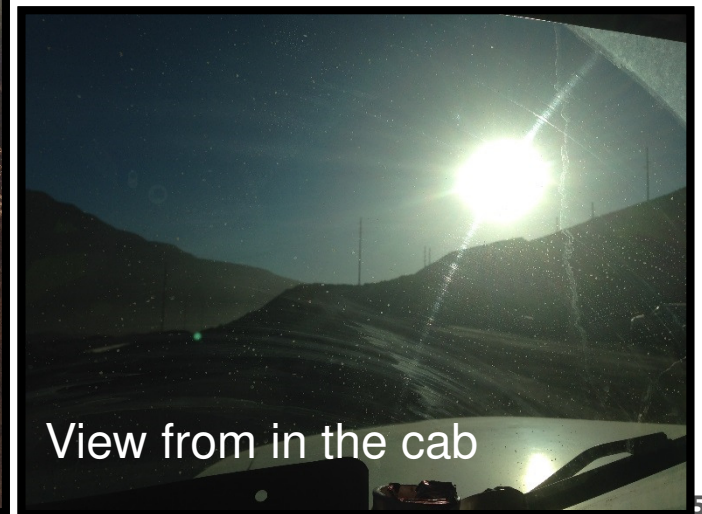
View from in the cab

Near Miss			
Date	01.19.2016		
Organization	Contractor		
Division	Leaching		
Potential Risk	3	2	6
	Consequence	Likelihood	Potential Risk
Brief Description	A B.J. Cecil driver was driving to unload acid at Ponderosa when the employee could not see so he reached up to put down his visor. The truck driver veered to the left striking a berm. The operator was traveling approximately 25 mph.

1. Conduct a thorough equipment inspection prior to vehicle use.
2. Ensure windows are clean prior to vehicle operation to aid in visibility.
3. Drive to weather / road conditions and decrease speed during adverse conditions.
4. When visibility is decreased or obstructed, pull to a safe location and stop.

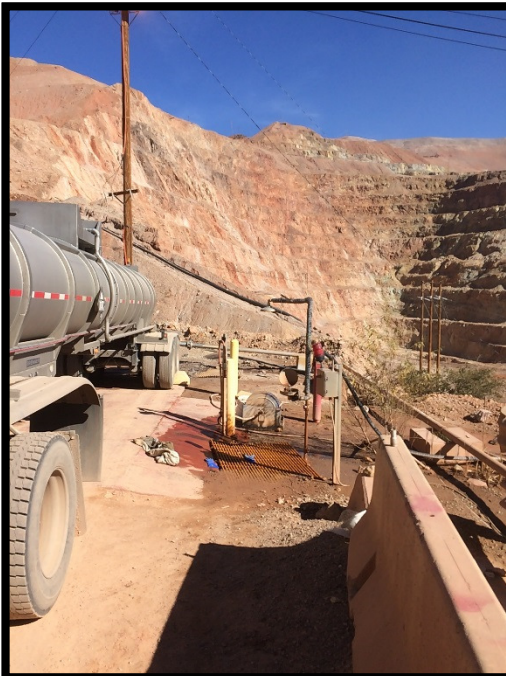
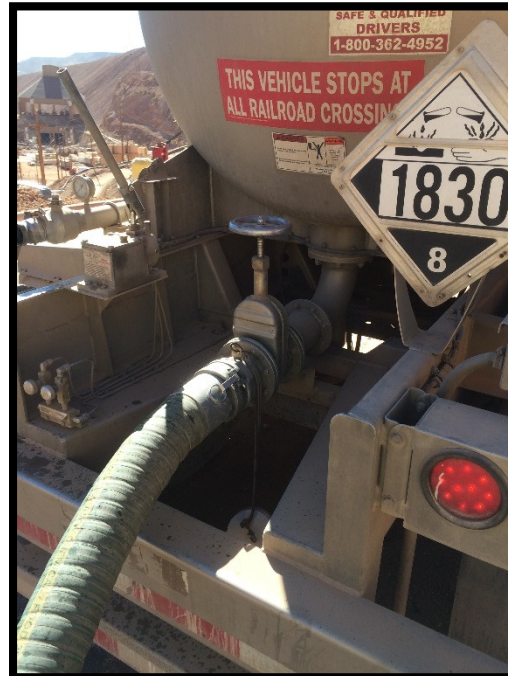
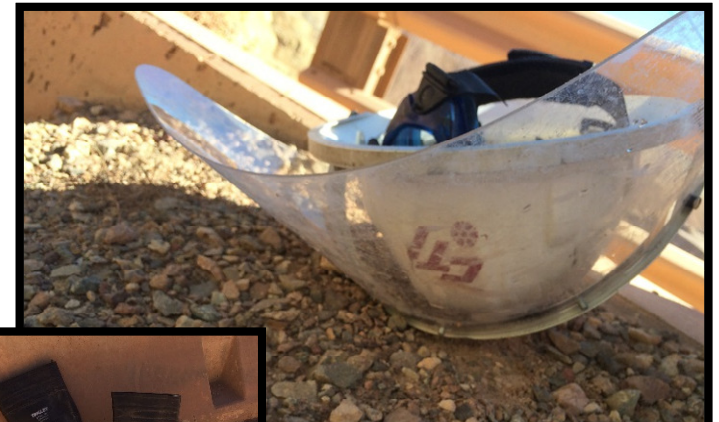
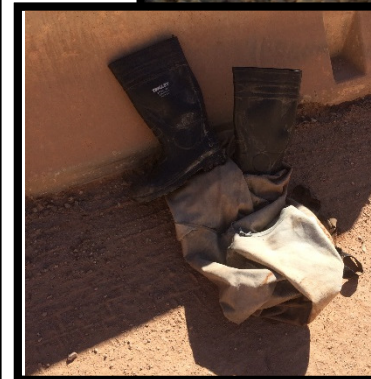
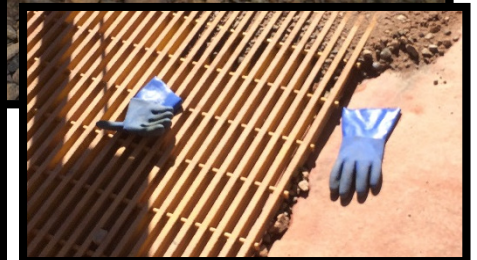
First Aid			
Date	01.20.2016		
Organization	Contractor		
Division	Leaching		
Potential Risk	3	2	6
	Consequence	Likelihood	Potential Risk
Brief Description	A CTI employee was preparing to unload acid at the Metcalf SX Acid Unloading Dock. When the employee opened the vapor recovery valve, there was stored pressure inside the pipe causing acid to be sprayed onto the employees face shield and acid jacket. Acid Contacted the employee's face and right arm causing minor burns. Employee was treated at GHR.

1. Always perform a workplace exam, JSA, equipment inspection prior to starting a task.
2. Ensure proper training
3. Ensure all equipment is properly functioning prior to unloading.
4. Ensure PPE is adequate for potential exposure.

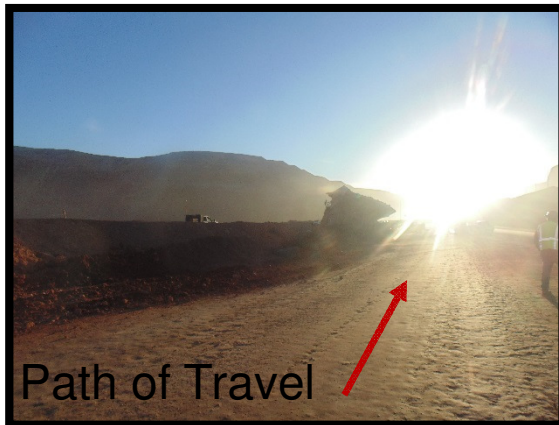
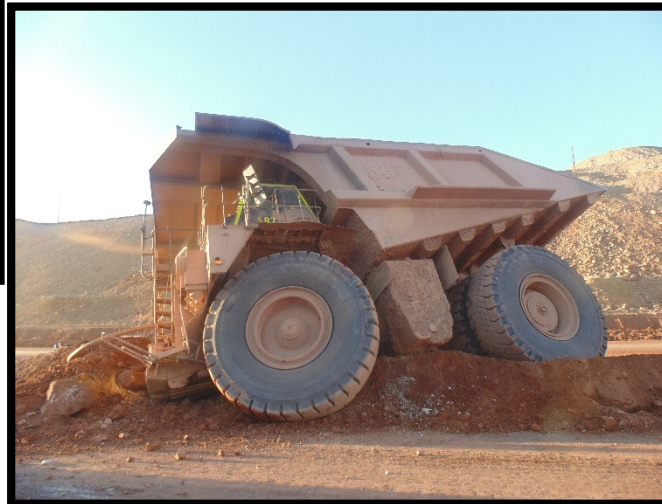
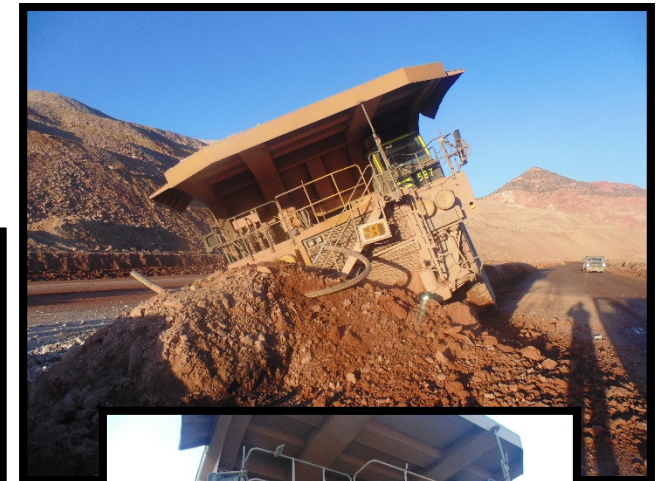
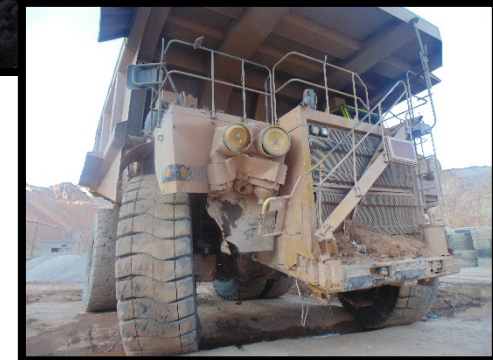
Property Damage			
Date	01.24.2016		
Organization	Mine		
Division	Haulage		
Potential Risk	4	2	8
	Consequence	Likelihood	Potential Risk
Brief Description	The operator of the 587HT lost control of the truck and drove into the safety berm that separates the LVA and Haul Roads. The operator stated he was blinded by the sun glare when he realized his front tire had gone over the safety berm. The truck was stopped when the rear tire was stopped by safety berm.

1. Ensure windows are clean prior to vehicle operation to aid in visibility.
2. Drive to weather / road conditions and decrease speed during adverse conditions.
3. When visibility is decreased or obstructed, pull to a safe location and stop.

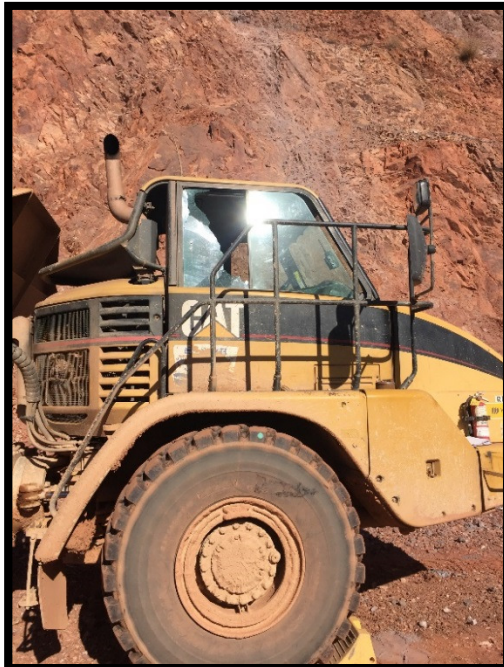
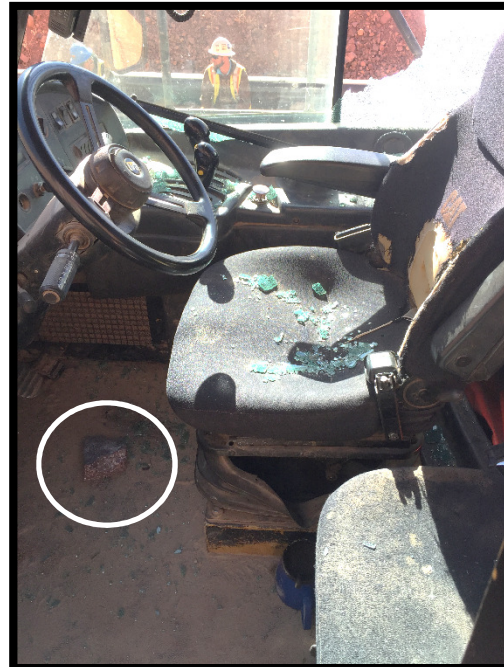
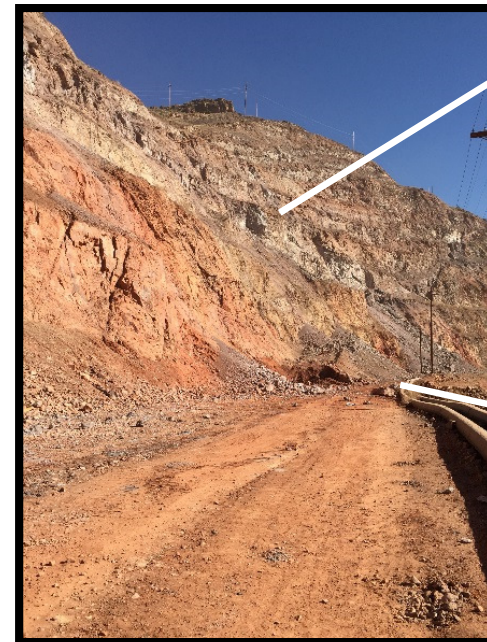
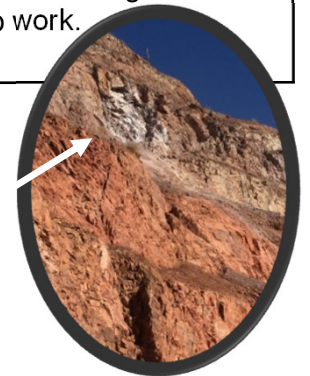
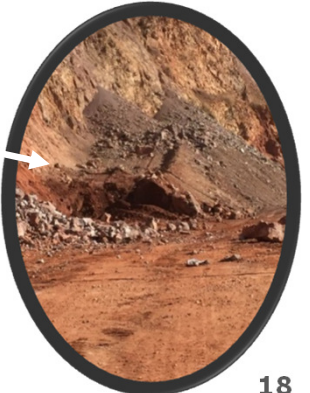
Property Damage			
Date	01.28.2016		
Organization	Contractor		
Division	Resource Management		
Potential Risk	3	3	9
	Consequence	Likelihood	Potential Risk
Brief Description	The 9002 articulating truck was being loaded by the 5012 excavator when the operator of the articulating truck noticed rocks raveling from the high wall. The articulating truck operator exited the cab to get a closer look and noticed a large chunk of rock released overhead. He exited the articulating truck and retreated to safety. The operator of the excavator also exited and retreated to a safe distance. Once the area was clear and raveling stopped, employees removed the equipment from the area a parked it a safe distance away.

Best Practices	
1.	Ground conditions must be examined by a competent person, prior to work.
2.	When necessary ground must be tested and scaling conducted.
3.	Loose and unconsolidated ground conditions should be reported immediately.
4.	Catch basins should be established to prevent loose material from falling where persons are required to work.

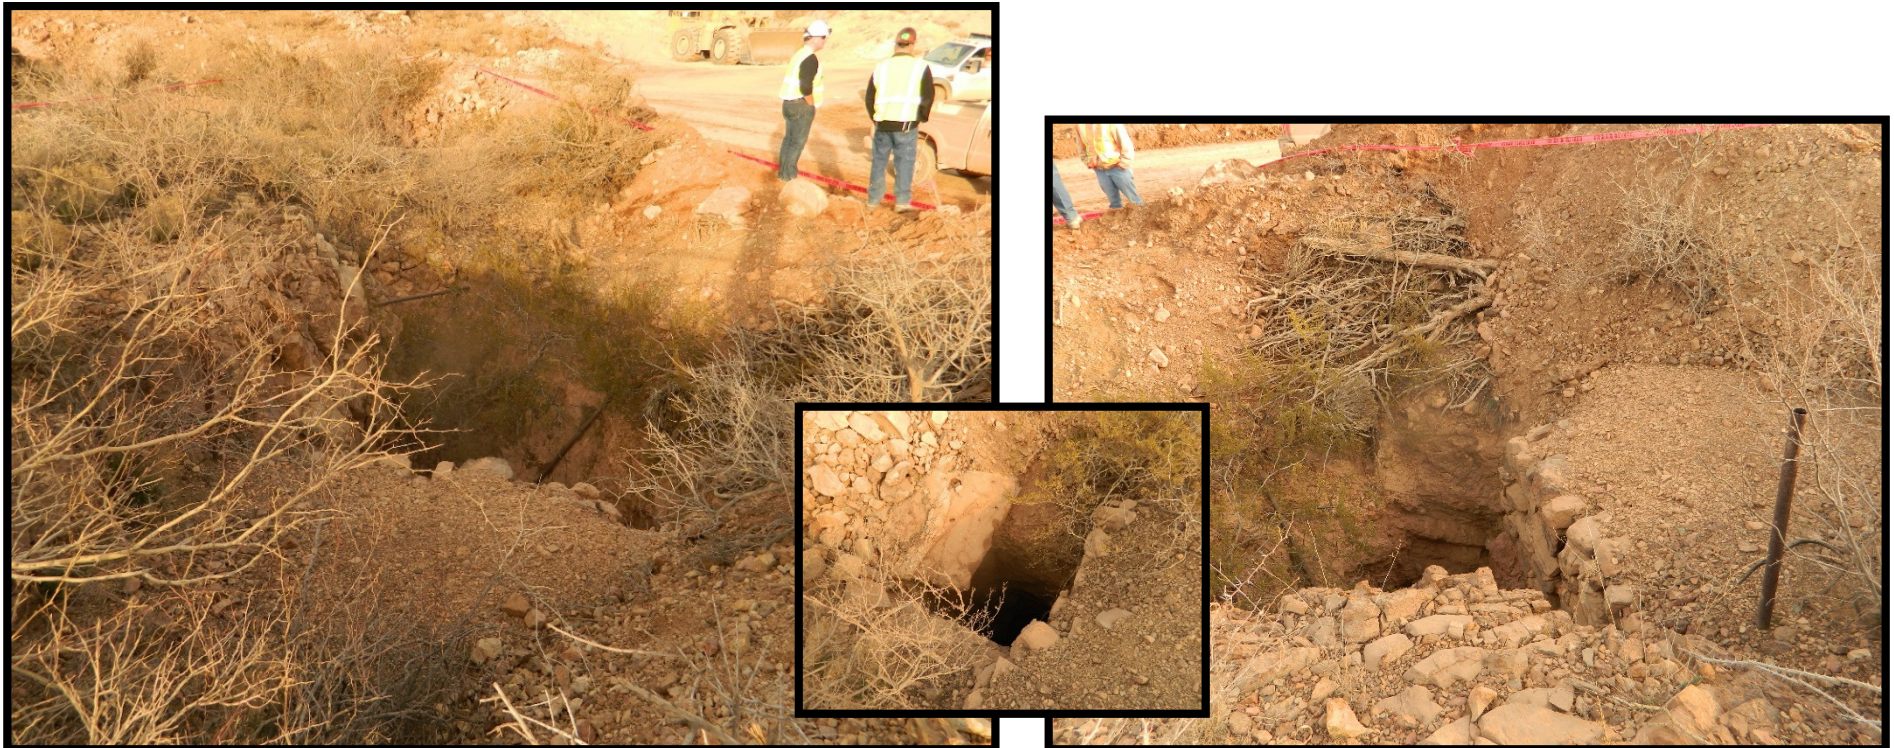
Near Miss			
Date	02.04.2016		
Organization	Mine		
Division	Fragmentation-Loading/ Support		
Potential Risk	3	2	6
	Consequence	Likelihood	Potential Risk
Brief Description	Two open vertical mine shifts were discovered unbermed and within 120 feet of a haul truck bathroom tie down. The mineshafts were unmarked.

1. Complete thorough workplace exams
2. Caution should be used when approaching areas of uncertain mining history
3. Newly discovered mine openings must be sealed and communicated
4. When open holes are discovered, hard barricades must be installed

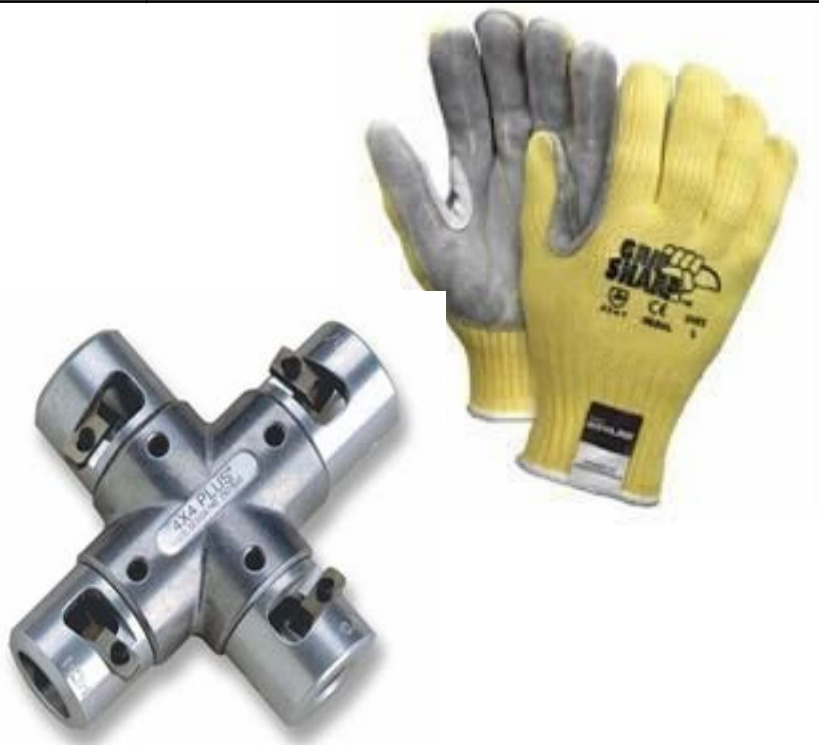
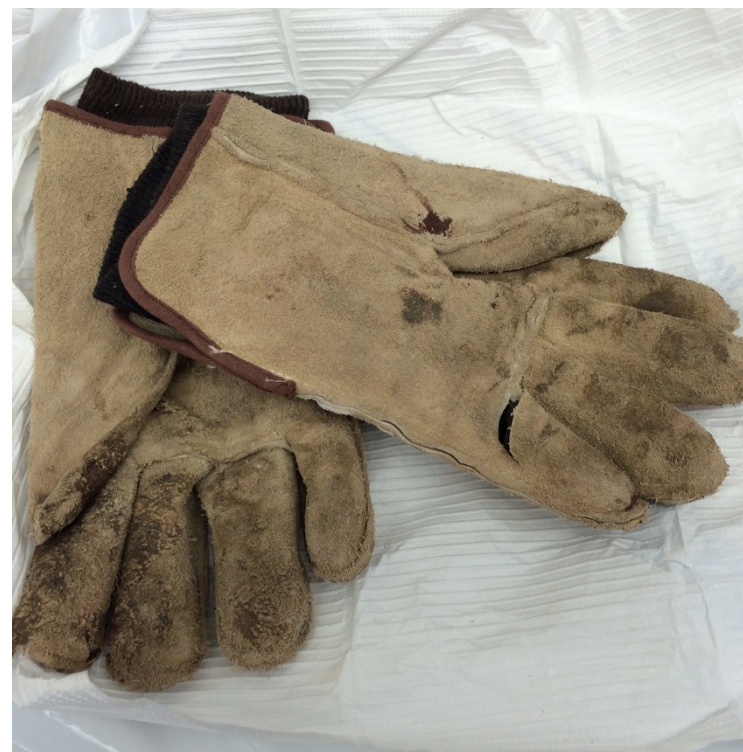
Near Miss			
Date	02.04.2016		
Organization	Mine		
Division	Mine Maintenance		
Potential Risk	3	2	6
	Consequence	Likelihood	Potential Risk
Brief Description	An employee was skinning insulation when his knife slipped causing significant laceration to left pinky finger. The employee was wearing leather gloves at the time of injury.

1. Always assess the task related risks prior to commencement of work
2. Use the right tool for the job
3. Ensure proper PPE usage (cut resistance gloves)

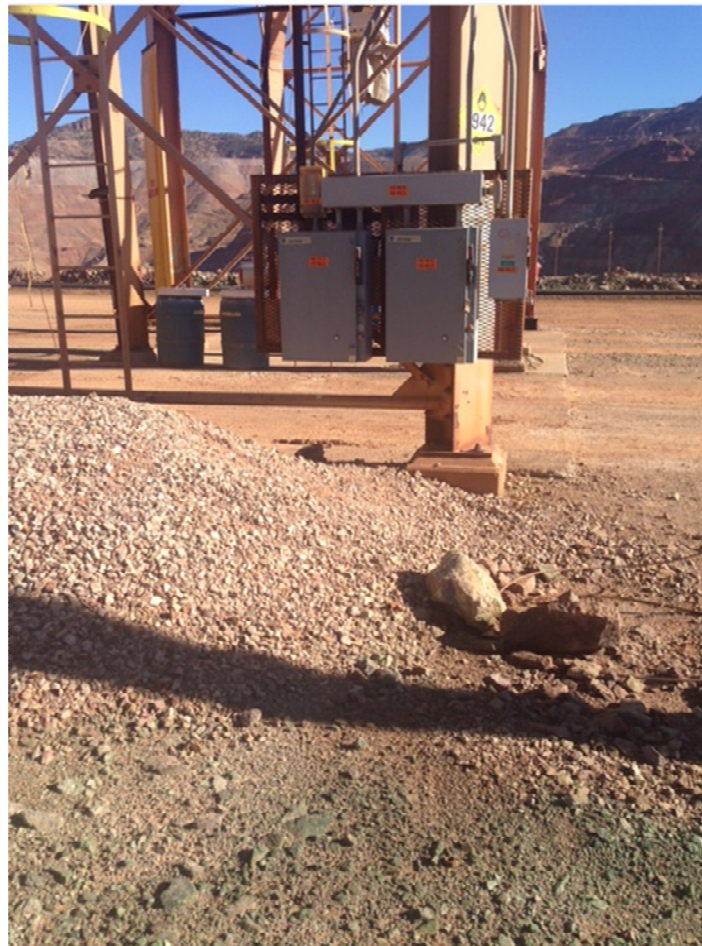
- Safe access was not provided to the electrical panels.

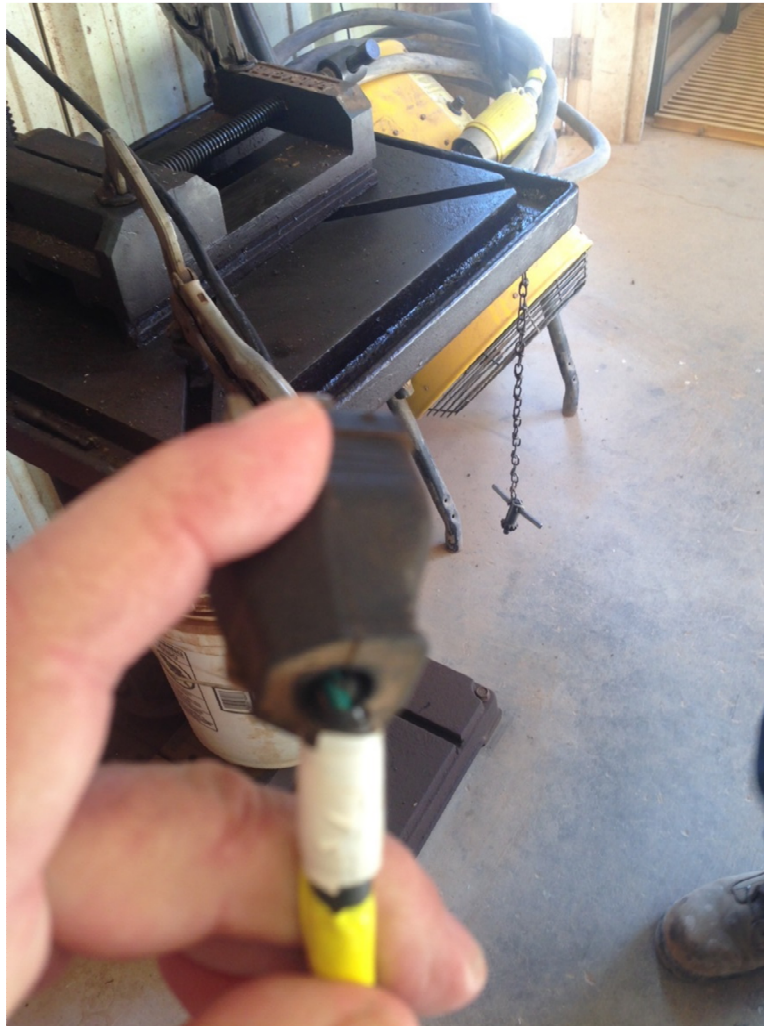
- A drill power cord had the conductors exposed.
