FREEPORT-McMoRAN

2016 April Contractor Safety Meeting

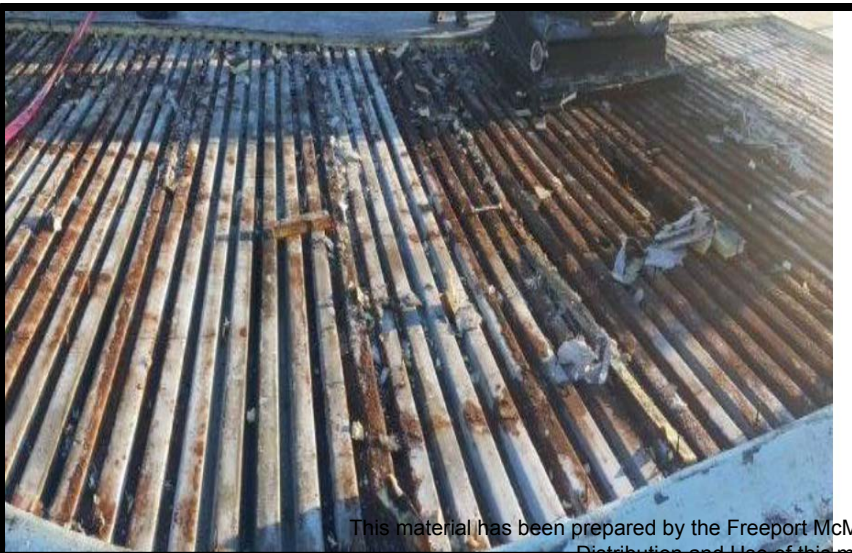
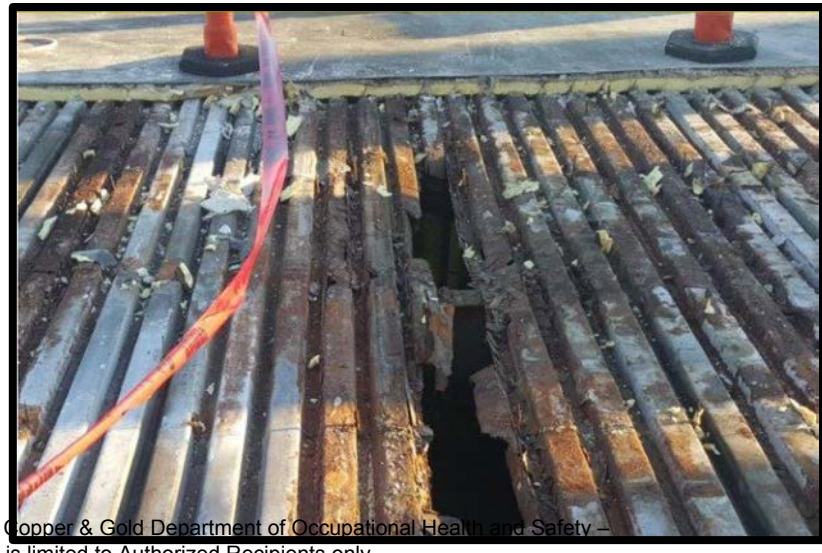
Norwich Rod Mill PREA

A roofing contractor working on roof replacement partially fell through the roof over the Rod Mill, up to his thigh. His leg went through a section of decking after the rubber roofing membrane was peeled back, and the underlying insulation had not yet been removed. The insulation prevented the contractor from seeing the corroded condition of the decking underneath. The contractor was able to crawl out, leaving a 12" hole behind. Some debris fell to the mill floor ~40 feet below, inside the taped-off area.

Prior to the event, a JSA and HazOps evaluation had been conducted with the contractor for this project. The contractor was following the existing work instruction for the task as the policy only required the contractors to don fall protection prior to creating an open hole by removing corroded decking material.

All work on the job was stopped to understand what led to the event. The policy was modified immediately to require the use of fall protection at any time the rubber membrane is being removed, and flagging and taping must be verified prior to the removal of membrane. Health and Safety as well as Engineering held a tailgate with the contractors to make sure they understood the plan going forward. The contractor will provide a safety watch on the floor below to ensure the flagging is effective, and there is no traffic in the area.

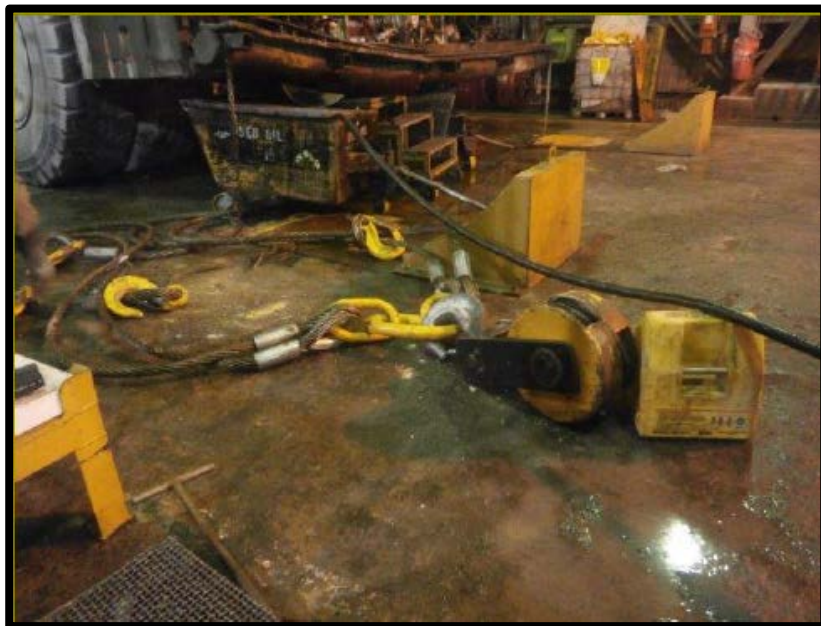
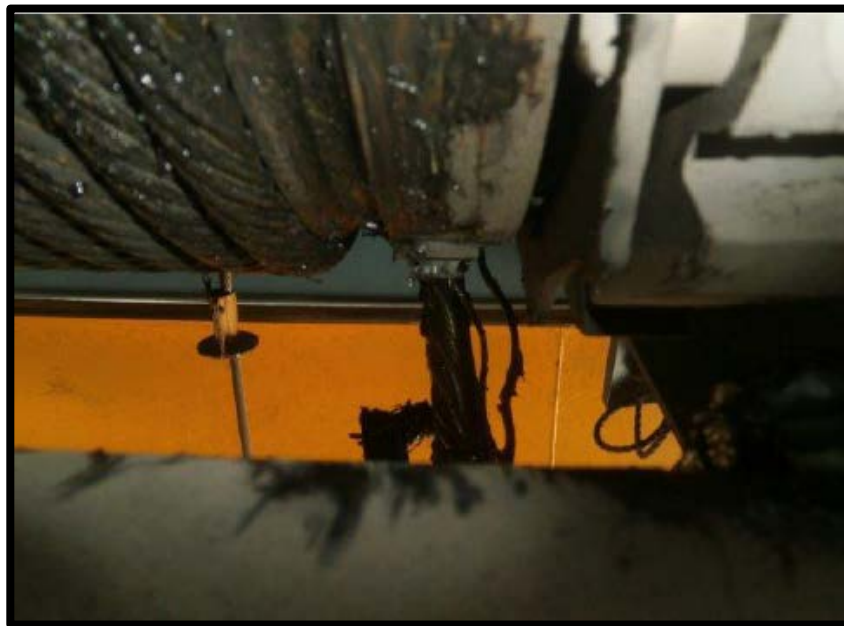
PTFI Overhead Crane

On Sunday 31 January 2016 at approximately 00.30 Local Time (WIT), an electrician carried out a repair on Overhead Crane #079 (40-ton capacity) at Bandung Shop to replace 42AC Volt contactor with 110AC Volt contactor. During the function test of the contactor, the electrician performed the test from the top position on OHC platform. The electrician switched on the pendant control and pushed the hoist up switch to move up the hoist. The electrician didn't recognize that the limit switch failed and caused the hoist rope to continue winding to the drum. The electrician didn't observe that the OHC hook block already contacted the OHC drum, as a result, excessive tension was created and the hoist rope snapped and the Hook Block (150 kg) fell from 18-meter elevation to the floor right behind HT#115. No one was working under OHC area when the incident occurred. No injuries were sustained during the incident

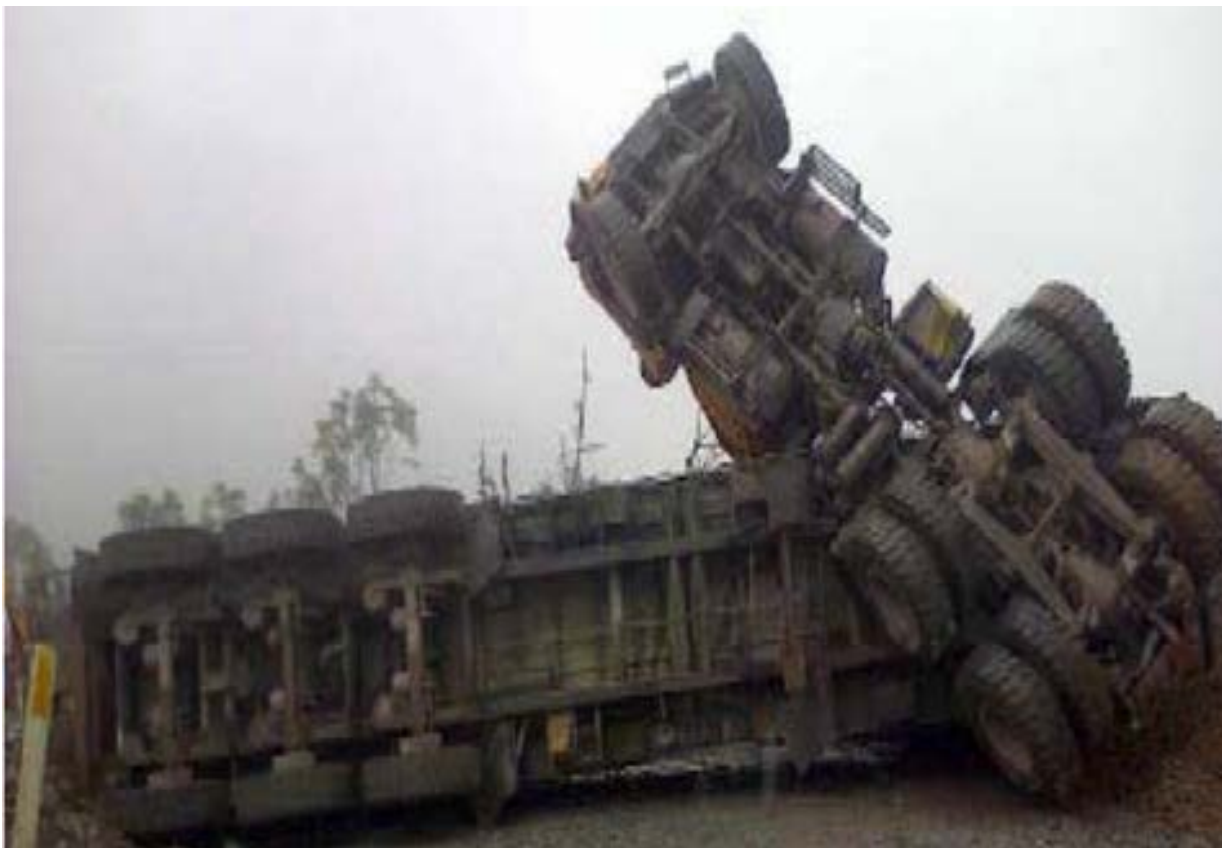
KPI Logistics Transport

On Tuesday February 09, 2016, a Cargo Transport Tractor Truck and Single Trailer were transporting a 25 ton load at Mile Post 62 along the main supply route (MSR) incline. The operator maneuvered the truck to a stop at a location of road heading in an upward position on a +15% incline. He had decided to take a personal rest at this point, placing the truck in neutral, setting the parking brake and then exiting the unit's cab. As he stepped out the door, the tractor trailer began rolling backward down the incline and out of control with the operator on the outside of cabin for a distance of approximately 25 meters. The truck and trailer struck the berm; the trailer flipped to one side while the tractor jack-knifed pointing upward.

The operator was outside the cabin during the event, he held on to the door while standing on the running board for the +25 meters the unit descended until the unit came to a stop. He then jumped down to ground. He suffered minor abrasions and bruising due to this event. When tested for alcohol consumption the result was negative. The operator was a senior driver. The location of the accident is one of the steepest sections of the MSR and is a location of several previous cargo accidents that have been reviewed and used to educate the drivers in annual refresher(s) and toolbox meetings; these last two issues demonstrate the extreme poor judgement and lack of caution exercised by the driver.

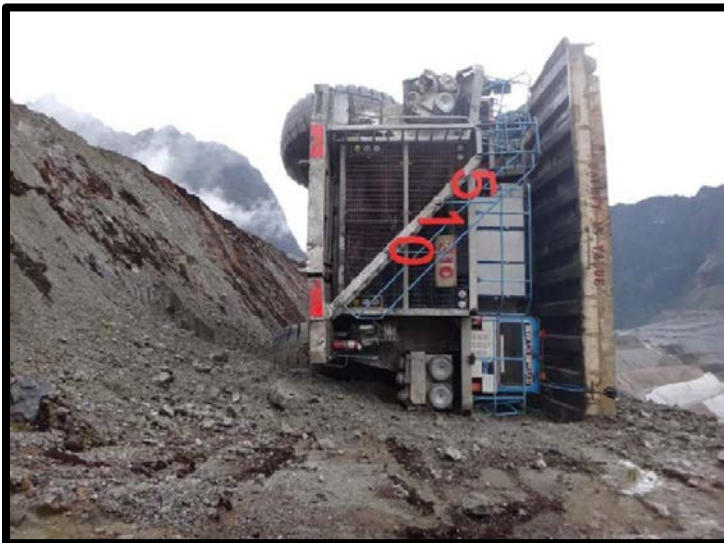
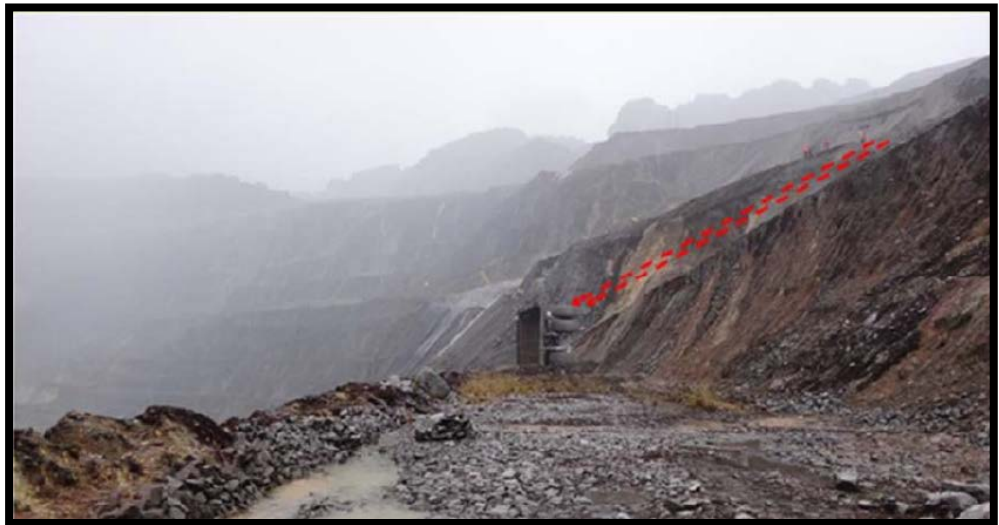
Haul Truck Lost Control

On Thursday, 11 February 2016 at approximately 12:43 local time, an empty Komatsu 930E haul truck traveling from Bali Dump to shovel #22 was involved in an accident at the junction of Kitamani 2 – Kintamani 1 – D4 (Pinang).

The haul truck was being operated by a Cat 793 operator that was training to operate the 930 class truck, he was accompanied by a qualified trainer. While coming down an inclined section of haul road the operator lost control of the truck and it slipped into the wall on the right side of the haul road. The truck continued traveling down the haul road to an intersection where the operator and trainer tried to steer the truck to the right and stay on the haul road. The operator and trainer again lost control of the truck and it traveled over a two meter high berm falling two benches below the intersection, about 30 meters.

The operator of the truck was uninjured but the trainer, who was not wearing a seat belt, sustained minor injuries.

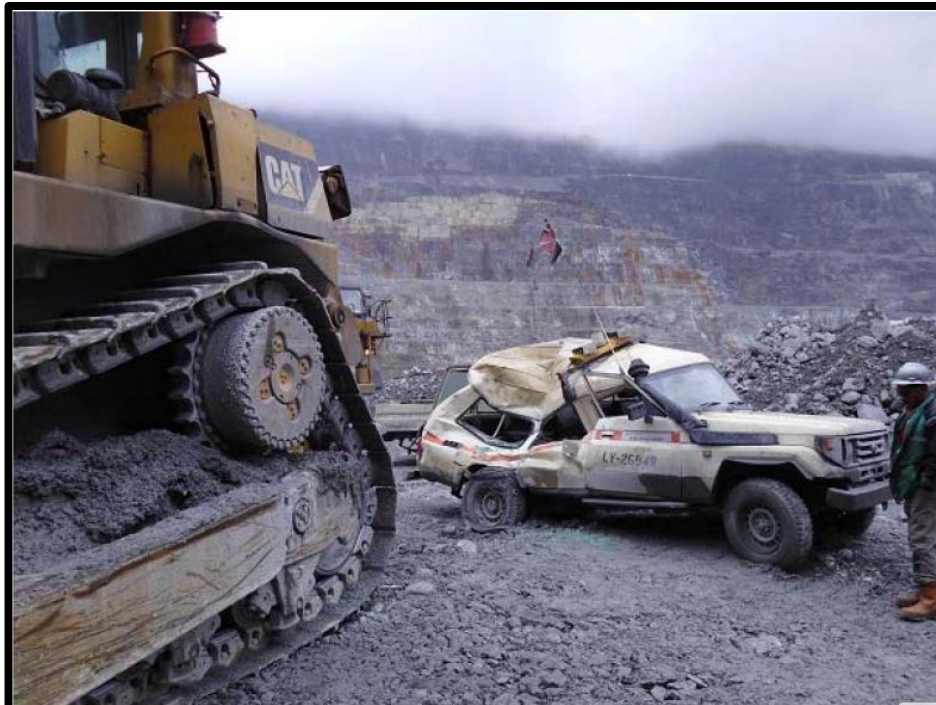
Light Vehicle hit by Dozer

A Mine Maintenance Light Vehicle (LV) was struck by a dozer while both vehicles were inside of a shovel loading area. The LV had parked behind the dozer with two occupants inside and the dozer backed up into the LV. No injuries were reported.

The Maintenance LV notified the dispatcher that it was entering the shovel loading area to facilitate refueling of the shovel. With the shovel parked the dozer was in the process of clearing off the loading pad. As The LV entered the loading area and parked the dozer reversed into the LV.

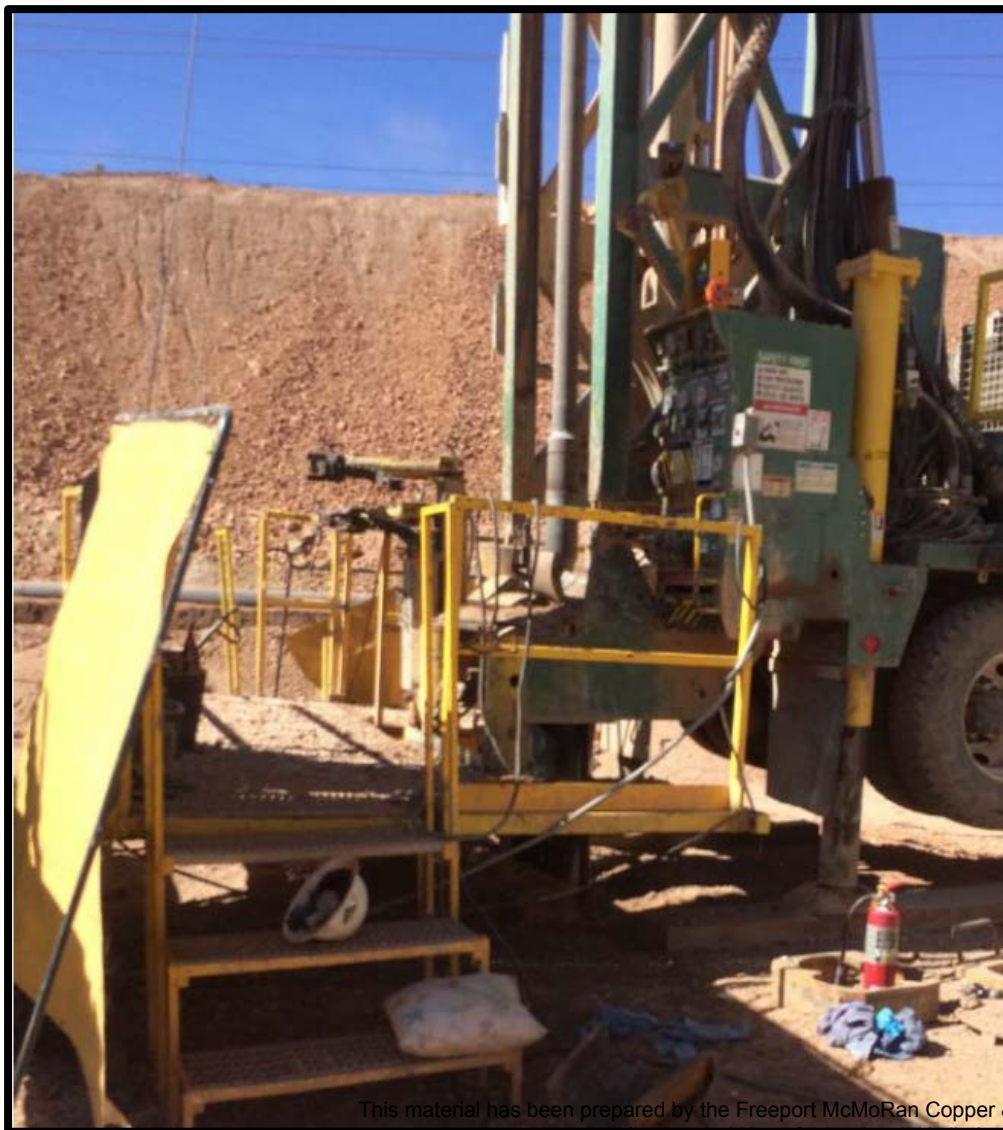
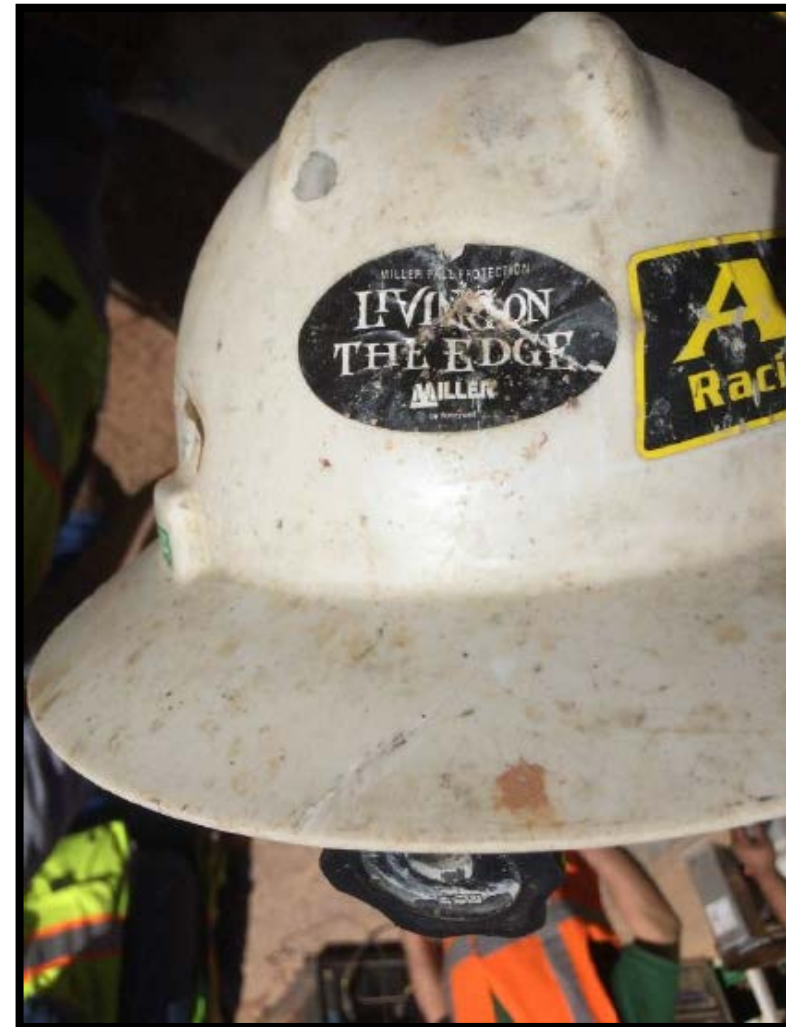
Uncontrolled Pneumatic Energy

A drilling company was in the process of drilling a dewatering well with an RD-20 rotary drill rig. Prior to reaching bedrock, the hole was being drilled in an old stockpile through approximately 185 feet of fill material. In this type of drilling, a 10 foot length of 16" casing (conductor) is attached to a casing bit, which pulls the casing down with it during drilling. Every 10 feet of depth, an additional 10 foot section is welded on at the surface, so the entire hole is cased to within approximately 1 foot from the bottom as it is being drilled.

At the time of the incident, the hole was 150 feet deep, and the drill pipe was being tripped out of the hole. Prior to tripping out of the hole, the casing bit was at the bottom of the hole, with the casing hammer on top of it with both being suspended by five-30 foot lengths of drill pipe. The pipe was pulled out of the hole as each 30 foot section was removed. When four sections (120 feet) of pipe had been removed, the bit became stuck at a depth of 30 feet due to stockpile material/cuttings wedging between the bit and the casing. Efforts to dislodge the bit resulted in the casing being drawn up to within a half a foot of the bottom of the deck.

Air was being used in an effort to dislodge the material jammed between the bit and the casing. The bit did not move and the air pressure continued to build up between the bit and the bottom of the hole, essentially becoming a 120 foot X 16" compressed air cylinder.

The pressure eventually released and blew past the bit and out of the hole, ejecting both the inner and outer split bushings at the collar. The driller quickly turned away to avoid being hit in the face by cuttings and was struck in the back of his hard hat by the 60 lb. inner bushing. The hard hat absorbed most of the force of the impact and was severely damaged. The driller received medical treatment for a laceration and was given a full duty release back to work.

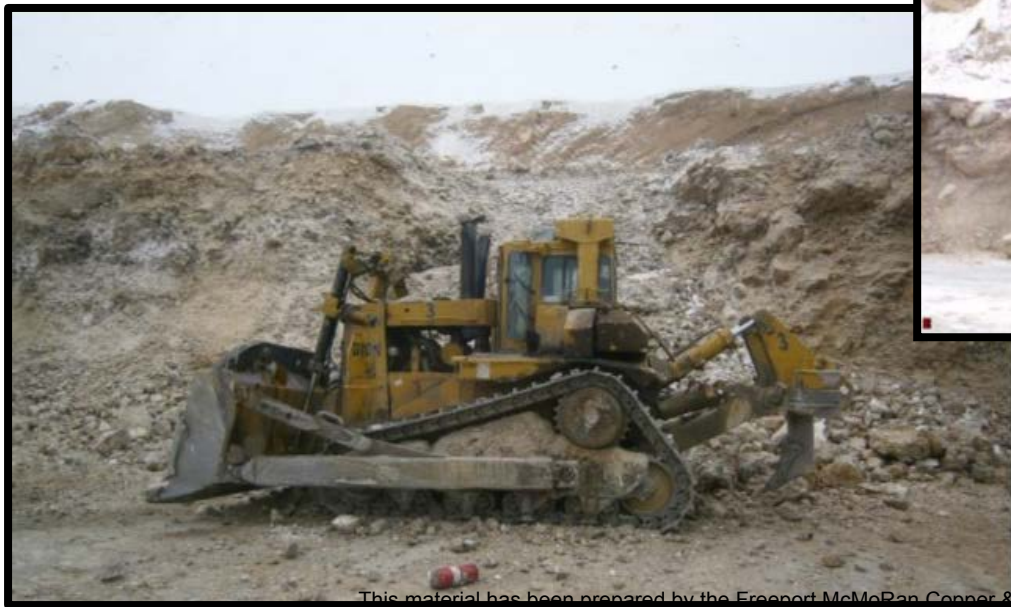
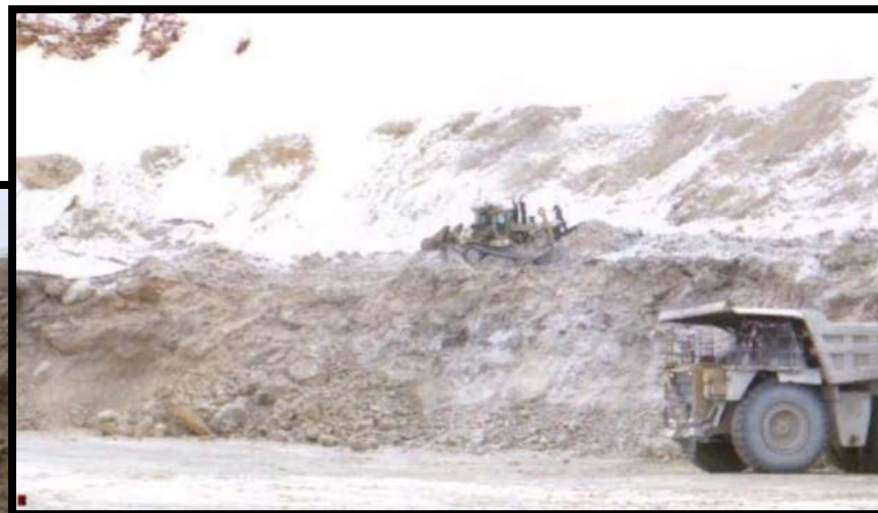
Climax Dozer Overturn

On the morning of March 7th at approximately 8:20 am, DZ03 was pushing material to LD01 on 12160 bench. The dozer was working parallel to the crest of 12200 when material below gave way. This caused DZ03 to roll one full rotation and land on its tracks on 12160. The operator was able to exit once the dozer stopped and was examined by site medical personnel. The operator was wearing his seatbelt and there were no sustained injuries.

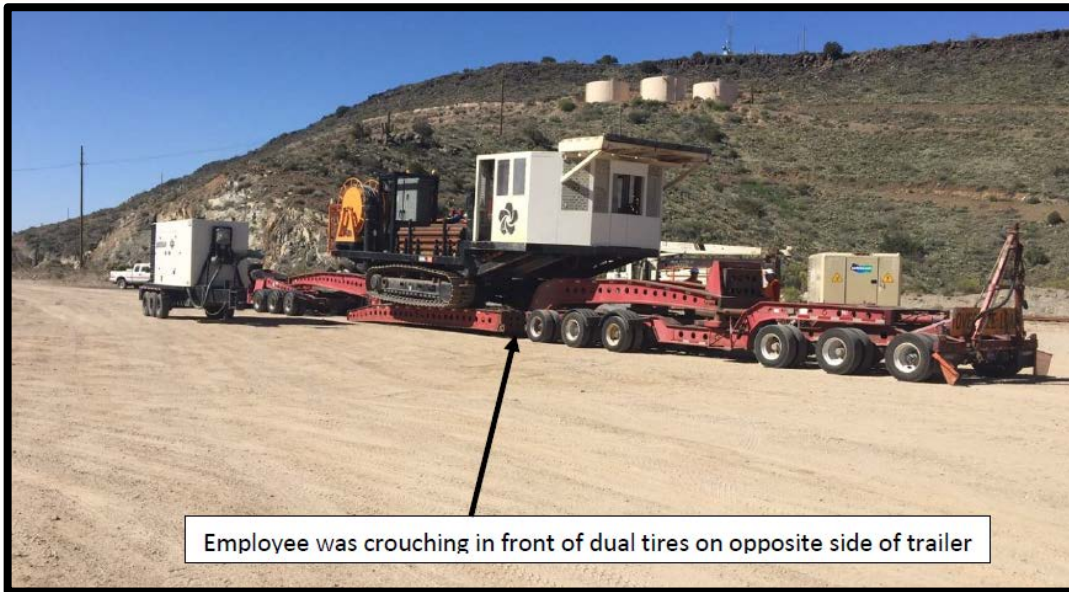
Air lines from the tractor to the rear part of the trailer were disconnected so that loss of air pressure to the rear trailer brakes would lock the brakes. No wheel chocks were put in place at the wheels of the rear part of the trailer. The central portion of the trailer was lowered to rest on the ground, and the fasteners holding the two parts of the trailer together were removed.

At this point, the driver attempted to separate the two trailer parts by pulling the front part forward, away from the rear part that had the drill rig on it. A spotter was on the right side of the truck cab where the driver could see him. One employee was crouching in front of a set of dual tires on the right side of the rear part of the trailer, attempting to remove a tie-down chain. The driver sounded the truck's horn once and without a pause drove forward. The rear part of the trailer failed to separate immediately and began to move forward with the rest of the truck, for a distance of about one foot. The rear trailer brakes did not prevent the movement. The employee who was endangered by the rear duals jumped clear as the spotter called to the driver to stop.

Employee was crouching in front of dual tires on opposite side of trailer

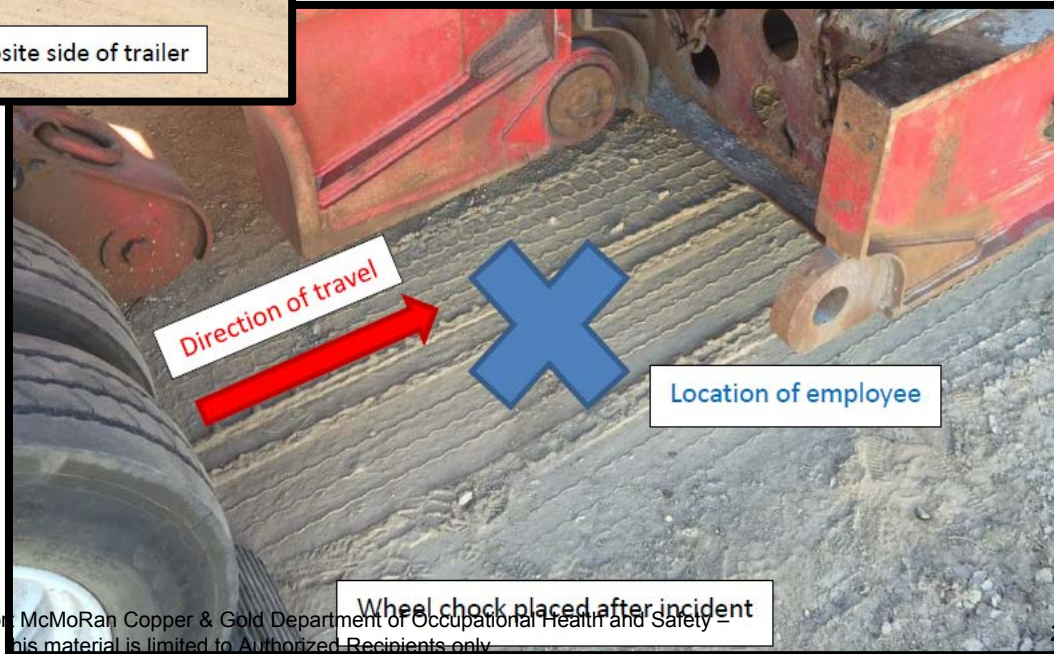
Wheel chock placed after incident

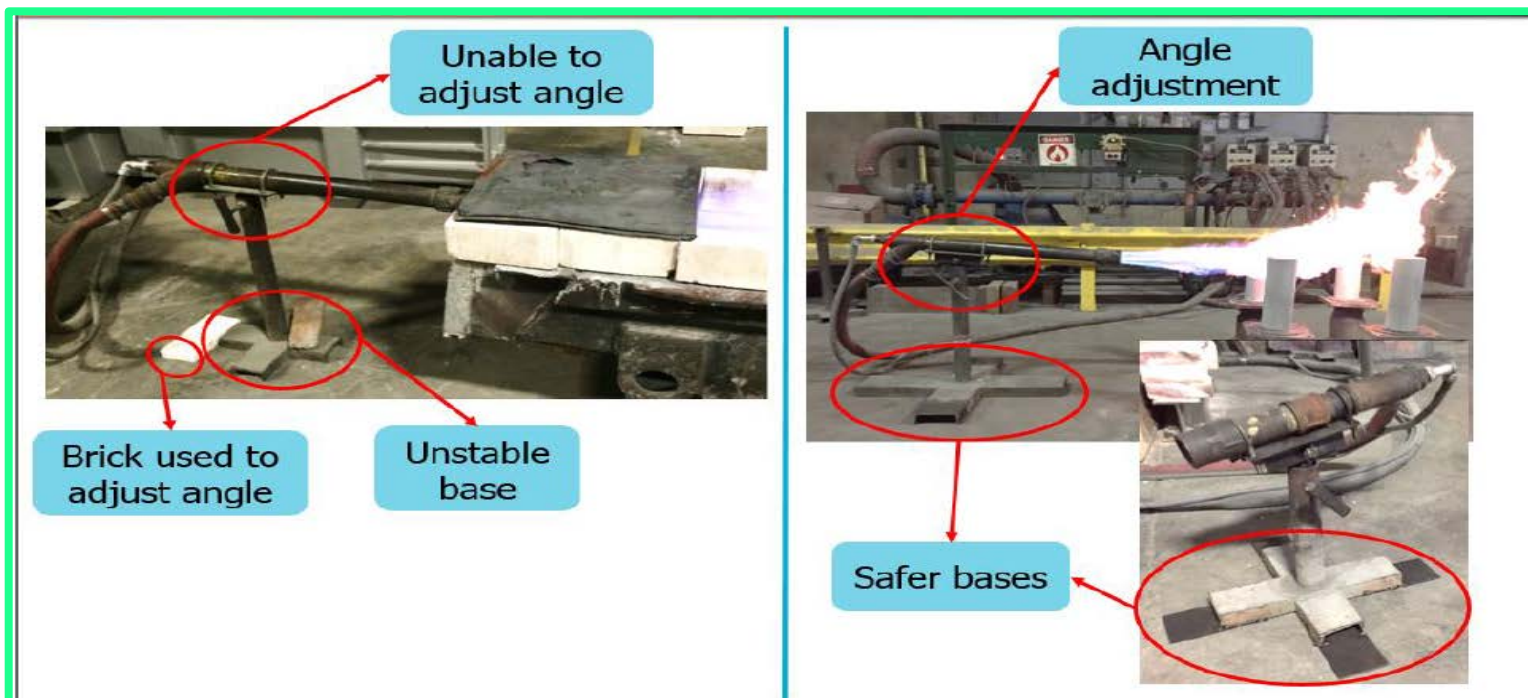
Safety Success

As part of the Safety Focus Group the Refractory Room in Norwich was analyzed for improvement opportunities, the Operator stated that the torch did not have a stable base and he needed a way to adjust the torch since he works with different angles when curing materials. He used bricks to tilt the torch and get the work done. An opportunity to redesign the torch was identified.
