THE VALUE OF
COPPER

Morenci Contractor Safety Meeting

Aug 13, 2024

Freeport Safety Incidents, Successes & Alerts

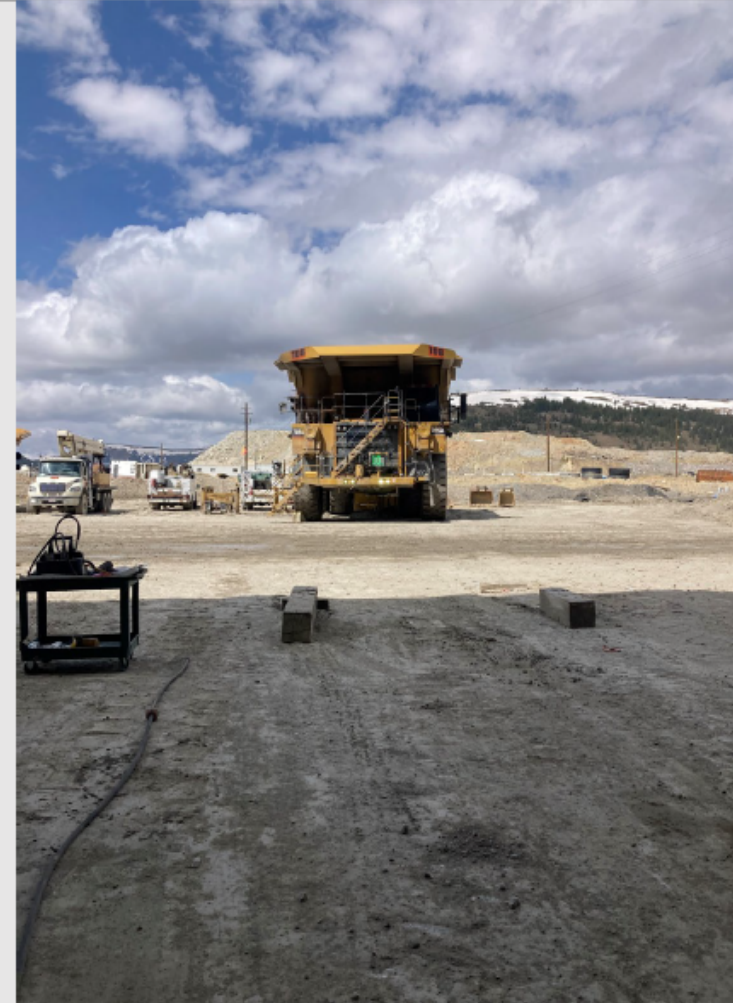
| Summary | As part of routine maintenance activities, an employee set up a haul truck on wood planks in front of a bay at the shop to remove both outer tires. The employee noticed the truck wasn't properly centered and went to move it, but it wouldn't start. The employee called over two other technicians, who went under the truck and behind the front left tire to air start it. When air was applied, the truck started and rolled backward, missing the two technicians underneath. The truck traveled about 25 yards in reverse across the road before coming to a stop against a berm. Initial review indicates the park brake was not set and only one chock was set. |
| Findings / Missing Controls | <ul style="list-style-type: none"> • Failure to follow proper protocols • Park brake was not set • Only one chock was placed to prevent movement |

A view of the haul truck after it rolled off the wood planks and crossed the road in reverse before coming to a stop against a berm.

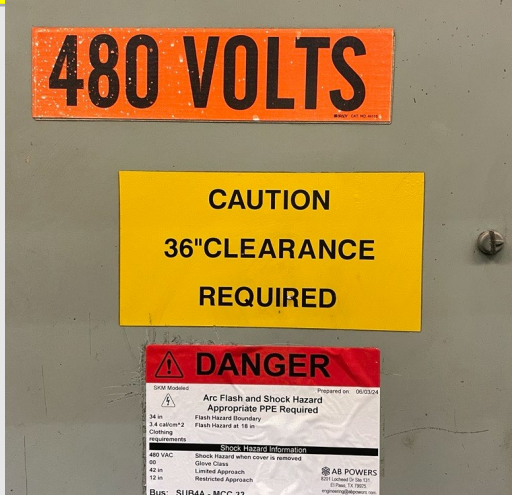
| Summary | An electrician was called to reset an overloaded and tripped breaker at the coil collecting process of the Rod Plant. After the first reset, the table section of the conveying system did not respond. As the electrician returned to the breaker to troubleshoot, an arc occurred when a voltmeter contacted a contactor. |
| Findings / Missing Controls | <ul style="list-style-type: none"> Faulty electrical equipment |

Arc flash label

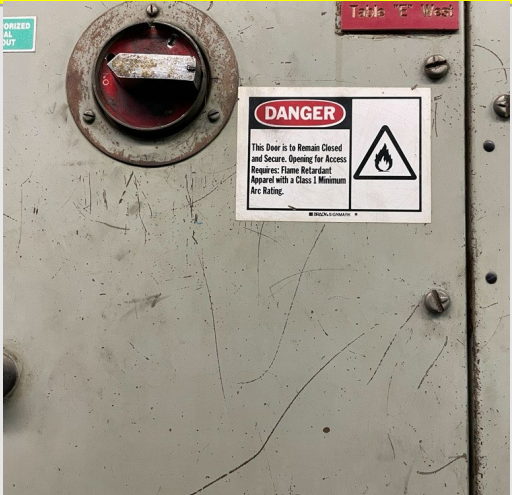
Table E conveyor door

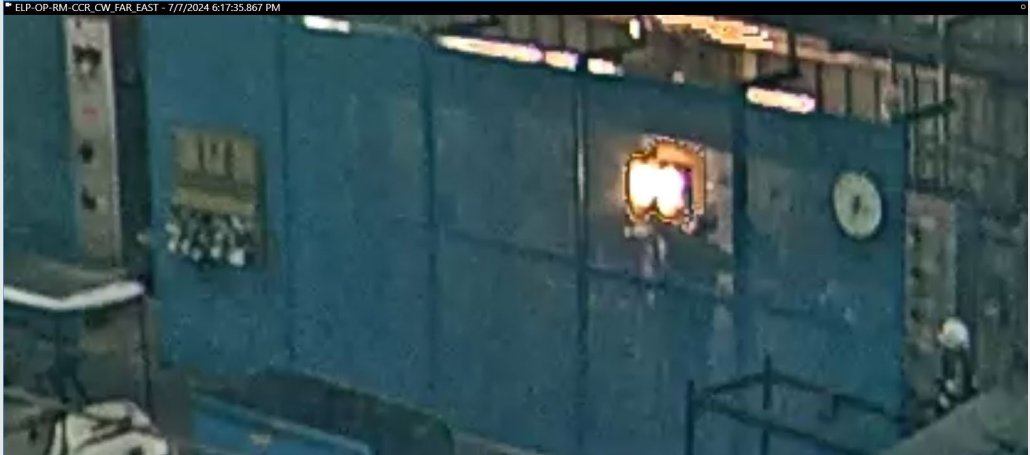
Electrician inside of the motor control center when arc flash occurred

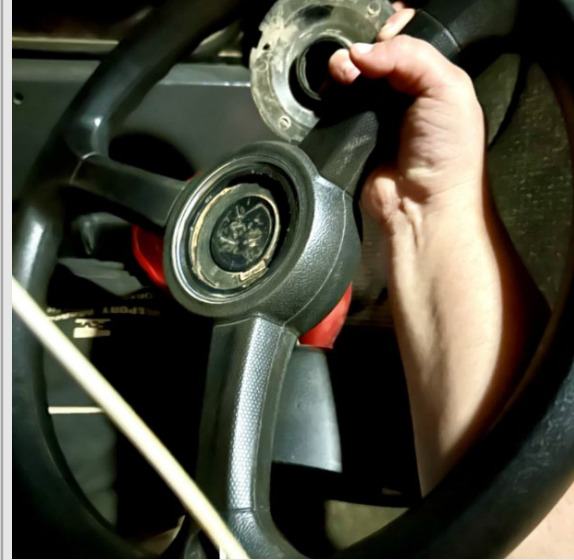
| Summary | A haul truck operator was traveling uphill, at low speed, on the haul road when the steering wheel fell off. The operator was able to stay in their traffic lane and stop the truck. There was no exposure to oncoming traffic. |

Detached haul truck steering wheel.

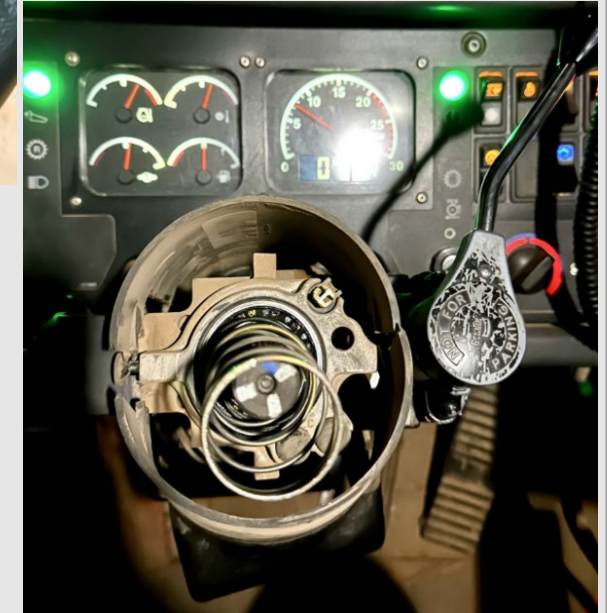
| Findings / Missing Controls | <ul style="list-style-type: none"> Steering wheel locknut was not torqued to specified 60 lb./ft. Quality check to verify torque specifications was not applied by service contractor. The verification was to be conducted as part of the action plan following a previous PFE incident with a similar failure. |

A photo showing the unsecure haul truck steering wheel locknut.

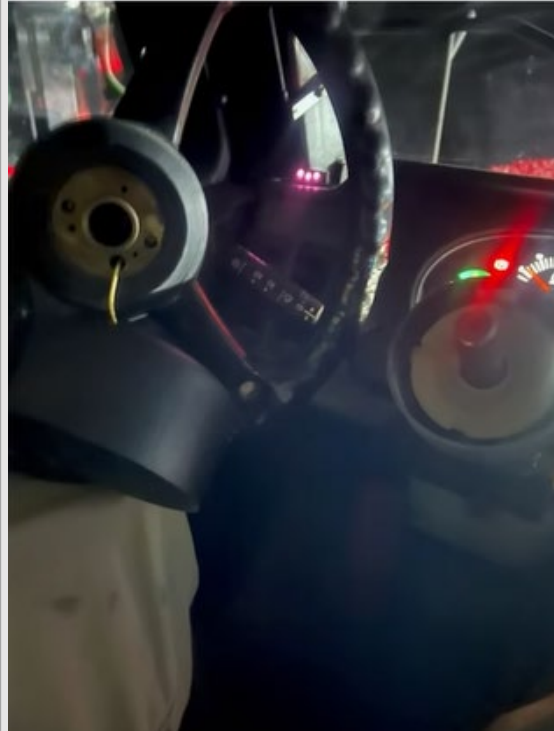
| Preliminary Incident Details | |
|---|---|
| Summary | A haul truck operator was preparing to reverse to a shovel when the steering wheel came off. The operator used the secondary brake to stop, put the truck in neutral and set the parking brake. There was exposure to oncoming traffic. |

Detached steering wheel.

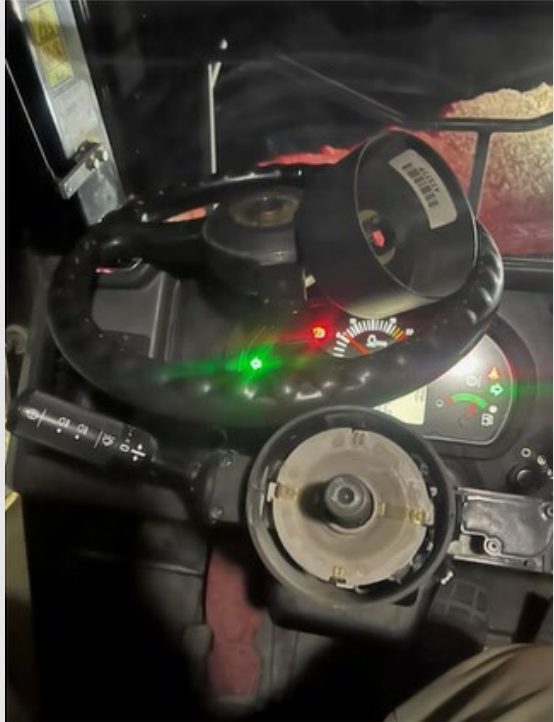
| Preliminary Incident Details | |
|---|---|
| Findings / Missing Controls | <ul style="list-style-type: none"> Steering wheel keeper nut was not torqued to proper specifications. Quality check to verify torque specifications was not applied by service contractor. |

Steering wheel assembly after wheel was detached.

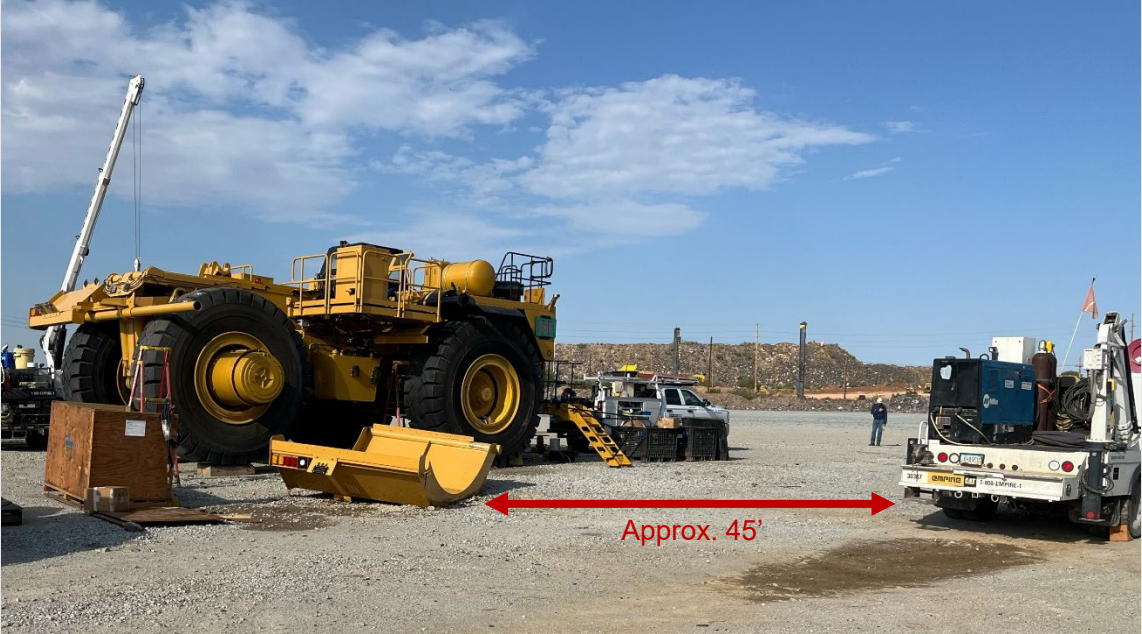
| Summary | Contractor technicians were replacing a lowboy rear fender. The night crew positioned the fender with a crane but did not tack weld it in place before removing the crane and leaving site. The next morning, the fender fell to the ground as the day crew was preparing for work approximately 45 feet away. |
| Findings / Missing Controls | <ul style="list-style-type: none"> • Failure to follow standard operating procedure. • A welder was unavailable during the evening shift. |

Lowboy fender after falling to ground (approximately 45 feet to crew members gathered at truck).

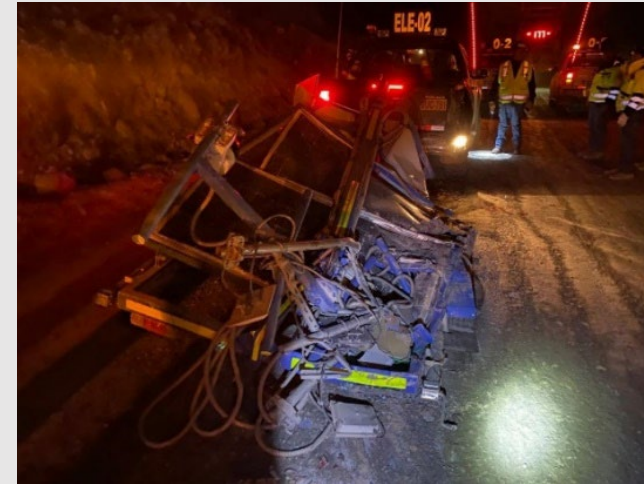
| Summary | A haul truck was travelling down a ramp behind a light vehicle towing a solar repeater on a trailer and other haul trucks. As traffic slowed, the haul truck drove over the trailer and contacted the rear of the light vehicle with the left front tire. On impact, the haul truck operator veered right. The two workers inside the light vehicle were able to exit the vehicle without injury. |
| Findings / Missing Controls | <ul style="list-style-type: none"> • Driver fatigue based on initial review of Driver Safety System data and video footage |

Trailer damage following impact

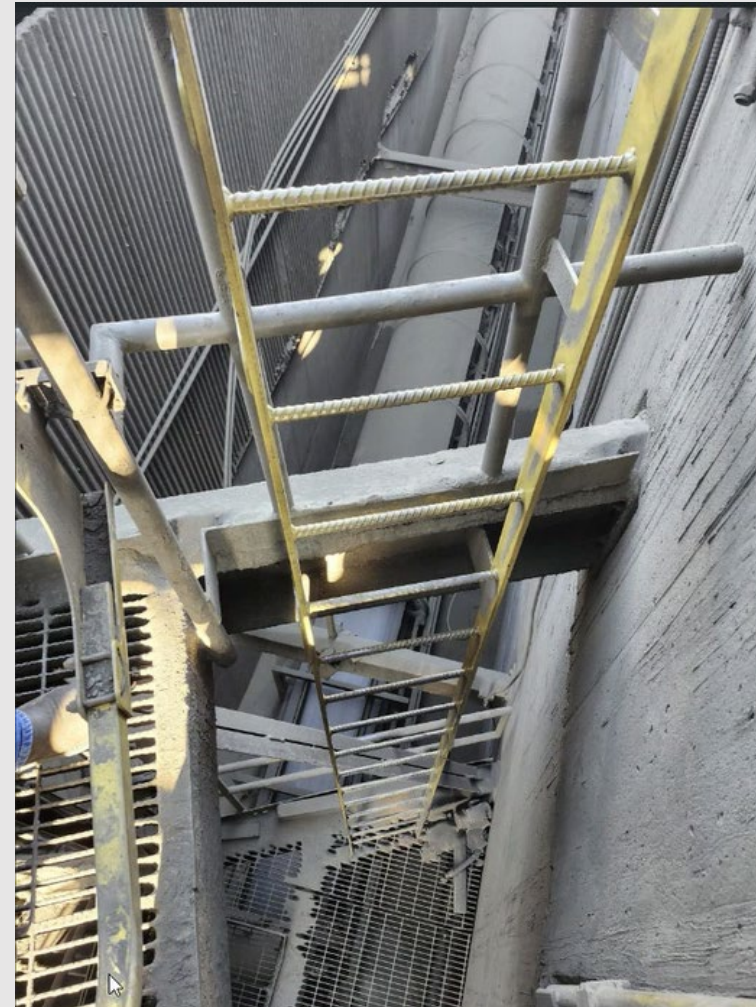
| Summary | An employee was climbing a fixed ladder after cleaning hoppers. Approximately 12 feet up from the landing, the employee lost their grip and fell to the grating at the base of the ladder. The employee landed on their left arm and struck their head. |

Location of ladder and fall.

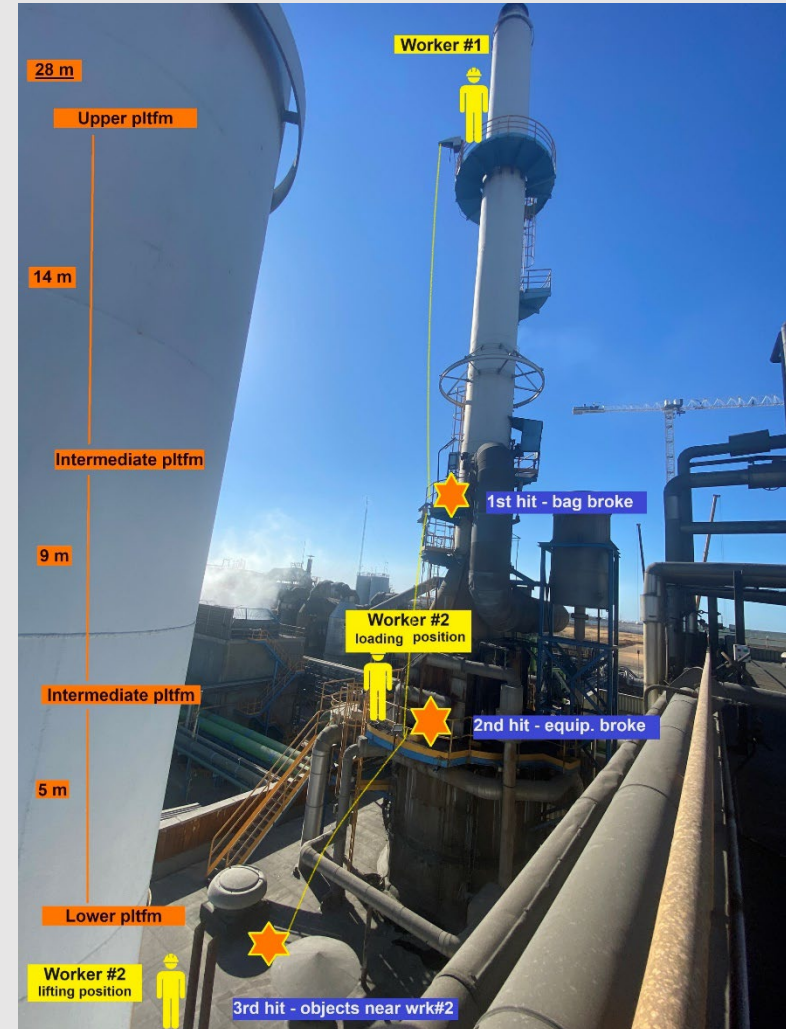
| Summary | <p>Two contractors were lifting measuring equipment up the stack for environmental samples. Worker #1 was operating the electric winch on the stack's upper platform. Worker #2 put the equipment in a lifting bag and flagged the intermediate platform, then proceeded to walk down to the lower platform.</p> <p>When the lifting bag reached the upper platform, the hoist steel cable broke. The bag, weighing approximately 132 lbs (60 kgs), fell and hit the intermediate platform, releasing the equipment. The equipment continued to fall to the lower platform and stopped near Worker #2.</p> |
| Findings / Missing Controls | <ul style="list-style-type: none"> The lifting cable was rusty and deteriorated. The area immediately below the winch was flagged, but the lower platform was not barricaded. |

Diagram of the dropped object path, contact points and elevations.

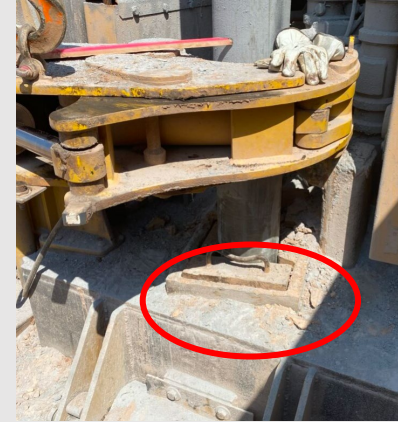
| Summary | Mechanics were replacing a bit sub on a worn drill pipe. Metal wedges were used to separate the pipe. As the drill operator turned the breakout wrench on the pipe, a metal wedge, approximately three pounds, popped out of place and struck a mechanic on the chin. The wedge landed approximately 51 feet from the drill. |
| Findings / Missing Controls | <ul style="list-style-type: none"> Diagnostic mechanic had two years of experience. Struck mechanic was an apprentice 1, in the role for nine months. Failure to segregate the employee from fatal energy. No barricading or guard to control energy. Improper tool (steel wedges) was used to secure the stuck drill pipe. |

Position where steel wedge was installed and later dislodged.

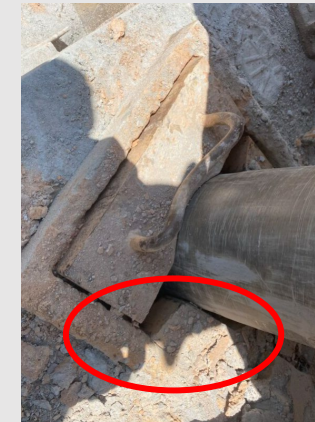
Top view where steel wedge was installed and later dislodged.

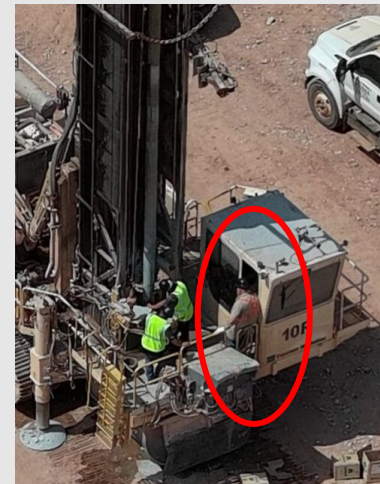
Position where the mechanic was standing at the time of the event.

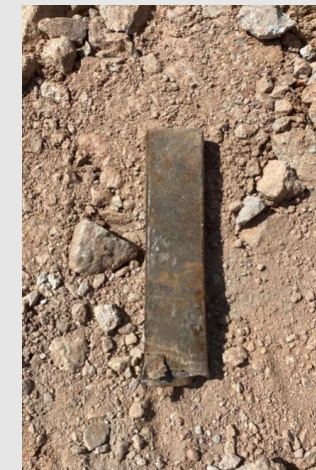
Steel wedge (3 lbs) landed 51ft from the drill.

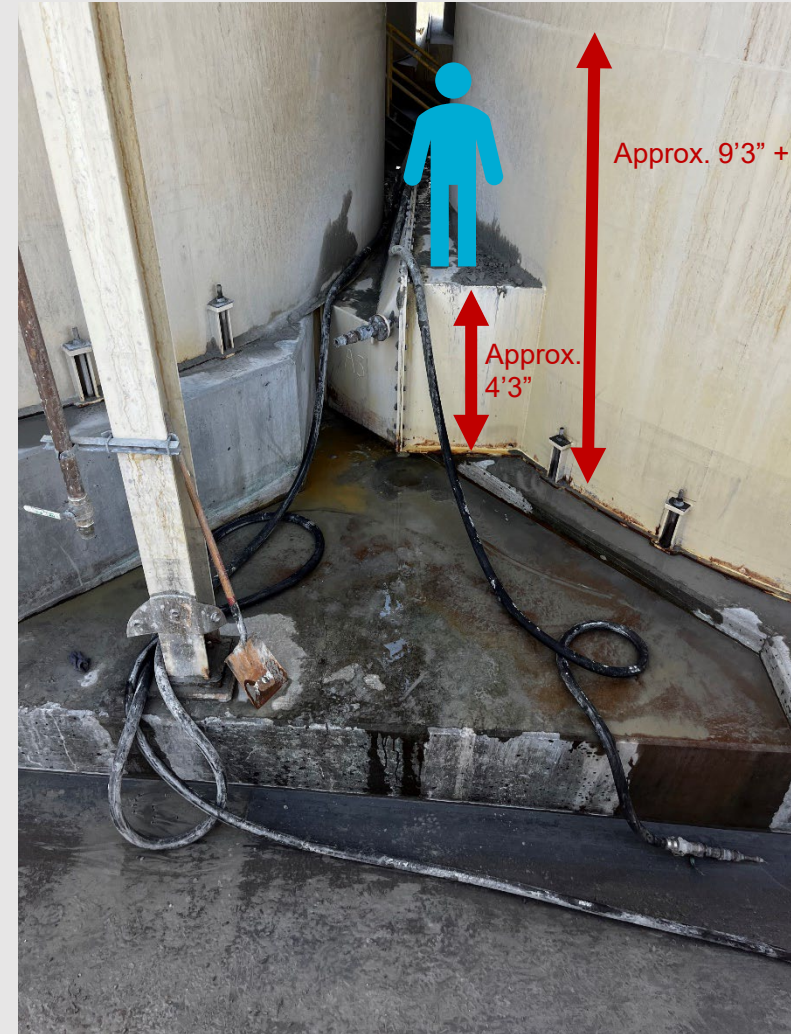
| Summary | A mill employee was standing on top of a rougher flotation crossover approximately four feet from the floor. The employee fell backwards, hit their ribs on a pipe and fell to the floor. |
| Findings / Missing Controls | <ul style="list-style-type: none"> No fall protection was being used above four feet. Employee should not have been on top of crossover. No field verification by supervision that employees were working safely. |

Diagram of employee location prior to fall and approximate heights.
