## January 2024

Contractor Safety Meeting

*Morenci Mine*

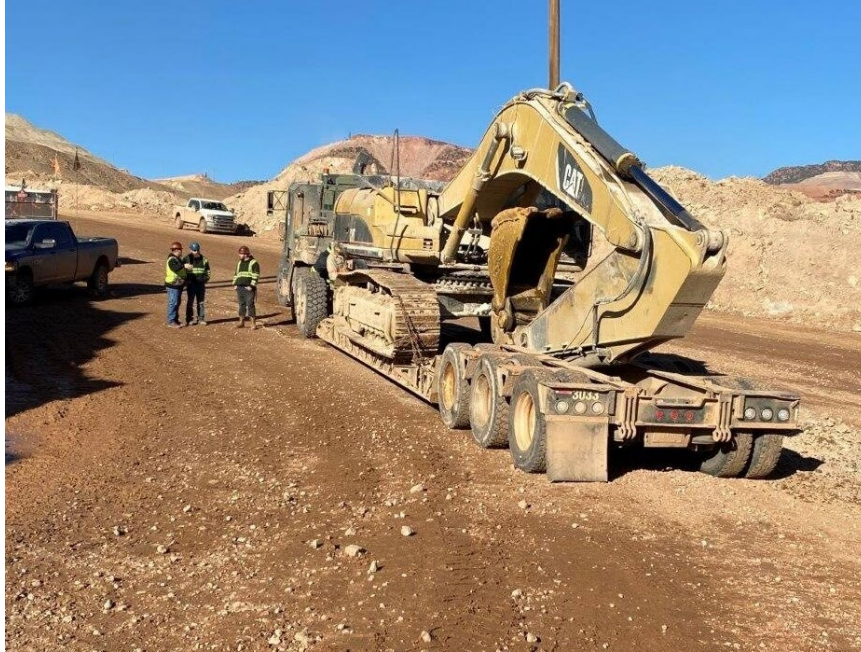
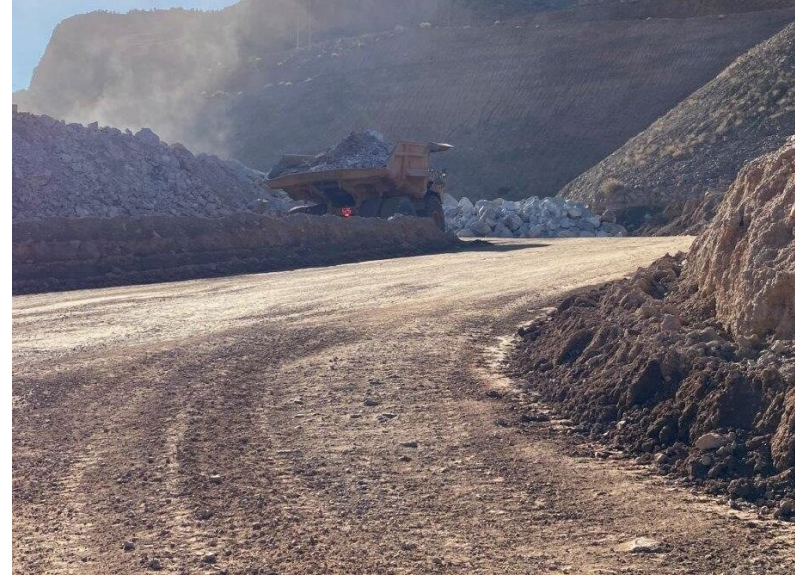
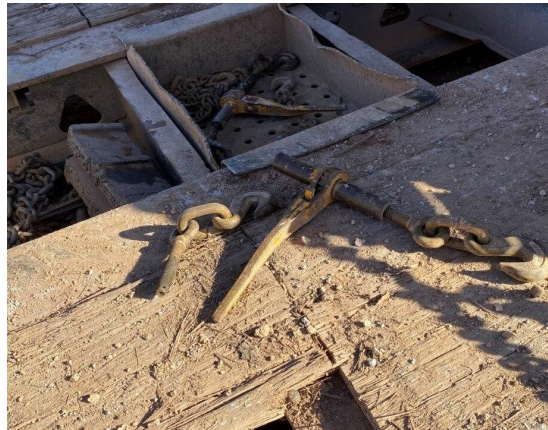
# SWAPP – Lowboy Trackhoe Event

- Right front track fell off Lowboy
- Binder / tie down stripped

- Storage and Maintenance of Binders
- Pre-use inspection
- Communication on Haul roads to secure scene

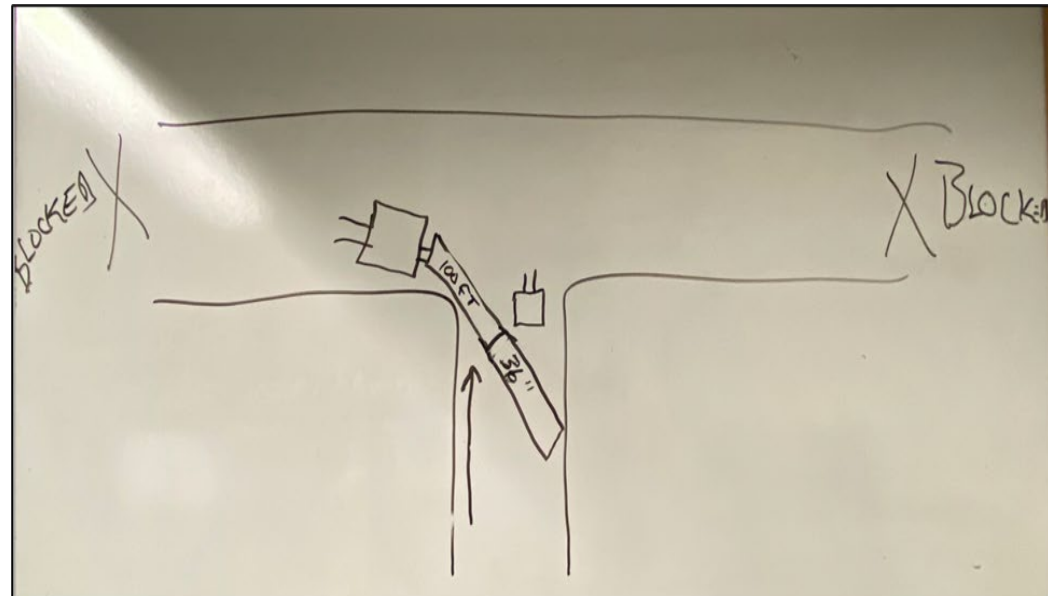
# HDPE Pipe Pulling Incident

The end of the pipe came up to the place where it climbed the berm, causing pipe to go higher than the wheels. As pipe straightened out it contacted cab door that was open. The window was shatter door basically destroyed.

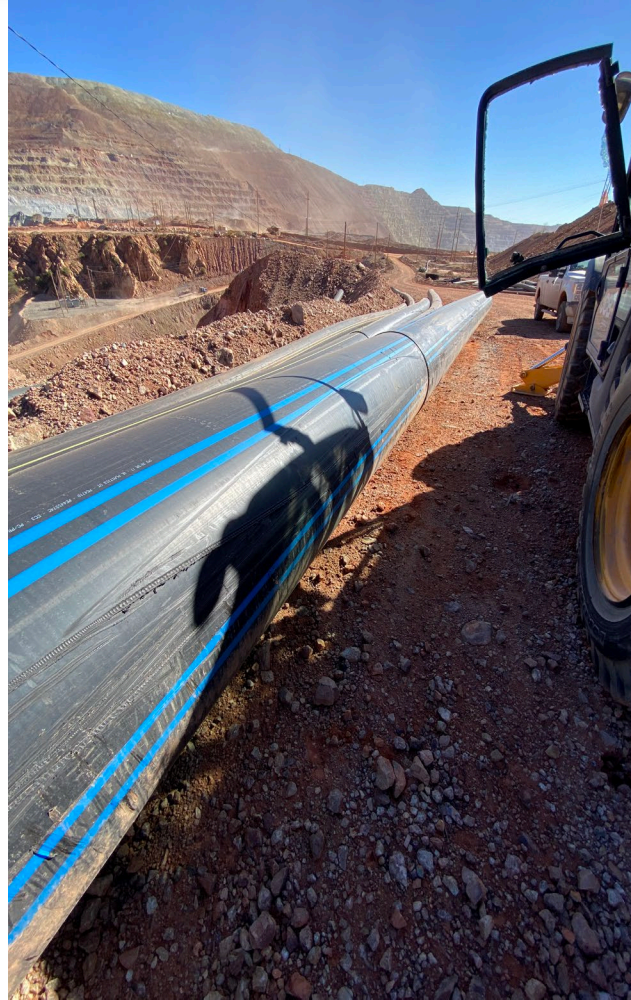
- Damage to forklift
- Tire/Pipe comparison

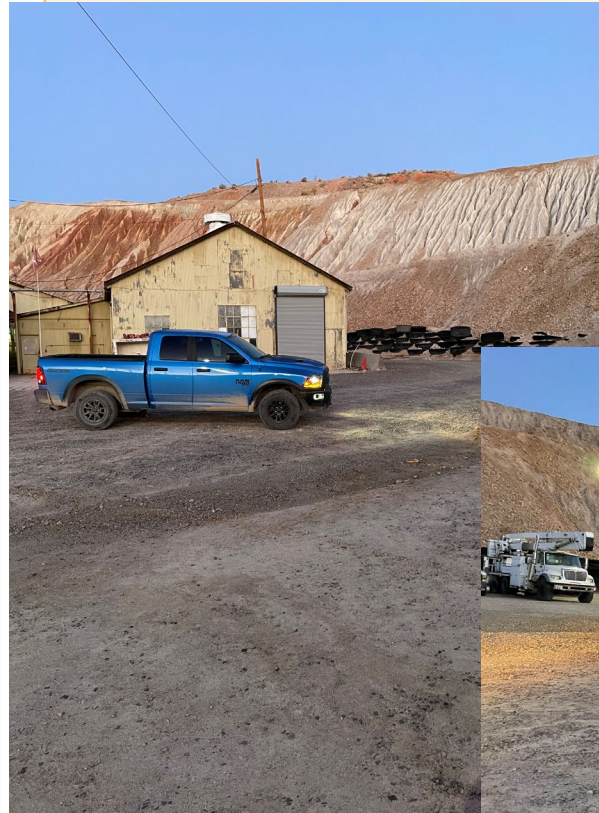
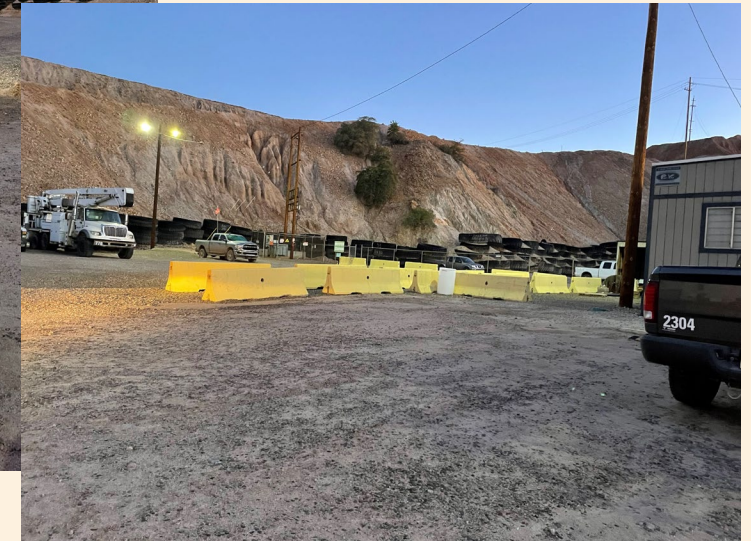
The light vehicle (left) that struck the employee and the parking spot.

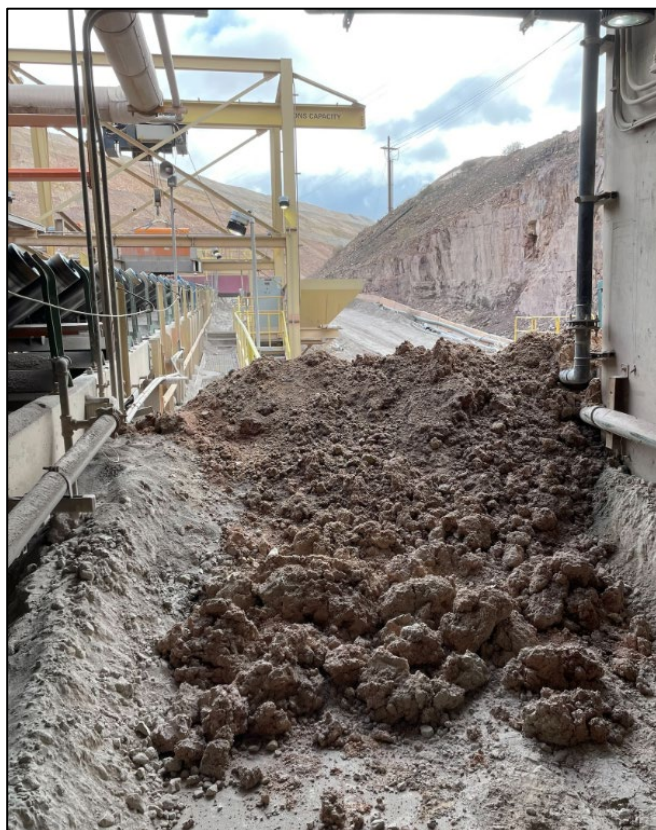
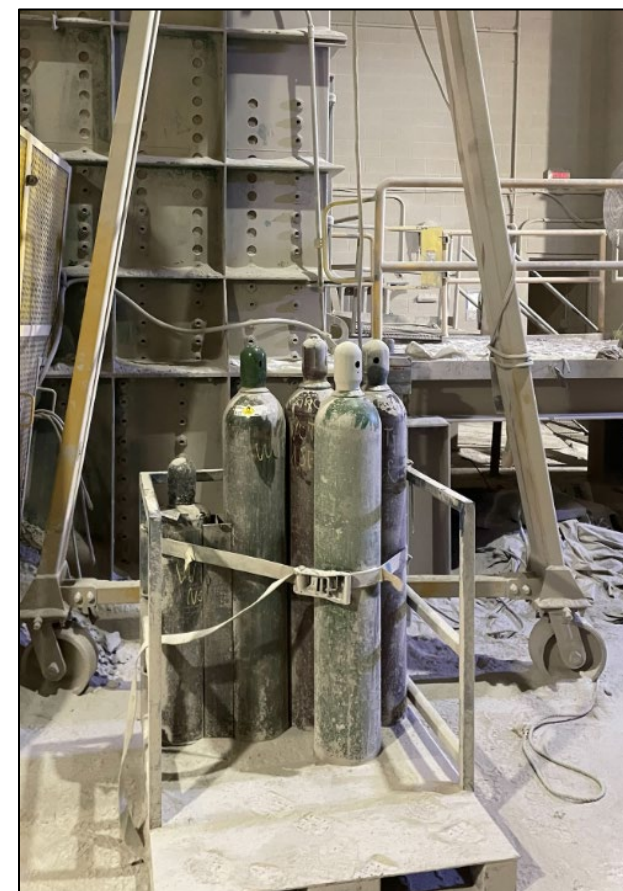
Housekeeping – Berm  
blocking entrance to P-11  
tunnel Footprints on berm

Gas cylinders stored at crusher 3 without no smoking/flames warning sign.	56.7805	Fire
--	---------	------

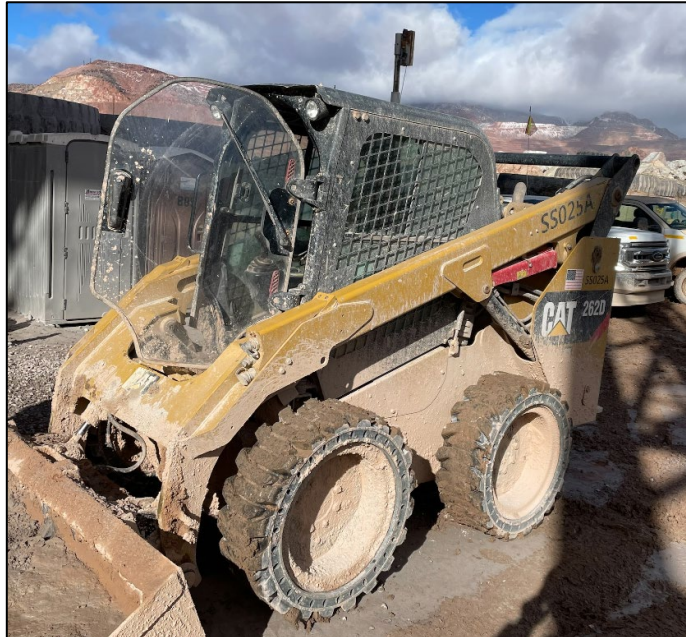
Emergency Hyd Safety  
Release not functioning  
on skid steer  
56.14100b

Defects shall be corrected in a  
timely manner

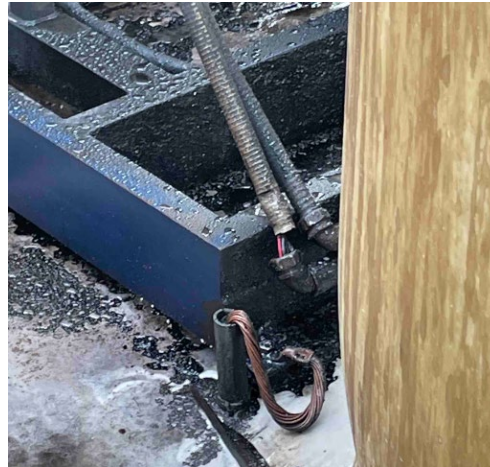
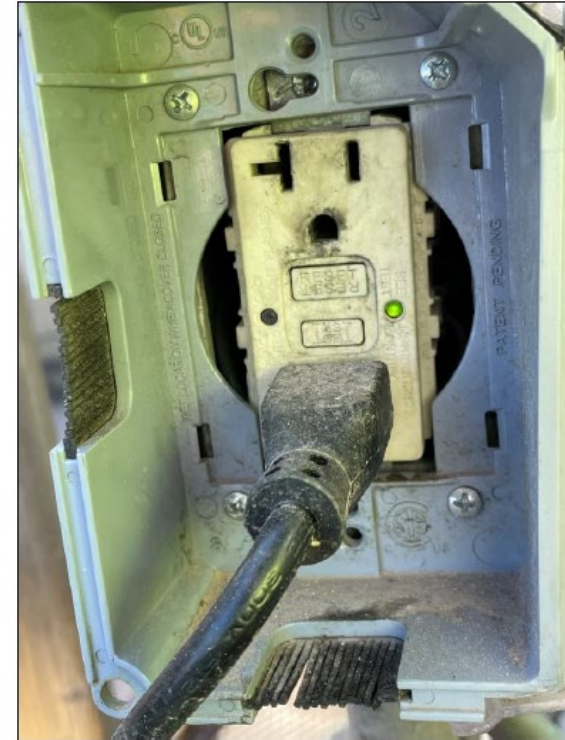
Exposed Wires  
56.12004 Electrical

Cited – Wrong face plate  
installed, wiring accessible  
Non S/S- 56.12032  
Electricians repaired.

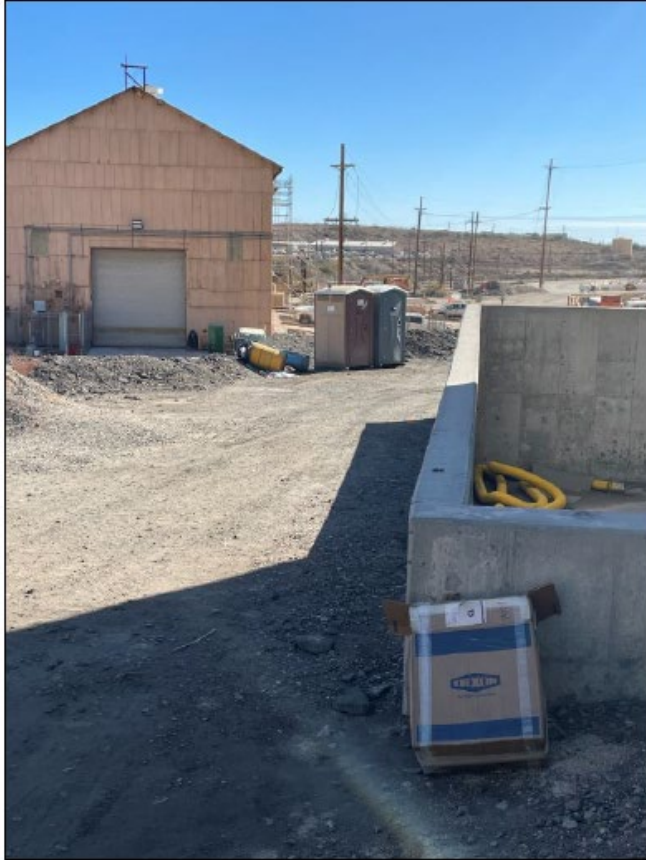
Full trash can /hand wash station tipped over/ Not cited

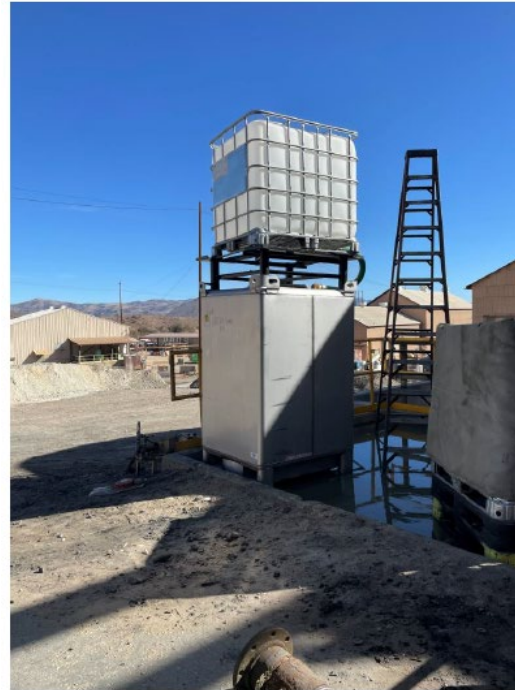
Tote- was empty- had rotated in frame in had been set on. Would not be stable in high wind determined by ease of shaking it. Need more diligence when set in holders or additional securement. D Bonilla arranged to stable-ize

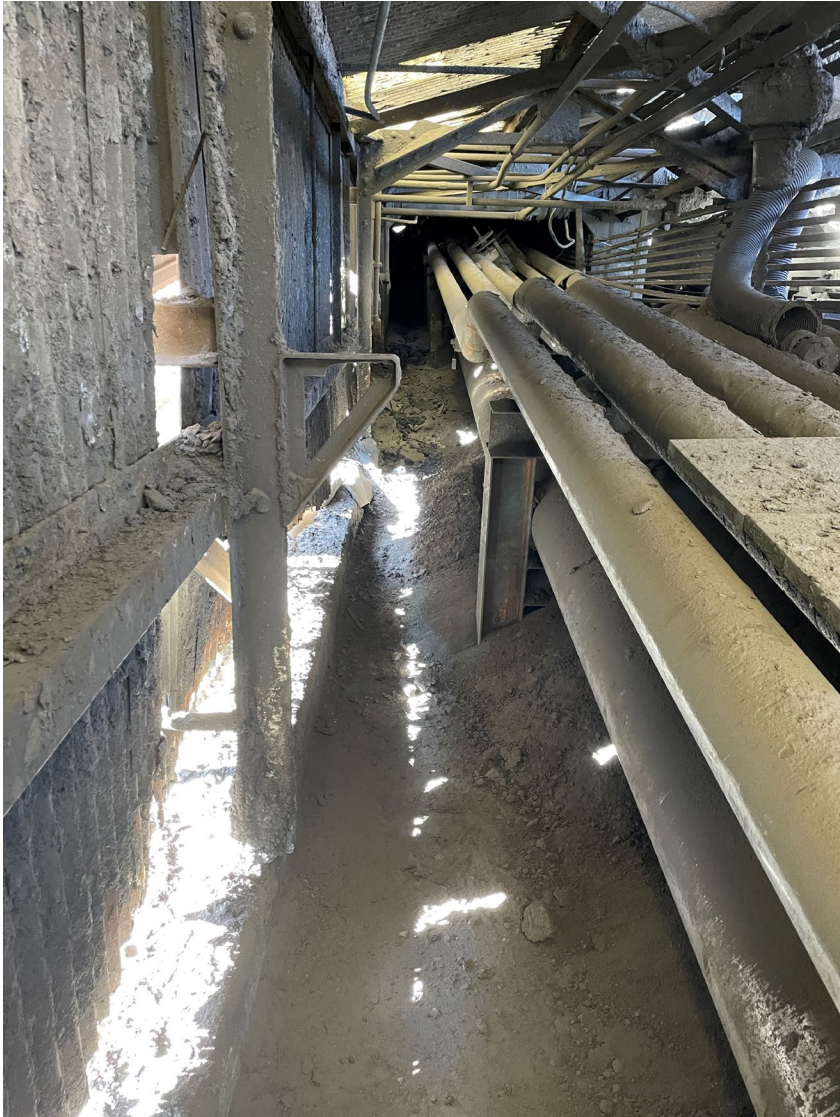
Walkway in past inspections was determined to be high spillage that could not be adequately maintained for housekeeping. Access was blocked off with barricaded on both sides.

Discovered barricades have been removed. Has been used as a travel path.

Non S/S 56.20003 b  
Housekeeping

Barricaded

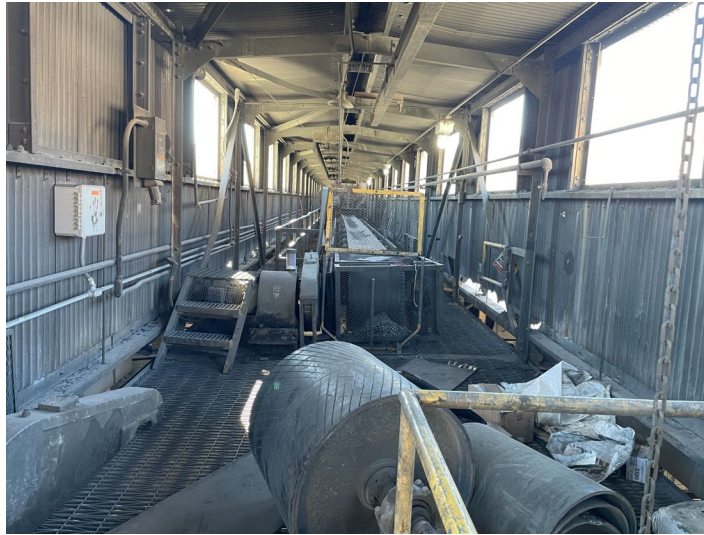
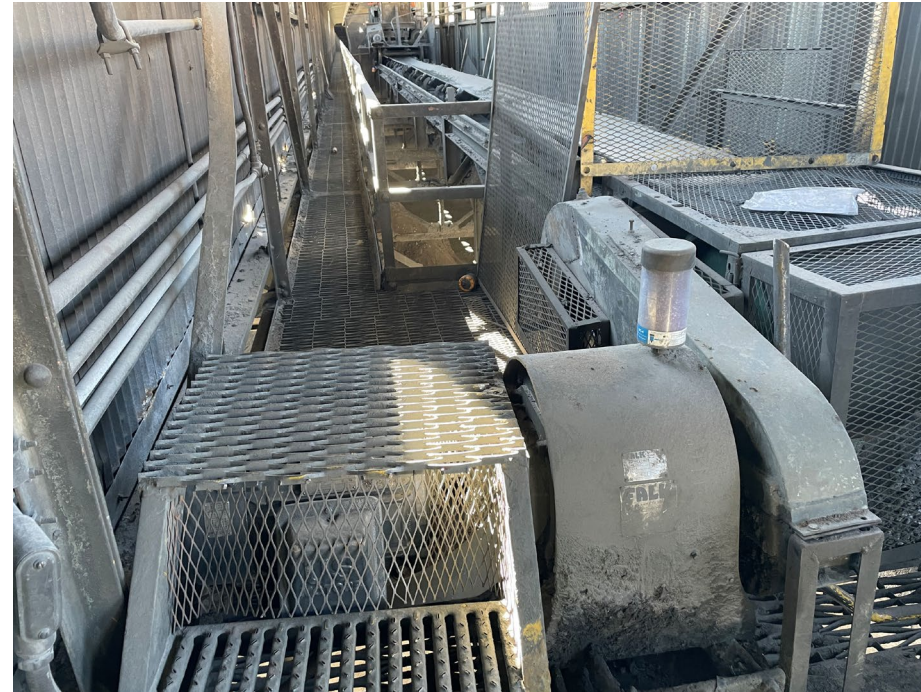
Bedding plant

No.2 belt at bedding plant. Unfinished maintenance left exposure to hazards.  
Crossover – no handrails – general clean up poor. Not cited-  
Erected warning tape

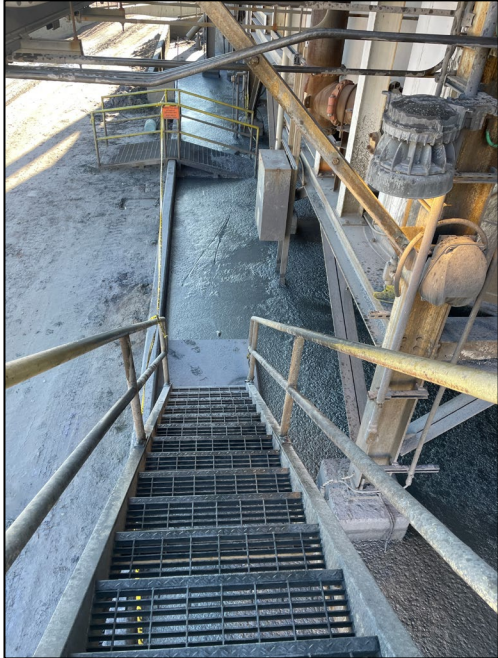
Sheer Feed containment area – one side yellow flagging/ bottom of stairs still accessible

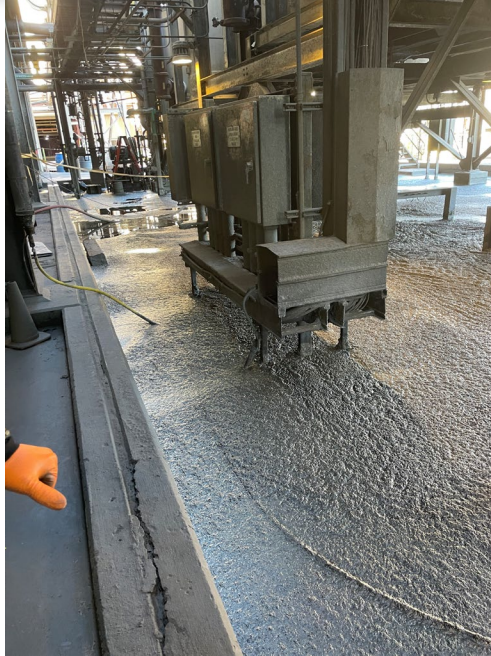
Sheer Feed containment area – one side yellow flagging/ open to all other sides

Sheer Feed containment area – one side yellow flagging/ open to all other sides. This condition can occur when drains plug or defects in valves. Recommend: Install handrails around containment with signage indicated restricted access when spills create hazards

Non S/S Citation  
56.20011  
Barricading and signage

Erected yellow flagging

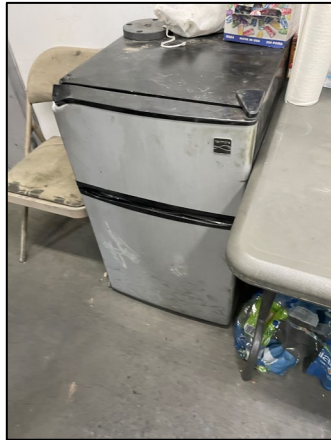
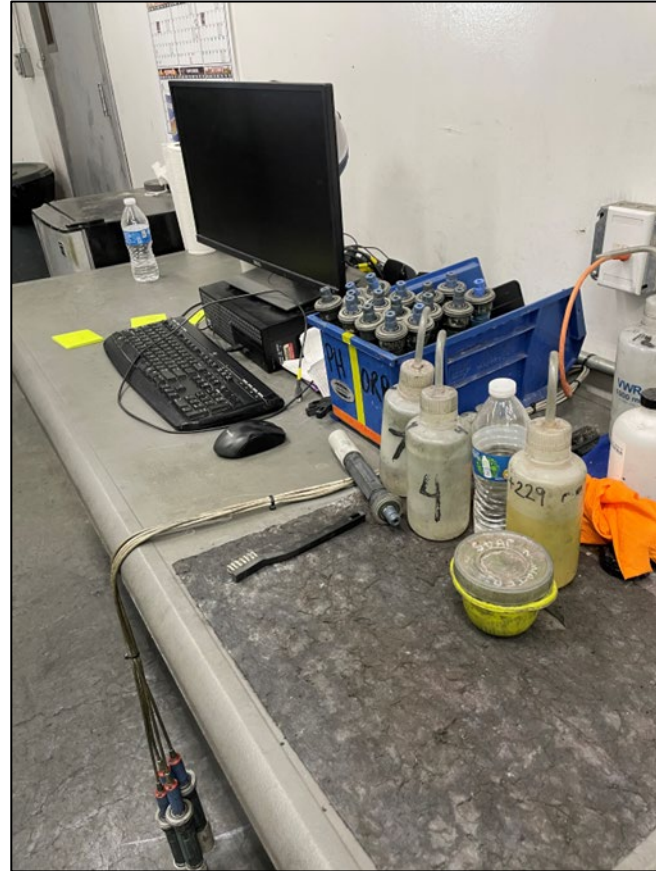
Food consumption area next to chemicals.  
Not cited, but could have been. 56.200014

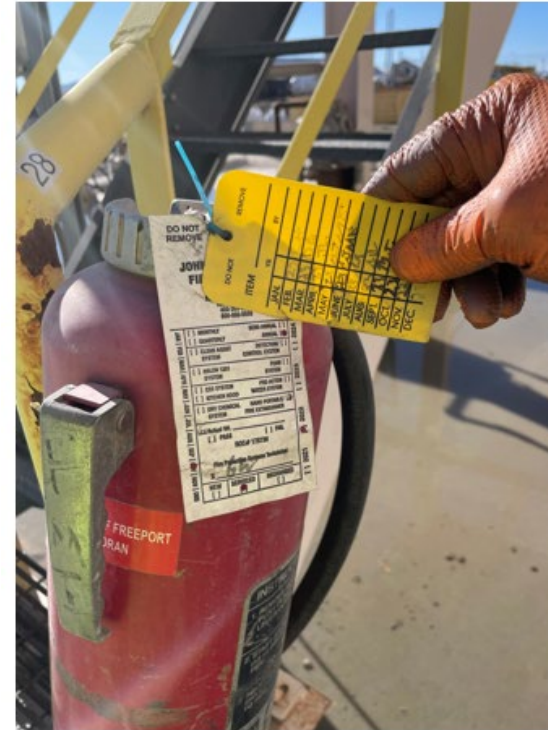
Expired fire extinguisher Caustic unloading area.  
Non S/S Citation 42.01b  
Terminated

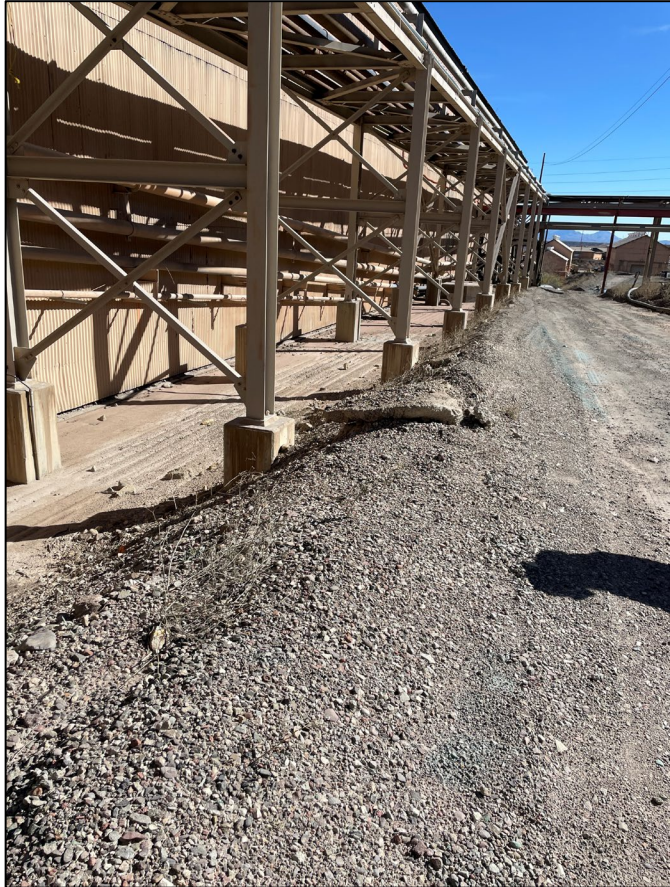
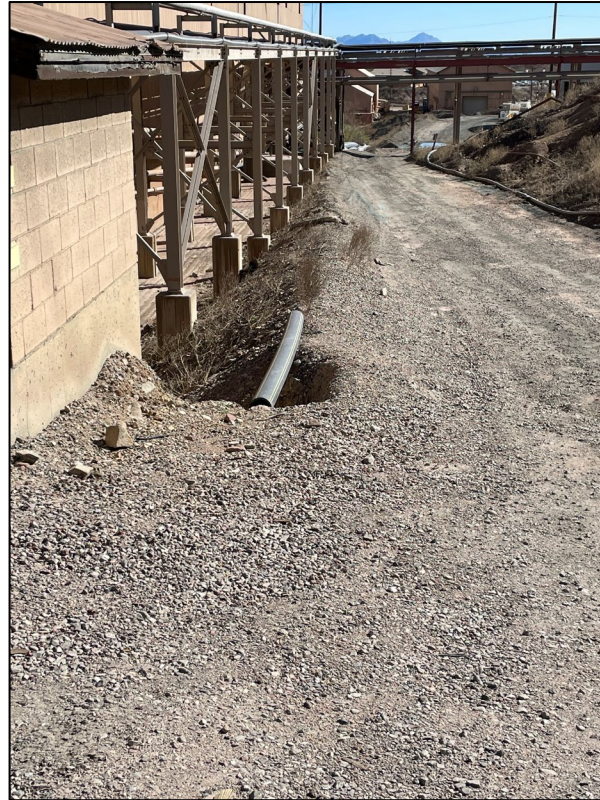
Not cited – berm insufficient alley behind bedding plant. Had tire tracks on edges of berm . Contacted Surface dept via Will Wearne to address. Not cited but could have been. Discovered other equipment besides LVs use this thoroughfare.

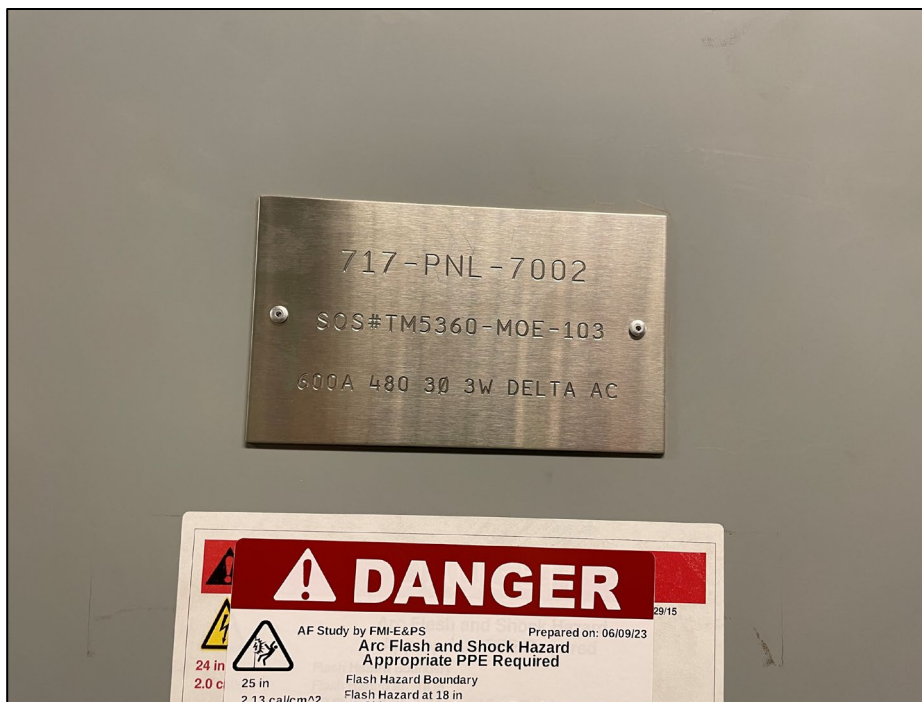
2 Spare breakers behind this panel were not labeled but in “ON” position. Discovered they were landed. Non S/S Citation 56.12004  
 Were turned off – need a down day to identify what they supply and if circuits are still in use – to determine if they need to be de-termed or breakers locked out.

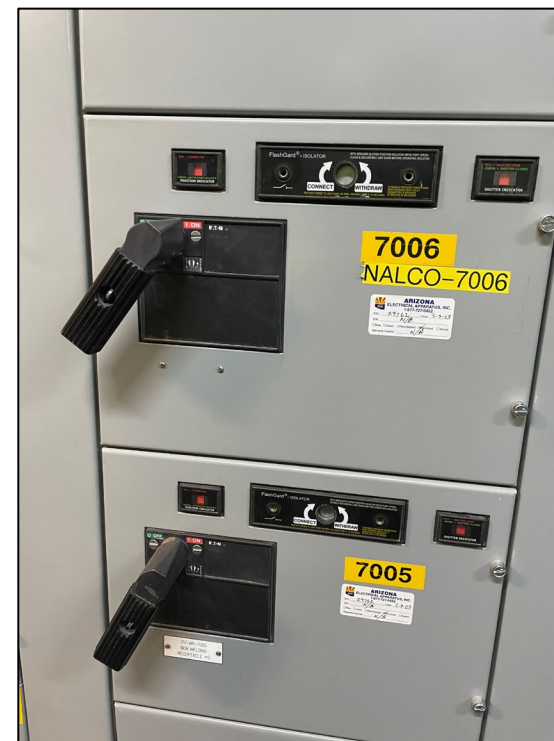
## Moly MCC Room

Label identifying equipment missing
