SAFETY ALERT NOTIFICATION

OPERATION:	Sierrita Operations		Incident:	Near Miss
ISSUED BY:	John Murphy		Injury:	
DATE:	2/7/14		Property Damage:	
TIME:	11:00 pm		Process Loss:	
LOCATION/DEPARTMENT:	3 rd Floor Fine Crushing Building / Crush and Convey			
INCIDENT DESCRIPTION:	<p>At approximately 10:59om on 2/7/14 the 5T (Sandvik H8800) cone crusher feeder belt went down due to a high crusher hopper lever. A Field Operator was dispatched to the 5T crusher and found the Dodge Para-Flex PX240 coupling between the crusher pinion and motor was no longer intact. At approximately 11:14pm immediately after finding the failed coupling the Field Operator called the Secondary Control Room Operator and asked for the 5T crusher motor to be shutdown.</p> <p>Maintenance Shift Mechanics were dispatched to repair the failed coupling. As the Mechanics were performing a JSA and Area Inspection damage to the coupling guarding was noted and the inner ring on the pinion side of the coupling was found to be missing. While the Mechanics were searching for the inner ring damage was found to the Secondary Building siding on the 3rd floor directly South of the 5T coupling where the inner ring exited the buildin

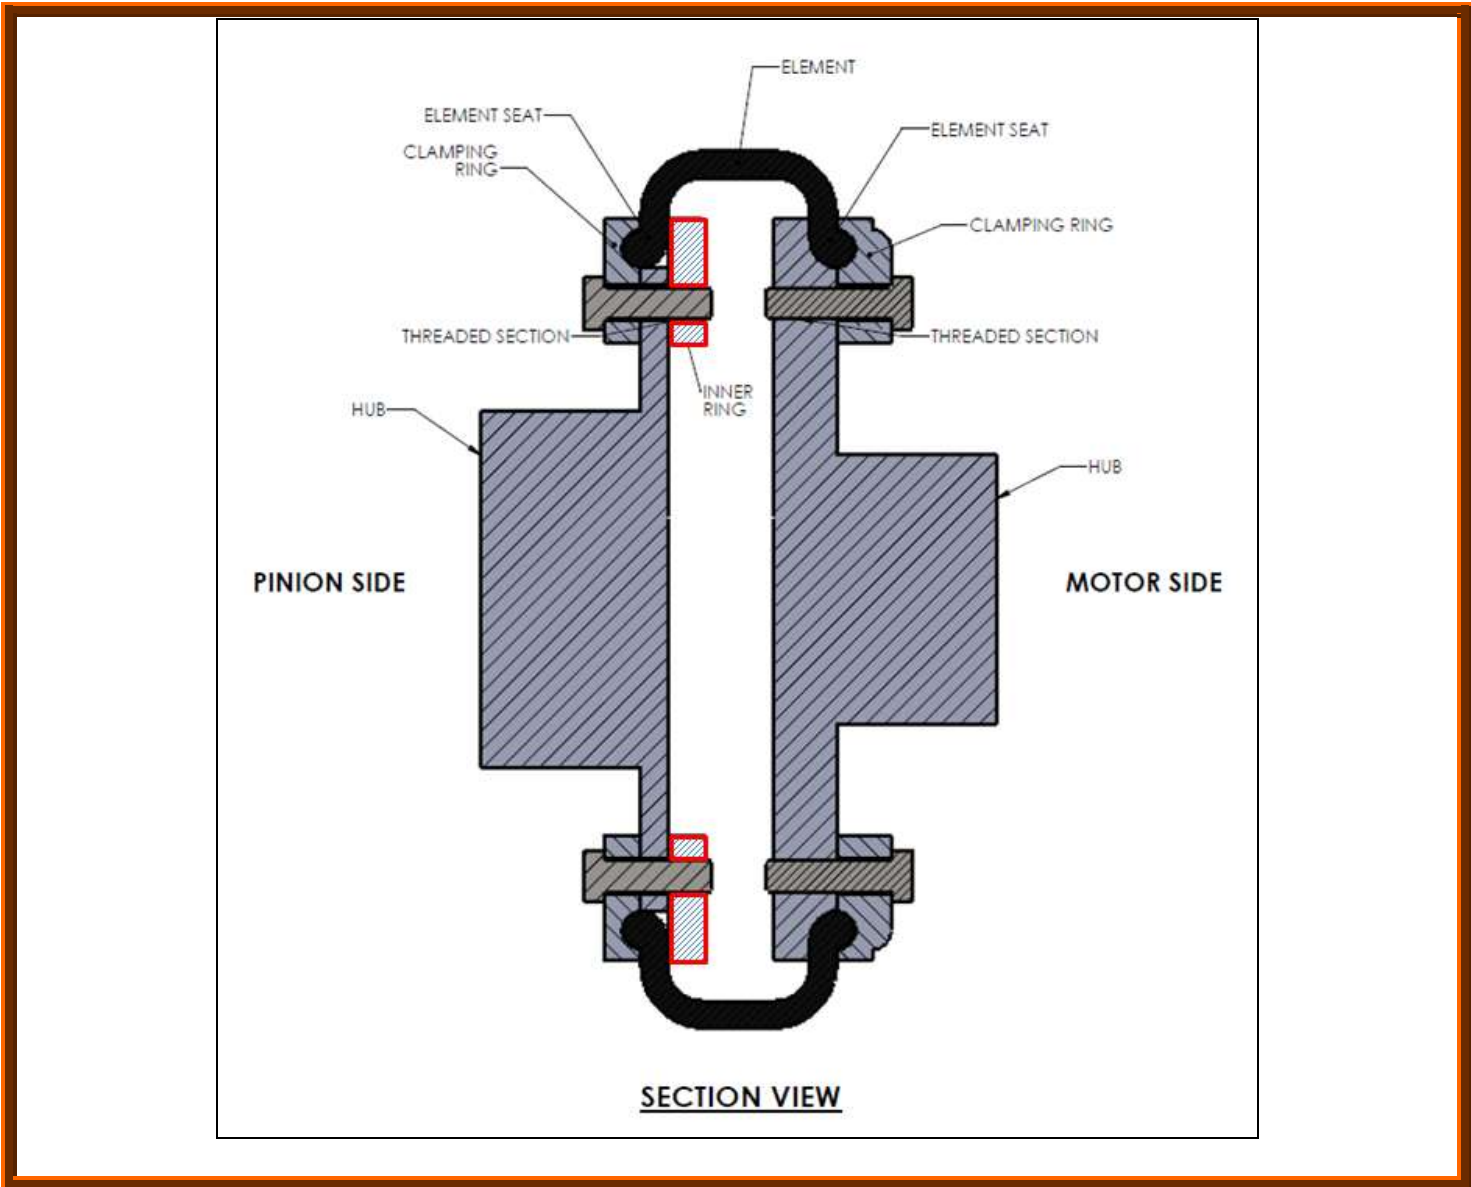
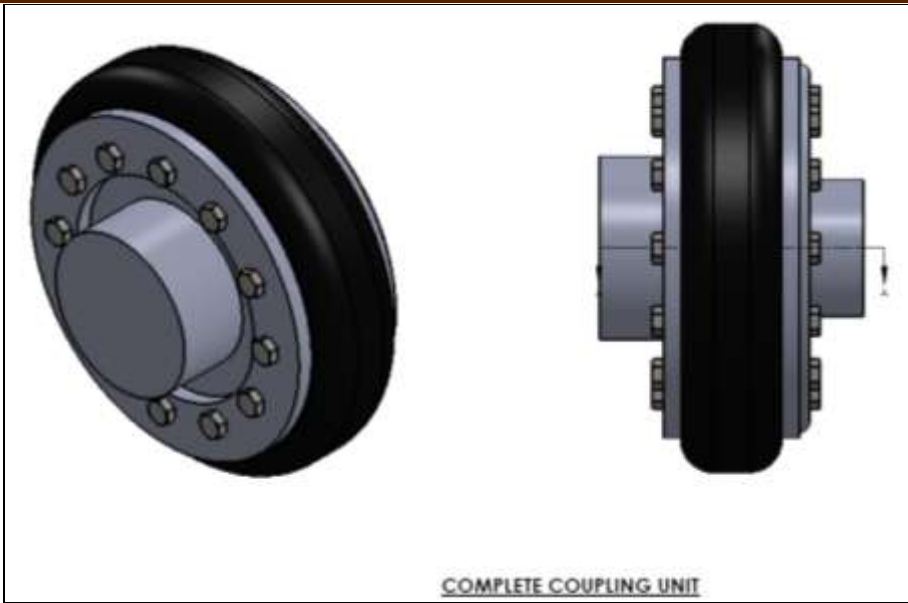
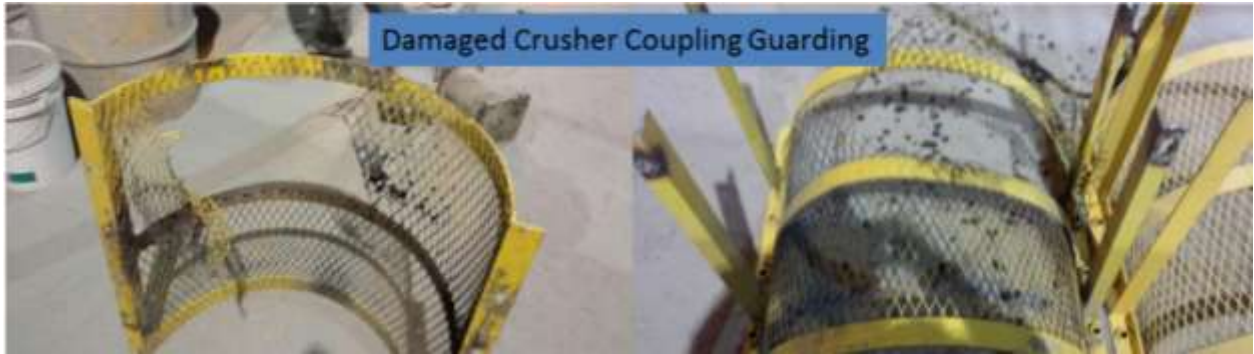
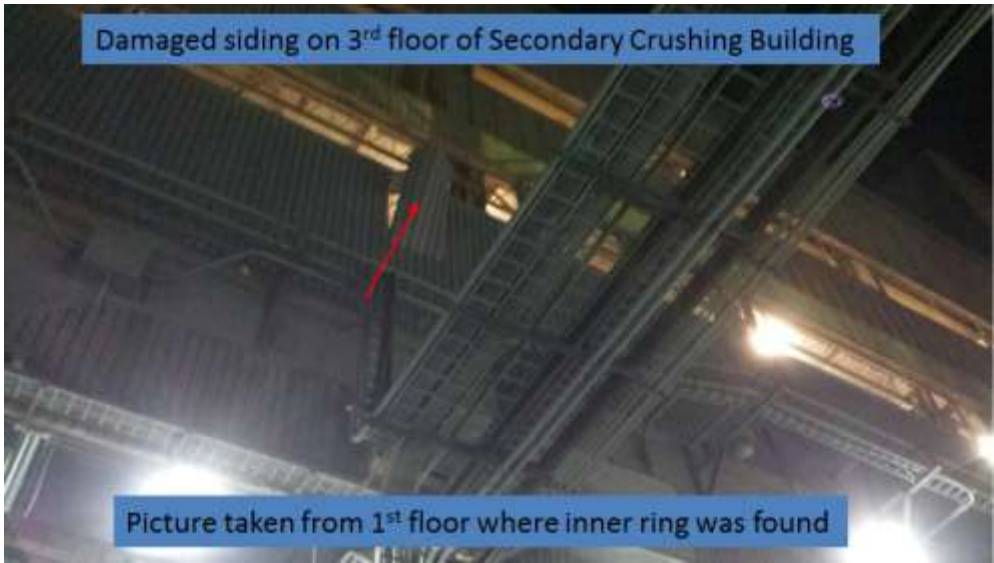
DETAILS OF INJURY TYPE:	No injuries. High potential for serious injury.			
POTENTIAL FOR INJURY:	Fatality	Lost Time	Permanent Disability	Other Potential
	x			
PROBABLE DIRECT CAUSES:	<ul style="list-style-type: none"> Loose clamping ring bolts. Due to the pinion shaft diameter a Dodge PX240 bore to size hub assembly is utilized. Dodge only manufactures a 3 piece hub assembly in the bore to size PX240 coupling. If not maintained properly the inner plate in the 3 piece design can become a projectile. No zero speed indication to shut down crusher motor in the event of a coupling failure.

IMMEDIATE CORRECTIVE ACTION:	<ul style="list-style-type: none">• Flagged off “line of fire” areas around all 14 crushers.• Redesigned coupling guarding to contain projectiles if similar failure occurs.• Redesigned guarding being installed and thorough inspection of couplings being completed.• Review and retorque the Dodge Para-Flex PX 240 coupling between the crusher pinion and motor on the remainder of the other crushers.
REQUIRED ACTIONS:	<ul style="list-style-type: none">• Continue investigation.• Verify coupling design meets application criteria.• Investigate alternative coupling or design that minimizes projectile potential.• Review and improve coupling installation/preventative maintenance practices.• Install zero speed indication that will shut crusher motor down in the event of a coupling failure.
