## SAFETY ALERT NOTIFICATION

OPERATION:	Sierrita			Incident:	
ISSUED BY:	Valerie Hannon			Injury:	Х
DATE:	01.12.2015			Property Damage:	
TIME:	1505			Process Loss:	
LOCATION/DEPARTMENT:	A-Side Floatation Pac 2 Cell 3 / Mill Maintenance				
INCIDENT DESCRIPTION:	On Monday January 12, 2015 four (4) Mill Maintenance employees were removing the drive sheave from the agitator on Pac 2 Cell 3. The process involved removing the agitator sheave from the shaft. The four (4) taper lock bushing bolts that hold the taper bushing to the sheave were removed. Two (2) of these bolts were then placed in the jack bolt location to press the bushing and sheave apart and were tightened, alternating between the two (2). At the time it was unclear if the bolts were loosening or stripping. The employee placed his left hand on the side (face) of the sheave to feel movement that would indicate the bolts were loosening and the start of the separation. Within seconds of movement being felt the pieces separated and both pieces dropped to the bottom guard plate approx. three inches (3"). The employee's left pinky finger was trapped between the sheave and the lower guard plate.

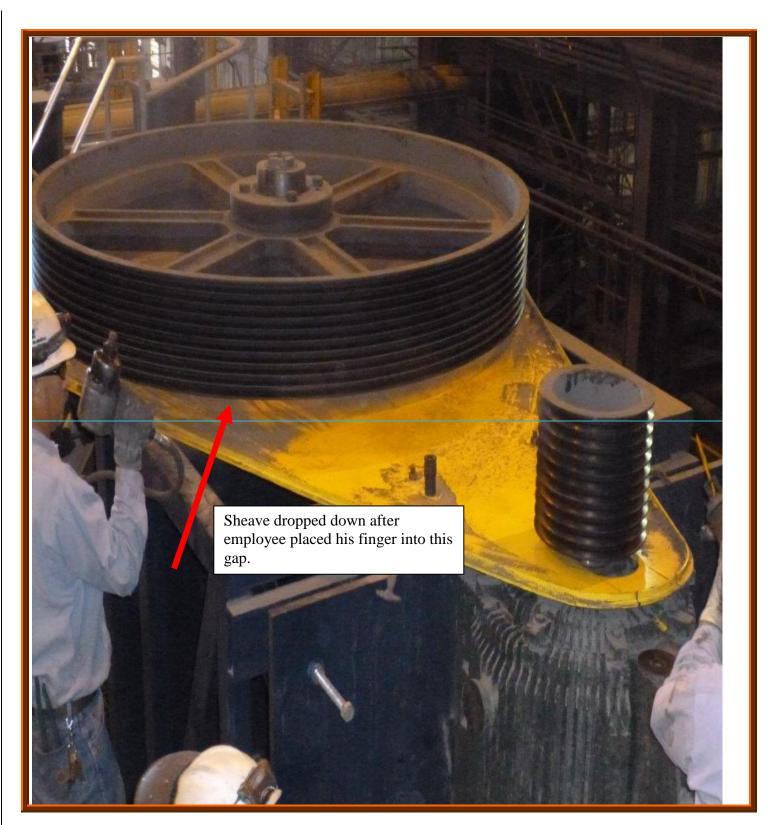
DETAILS OF INJURY TYPE:	3 hairline fractures and laceration to left pinky finger that required 10 stitches				
POTENTIAL FOR INJURY:	Fatality	Lost Time	Permanent Disability	Other Poten	tial
		X			
PROBABLE DIRECT CAUSES:	<ul> <li>Drive sheave not blocked or secured.</li> <li>Potential for sheave dropping not recognized.</li> </ul>				
IMMEDIATE CORRECTIVE ACTION:	<ul> <li>Stand down with maintenance department.</li> <li>Instituted requirement to utilize cribbing beneath sheaves when performing work on any sheaves</li> <li>Initiated a root cause analysis</li> </ul>				
REQUIRED ACTIONS:	<ul> <li>SOP was updated to include cribbing.</li> <li>Communicate to crews via monthly safety meetings.</li> <li>Share incident with other FCX sites.</li> </ul>
