SAFETY ALERT NOTIFICATION

OPERATION:	Freeport-McMoRan Morenci Operations			Incident:	X
ISSUED BY:	Justin Cross – Manager Hydromet			Injury:	
DATE:	06/20/2014			Property Damage:	X
TIME:	3:30pm			Process Loss:	
LOCATION/DEPARTMENT:	C-Cell Line, Central Tankhouse, Hydromet Division				
INCIDENT DESCRIPTION:	As the C-Crane was transporting a jumper frame, bridging south in the Central Tankhouse, the crane lost its hoist and the load descended downward in an uncontrolled manner until it made contact with the C-Cell line and center walkway. The load was approximately four feet off the cell line when this event occurred. No injuries were sustained.				
DETAILS OF INJURY TYPE:	N/A				
POTENTIAL FOR INJURY:	Fatality	Lost Time	Permanent Disability	Other Potential	
			X		
PROBABLE DIRECT CAUSES:	Defective tools – During the investigation, it was identified by the OEM that the most likely cause of failure was the joystick control used to operate the overhead crane. When tested the signal would hesitate and not function properly. *The joystick control had been in service for approximately 6 years yet <u>had not</u> been inspected, routinely for functionality.

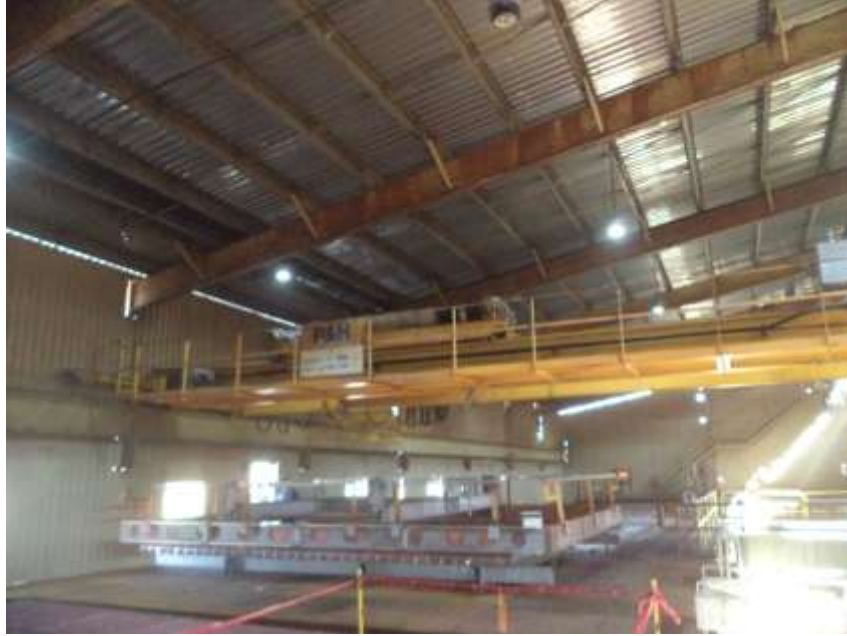
The load was approximately 4 feet off the cell line when the failure occurred

IMMEDIATE CORRECTIVE ACTION:	<ol style="list-style-type: none"> 1. All work in the area ceased and the scene was evaluated for hazards. All existing hazards were immediately mitigated 2. The overhead crane was taken out of service 3. Division repairmen and electricians attempted to identify why the failure occurred 4. The OEM was contacted and performed a thorough inspection on the unit 5. An RCA team was formed to conduct a thorough investigation on the failure 6. All walkways that were impacted were appropriated flagged until flooring inspections and repairs were completed 7. The jumper frame was taken out of service, inspected and repaired 				
REQUIRED ACTIONS:	<ol style="list-style-type: none"> 1. All Hydromet division overhead crane remote controls will be replaced with new controls. Each will be tested before going into service 2. * The division will implement a periodic inspection schedule for all overhead crane controls to check condition and functionality 3. Review operational practices to ensure that cranes are being operated in accordance with the equipment design 4. All other RCA findings will be communicated and necessary controls will be implemented to prevent recurrence
