SAFETY ALERT NOTIFICATION

OPERATION:	El Abra			Incident:	x
ISSUED BY:	Jill Schultz			Injury:	
DATE:	May 14, 2014			Property Damage:	x
TIME:	17:30 hrs.			Process Loss:	
LOCATION/DEPARTMENT:	Process Area - Leaching				
INCIDENT DESCRIPTION:	<p>A Sulfolix employee was operating a Yamaha Grizzly 700 All-Terrain Vehicle (ATV) to maneuver leach lines on the 4th level of Module 6B's cell 1 to be parallel to the edge of the leach pad. According to the information gathered, the gloves worn by the ATV operator had a hole in the thumb of his right hand. While attempting to back up to change directions, the throttle lever got caught in the hole of the operator's glove causing him to lose control of the ATV. Realizing that the ATV was going to travel backwards over the embankment, the operator jumped off the moving vehicle. The ATV continued over the side of the leach pad and fell approximately 26 feet. The employee did not sustain any injuries.</p>

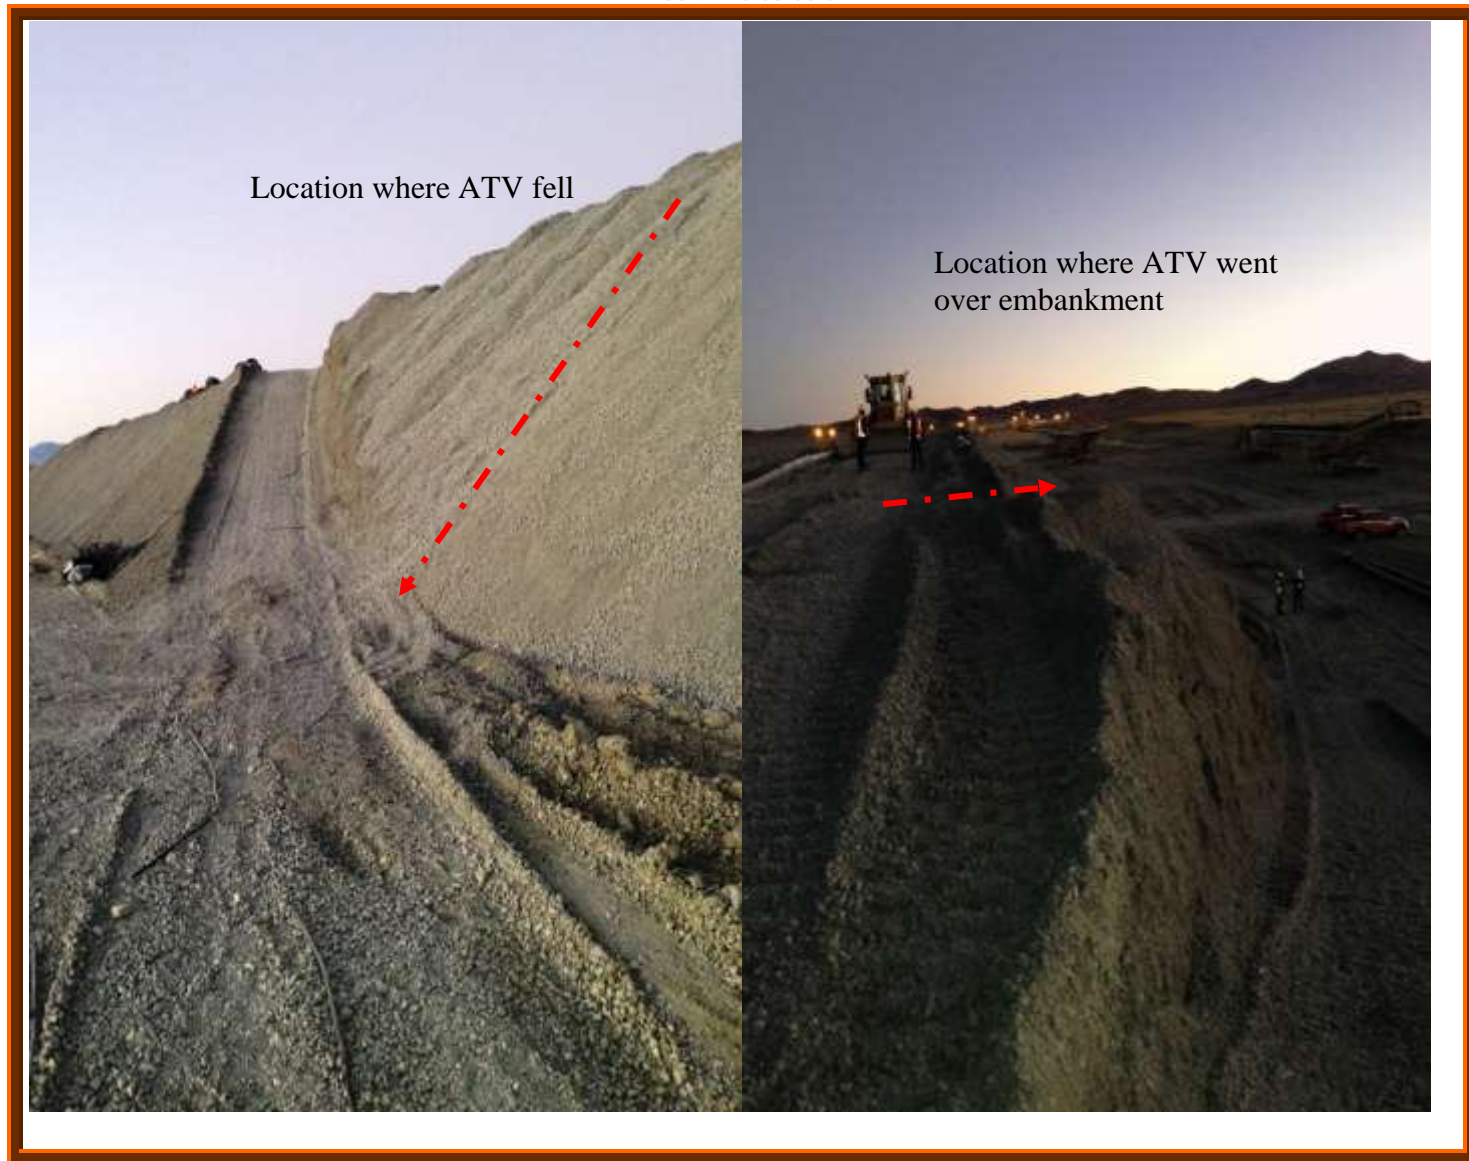
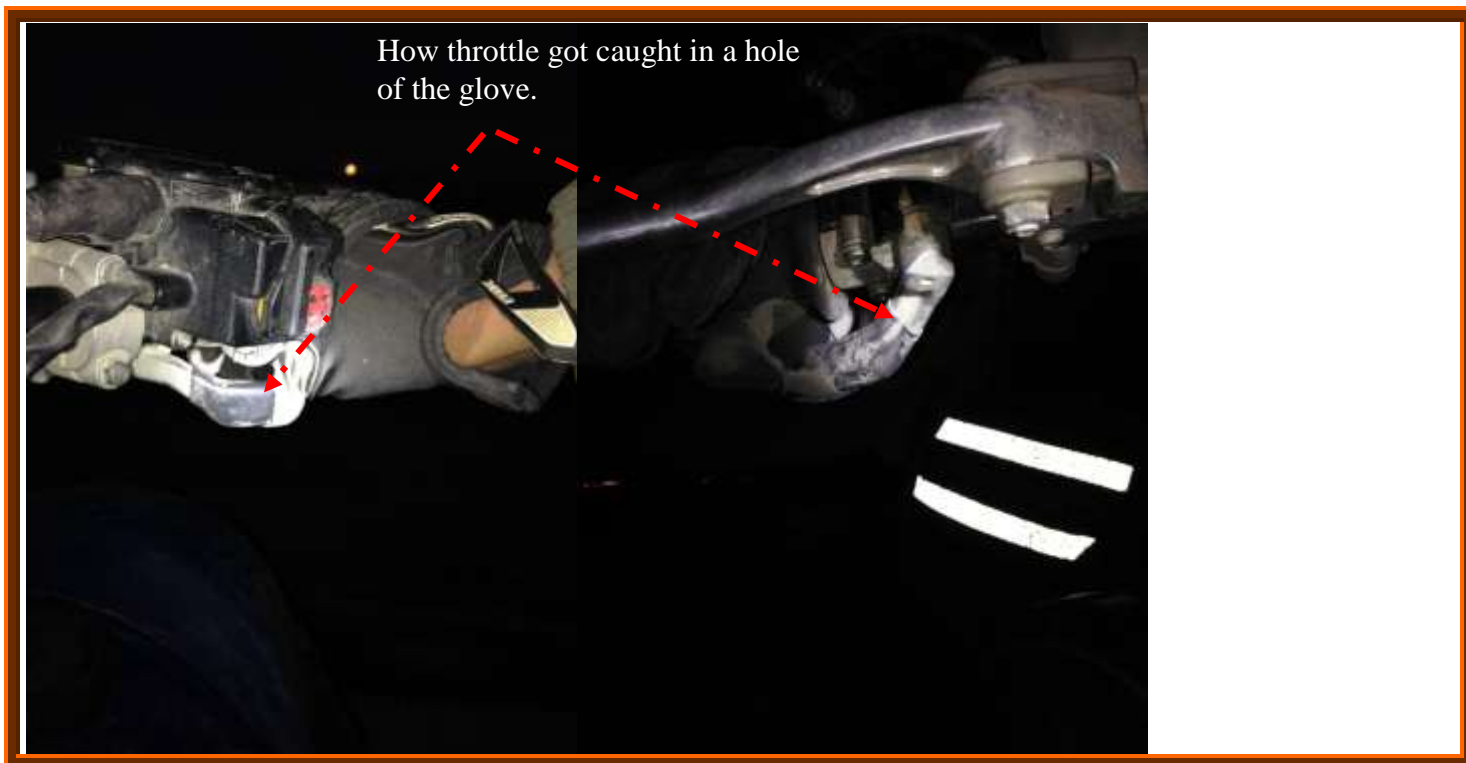
DETAILS OF INJURY TYPE:	No injuries				
POTENTIAL FOR INJURY:	Fatality	Lost Time	Permanent Disability	Other Potential	
			x		
PROBABLE DIRECT CAUSES:	<ul style="list-style-type: none"> • Incorrect evaluation of risk - operator did not assess the risk of changing direction by backing towards the embankment (blind side). • Inadequate protective equipment – operator did not maintain protective equipment in good condition. • Inadequate barrier – although a berm was present, the height was inadequate for all types of equipment used on the leach pad. • Inadequate ATV procedure – procedure did not adequately demarcate a safety zone along the edge of the leach pad where ATV equipment was not allowed to operate. 				
IMMEDIATE CORRECTIVE ACTION:	<ul style="list-style-type: none"> • Immediately stopped work and took employee to on-site clinic for evaluation. • Initiated investigation. 				
REQUIRED ACTIONS:	<ul style="list-style-type: none"> • Review ATV operating procedures on leach pads with employees. • Create checklist to ensure periodic review of the condition of ATV personal protective equipment. • Revise and update leach pad and ATV operating procedures to include:

- 2 meter (6.5 feet) safety zone along the edge of pad where ATV equipment is not to operate.
- construction of berms to be mid-axle height for the largest equipment operating on leach pad.
- Conduct periodic inspections and audits of leach pad operations.
