SAFETY ALERT NOTIFICATION

OPERATION:	Climax Mine			Incident:	X
ISSUED BY:	Matthew Main, H&S Manager			Injury:	
DATE:	August 27, 2014			Property Damage:	
TIME:	8:00 PM			Process Loss:	
LOCATION/DEPARTMENT:	Mine Operations				
INCIDENT DESCRIPTION:	<p>The supervisor was following the HT 102 from the loader and noticed the haul truck starting to drift to the left, high wall side, of the road. An attempt to contact the driver via radio was unsuccessful. HT 102 continued to "ride" the high wall through the curve and continued directly up hill in the direction of the berm on the right side of the haul road. (See Attached Diagram) The supervisor called a MAY DAY after several unsuccessful attempts to contact the driver and requested resources to the pit. HT 102 contacted the berm at full power and continued to try to power up/through the berm. Due to the slippery conditions and the size of the berm, the haul truck was unable to climb entirely over the berm or power through the berm. The haul truck's initial orientation with the berm caused the back end to pivot until it was perpendicular with the berm. The haul truck was knocked into neutral and the truck rolled back against the high wal

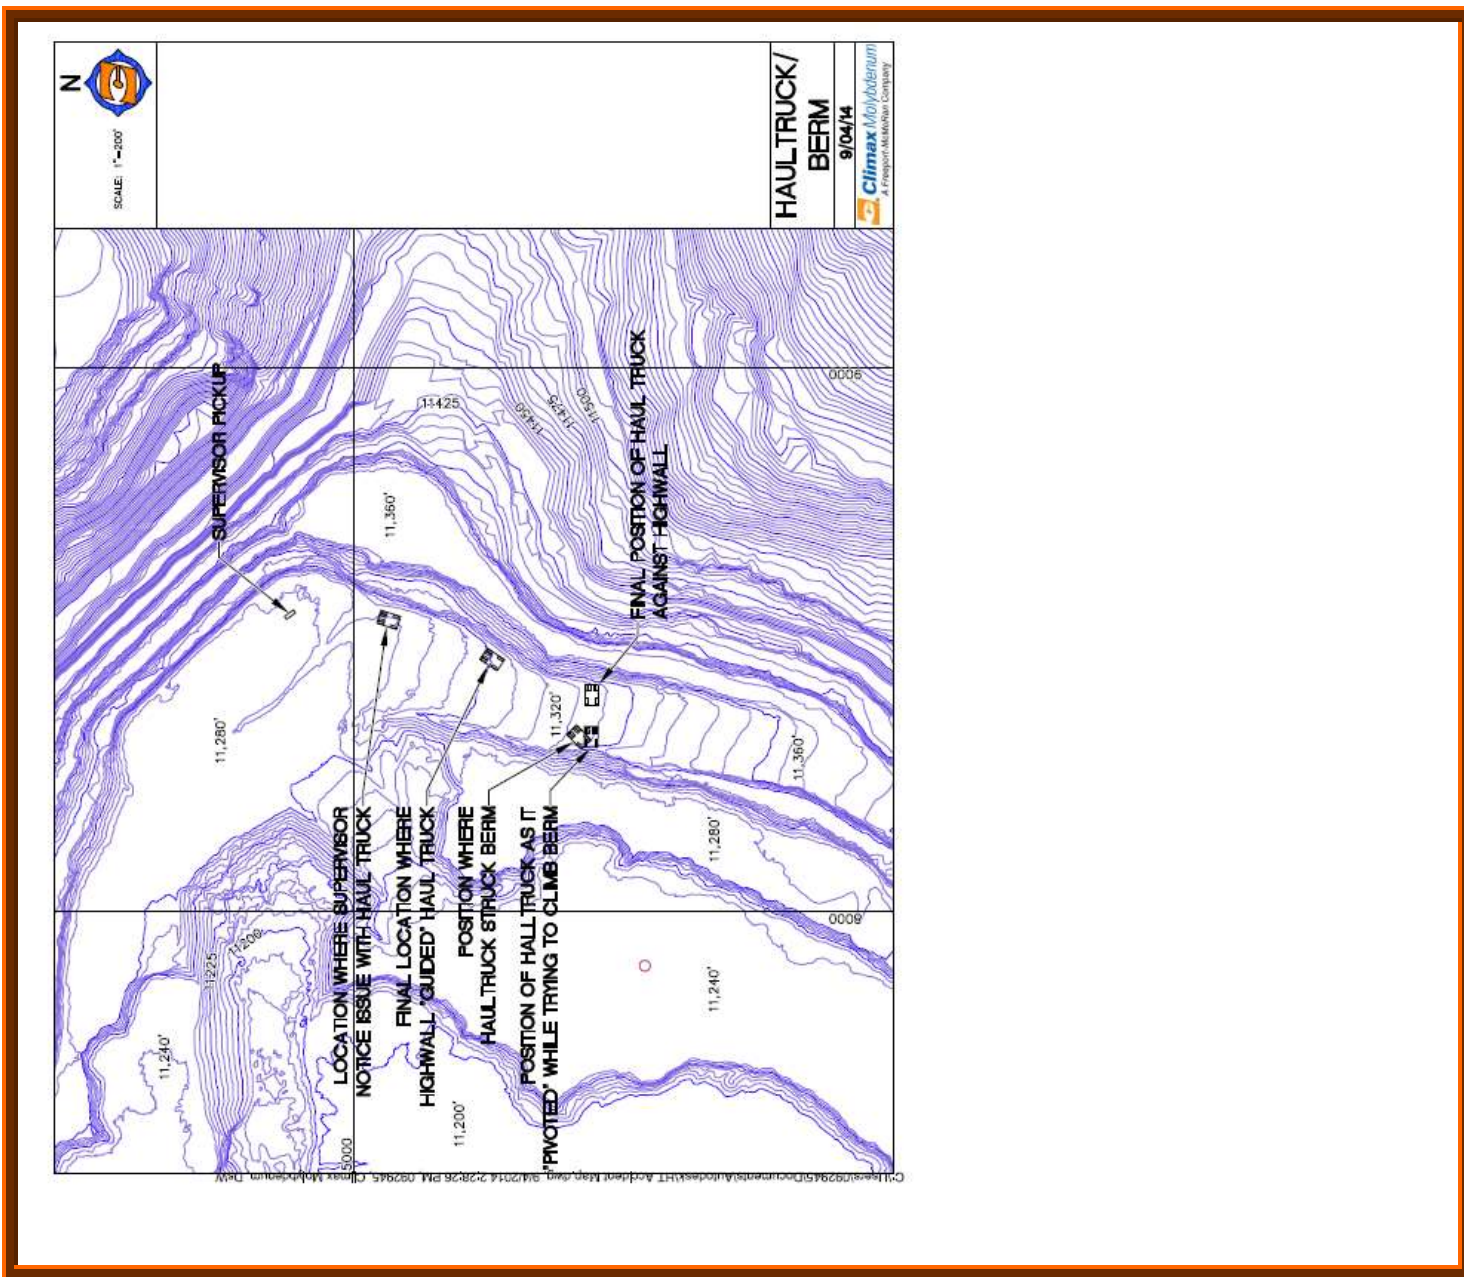
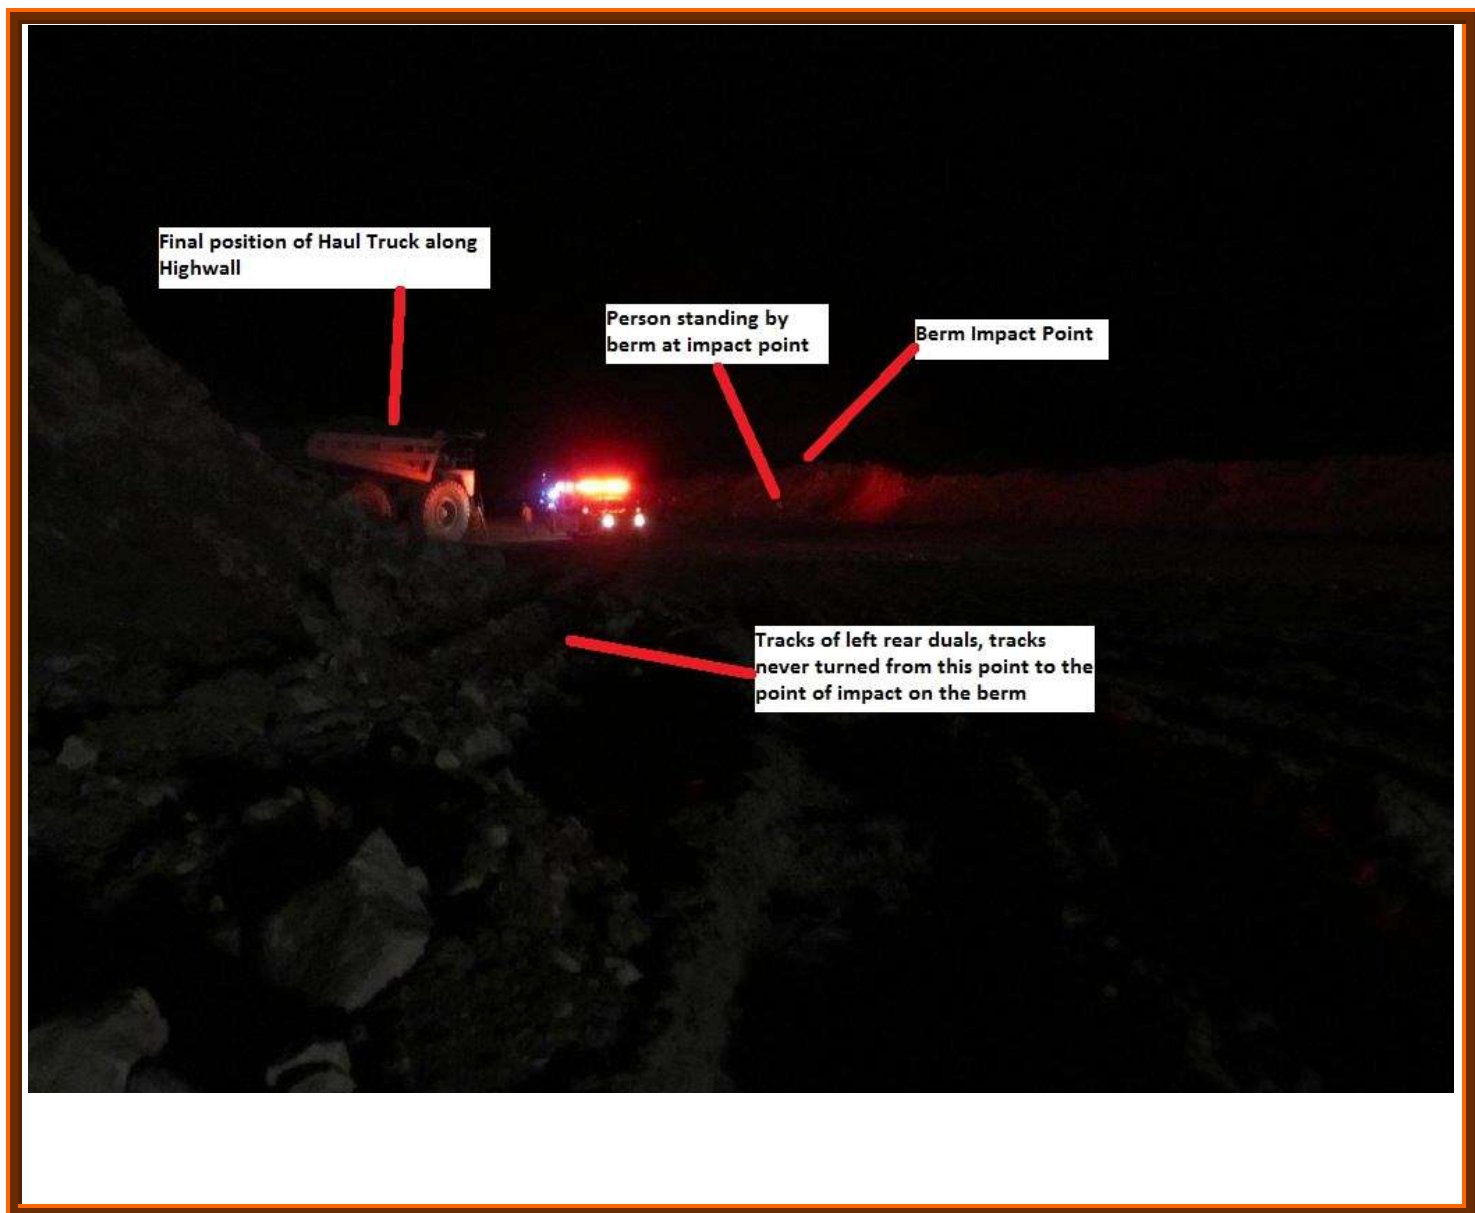
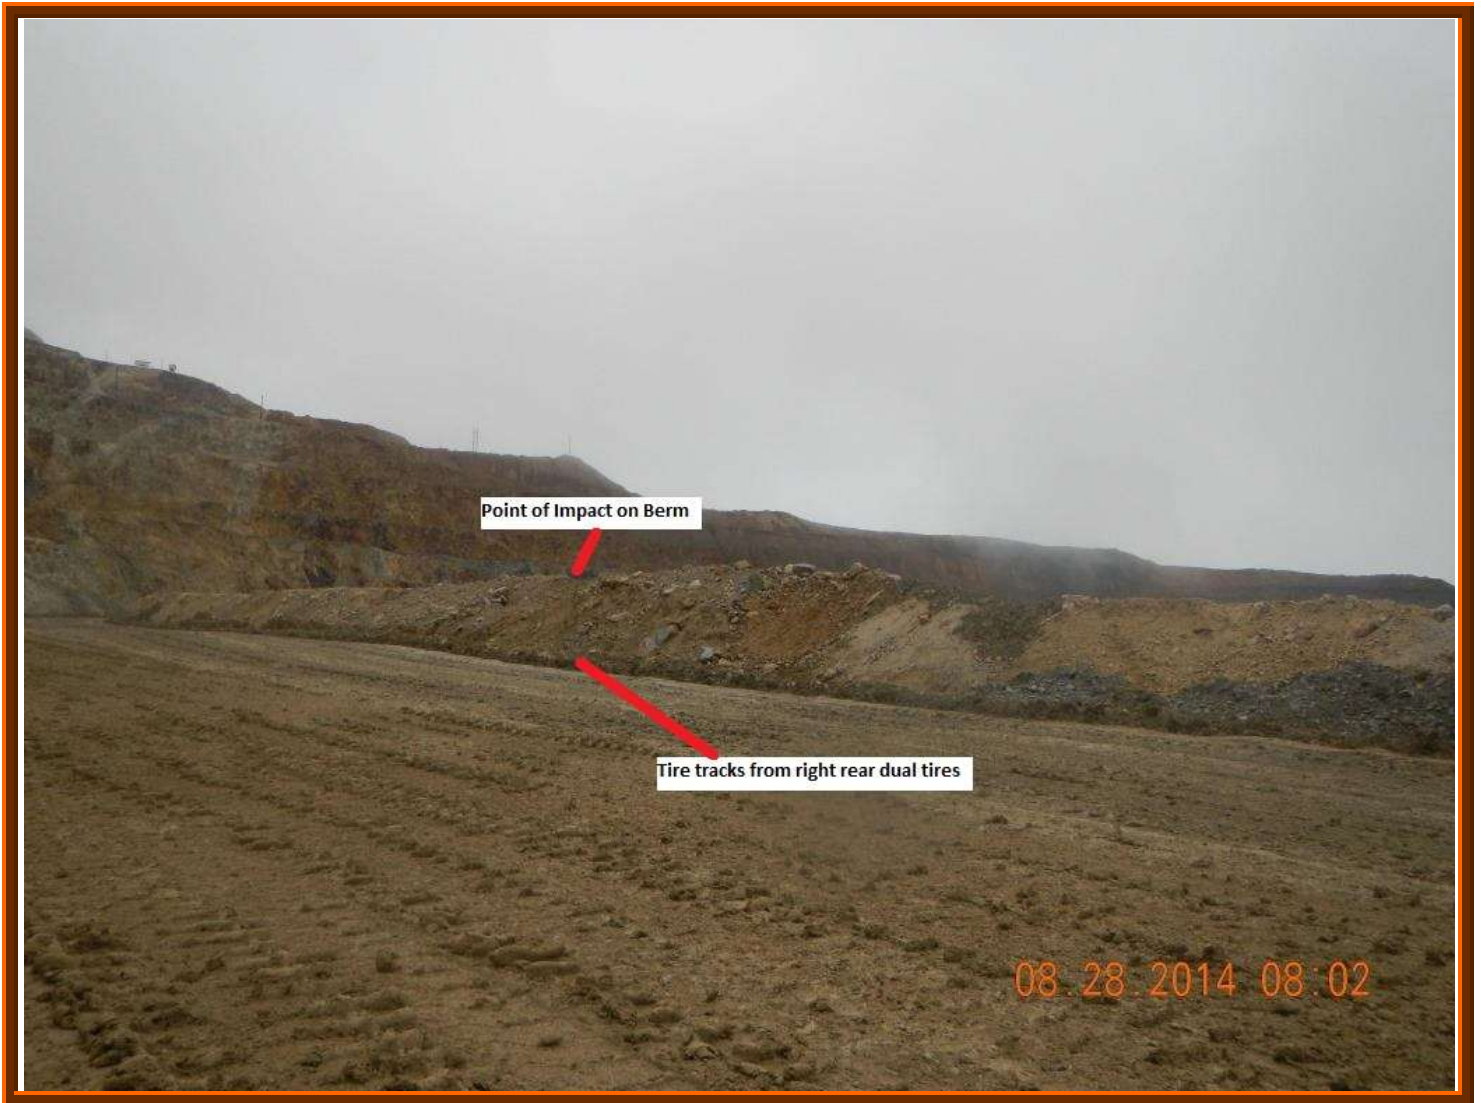
minimum required height because of the amount of snow and ice that we see on the haul roads in the winter. Although road surfaces are constantly maintained with gravel and snow removal, the potential for equipment to slide while ascending or descending a ramp in the winter exists. The berms were built to ensure that haul trucks won't power over or travel through berms.

The berms at Climax along the haul roads are approximately 12' – 15' high. At the point of impact, the berm was approximately 13.5' high.

DETAILS OF INJURY TYPE:	Personal Illness				
POTENTIAL FOR INJURY:	Fatality	Lost Time	Permanent Disability	Other Potential	
	X				
PROBABLE DIRECT CAUSES:	Personal Illness				
IMMEDIATE CORRECTIVE ACTION:	<p>Truck was secured Personnel attended to the driver EMS personnel arrived and transported driver to the Hospital Scene was secured Haul Truck was taken to the shop Investigation was started</p>				
REQUIRED ACTIONS:	<p>Evaluate the size of the haul road berms and consider whether the minimum requirement is sufficient.</p> <p>The minimum required berm height for the Climax site is 6'. (30 CFR 56/57.9300(b)) The Climax Mine has intentionally built berms that are 2+ times greater than the</p>
