SAFETY ALERT NOTIFICATION

OPERATION:	Henderson Mill			Incident:	
ISSUED BY:	Phil Lawlor			Injury:	
DATE:	2/11/2015			Property Damage:	X
TIME:	1:05 a.m.			Process Loss:	X
LOCATION/DEPARTMENT:	Nokes Building Caustic Transfer - Operations				
INCIDENT DESCRIPTION:	<p>At the end of dayshift on February 10, 2015 a caustic transfer was completed. Flush water was left on and the caustic storage tank valve was not completely closed. This caused the caustic storage tank to overflow and flood both the Caustic and Nokes sides of the Nokes building with caustic solution.</p> <p>At 01:05 a.m. on Feb 11, MCC P1 tripped, caused by the Nokes building flooding. A 480V portable heater was plugged in, using an extension cord, to the temporary power outside the Nokes building (set up during building construction activities). The connection between the heater and the extension cord was lying on the floor of the Caustic building. When this was submerged it caused electricity to go to ground, tripping the MCC. The emergency generator power turned on at this point, re-energizing the Nokes building and the 480V extension cord. This hazard remained in place until the building power was isolated as part of

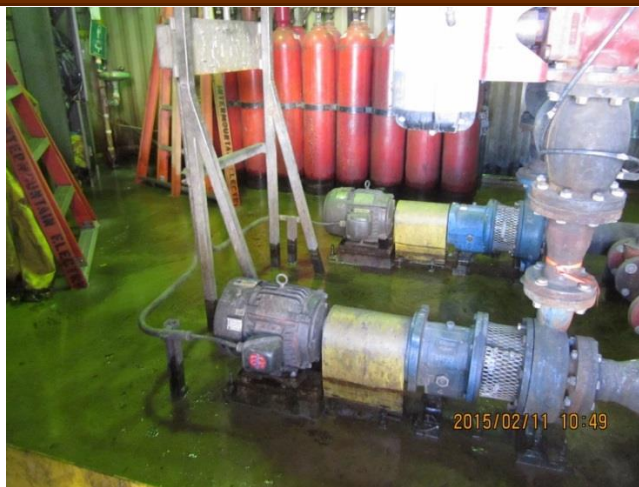
PROBABLE DIRECT CAUSES:	Failure to follow rule or procedure- The SOP for caustic transfer was not followed properly. Flush water was left on and caustic storage tank valve not closed completely. Inadequate Warning System - The High alarm was set to 100% so the alarm did not engage in the Mill Control room since the tank overflows before reaching alarm point.
IMMEDIATE CORRECTIVE ACTION:	<ul style="list-style-type: none">- The building power was isolated following LOTOTO procedures.- The material was pumped out of the building back into concentrator.- The emergency response team cleaned the building.- The Maintenance and electrical personnel inspected the building for any hazards or damage.
REQUIRED ACTIONS:	<ul style="list-style-type: none">- The team will perform a detailed review and improvement of the Caustic Transfer SOP- An Electrical review of the current Nokes Building Power supply will be completed to determine if any protection/safety upgrades are warranted.- A Root Cause Analysis will be completed.- FCX sites should verify there aren't non-rated power cords in locations vulnerable to being submerged.- FCX sites should verify that secondary containment is adequate for their designed application.- FCX sites should verify that alarm systems are set appropriately.

Flooded Caustic Building

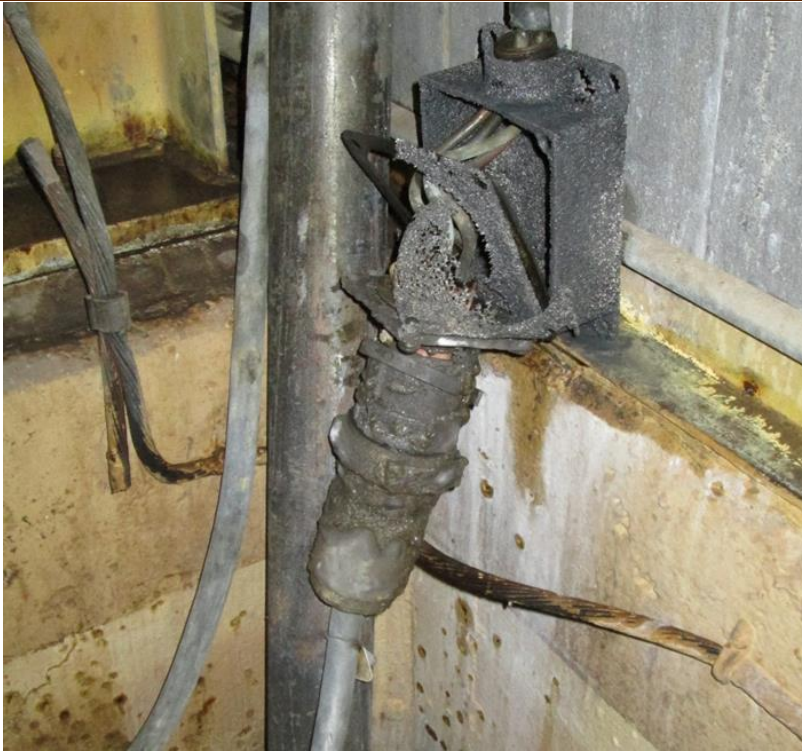
480V extension cord connection
