SAFETY ALERT NOTIFICATION

OPERATION:	Morenci		Incident:	
ISSUED BY:	Robert Chellini, Mgr Mine Planning Engineering		Injury:	
DATE:	5/11/2014		Property Damage:	X
TIME:	6:45PM		Process Loss:	
LOCATION/DEPARTMENT:	Morenci Mine			
INCIDENT DESCRIPTION:	<p>At 6:45PM on 11 May 2014 the Slope Stability Department was notified by the Mine Dispatchers that there was an alarm on the 200_WCP (Western Copper) IDS IBIS radar. This unit is located on the 5550 elevation on the western edge of Northwest Extension. This radar looks to the east and monitors high walls of the Western Copper Pit.</p> <p>Upon inspection it was found that the dust cover over the track, normally held in place by a bracket had come off of the bracket on one end and been pushed out of alignment by the radar unit as it tracked along the rail.</p> <p>It was determined that rubber isolators between the dust cover and accompanying bracket had deteriorated due to weathering causing the dust cover to dislodge. Normal scanning movement resulted in the dust cover becoming wedged against the rail preventing the system from operating.</p>

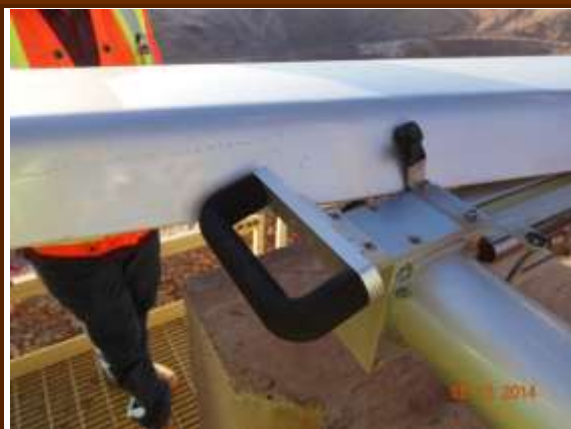
Deteriorated rubber cushion on bracket - Cover normally held in place by brackets, however was dislodged and pushed out of alignment as radar moved along track.

<p>The dust cover was removed and the unit placed back in service.</p> <p>The vendor shipped two brackets and the cover was replaced 14 May 2014.</p> <p>The other two radar units of this type in operation were inspected and it was determined that several brackets were deteriorating and also needed to be replaced.</p> <p>Additional brackets were shipped to site.</p>
<p>REQUIRED ACTIONS:</p>	<p>Checking these brackets has been included to the inspection schedule to make sure this type of incident does not reoccur.</p>

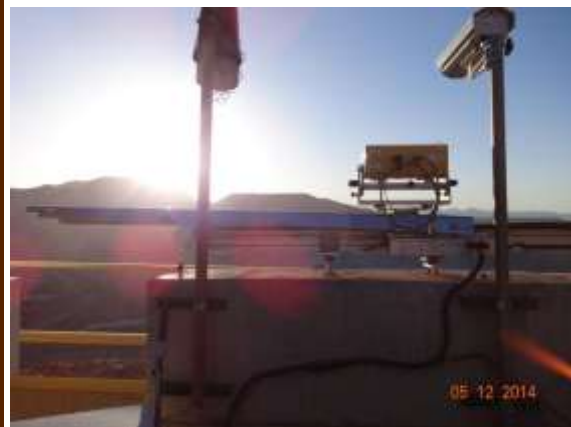
Cover moved out of alignment.
