SAFETY ALERT NOTIFICATION

OPERATION:	Freeport-McMoRan Morenci Operations			Incident:	X
ISSUED BY:	William Seibert, Mgr Fragmentation & Loading			Injury:	
DATE:	January 8 th 2014			Property Damage:	
TIME:	4:30pm			Process Loss:	
LOCATION/DEPARTMENT:	Mine Development / NW Ramp and LVA Intersection				
INCIDENT DESCRIPTION:	<p>A 777 haul truck (85 tons) was traveling north on the Dispatch haul road towards a ramp that is adjacent to the LVA (Light Vehicle Access) route. The driver of the 777 haul truck stated that he felt drowsy and began to drift the 777 haul truck towards the bottom entrance of the LVA. Two Jersey barriers were in place to separate the lanes of travel and to restrict larger pieces of equipment from entering the LVA road. As the 777 haul truck approached the intersection, the driver continued to drift to the left heading toward the LVA. Upon entering the LVA, the 777's right side tires hit the concrete barrier (breaking it in half) and waking the driver. The driver continued a short ways up the LVA and came to a stop. Just before the 777 entered the LVA, a loader operator traveling south and approximately halfway down the LVA saw the situation unfolding, immediately

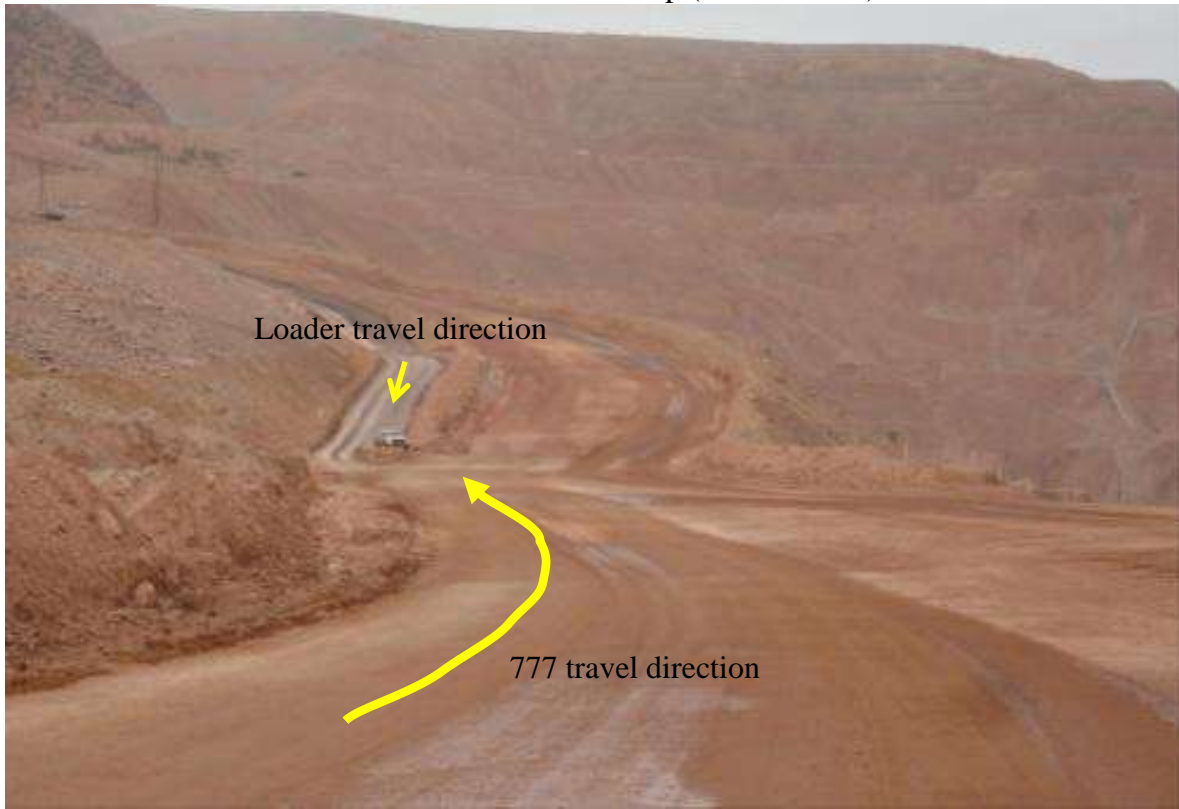
Base of the Northwest Ramp (LVA on Left)

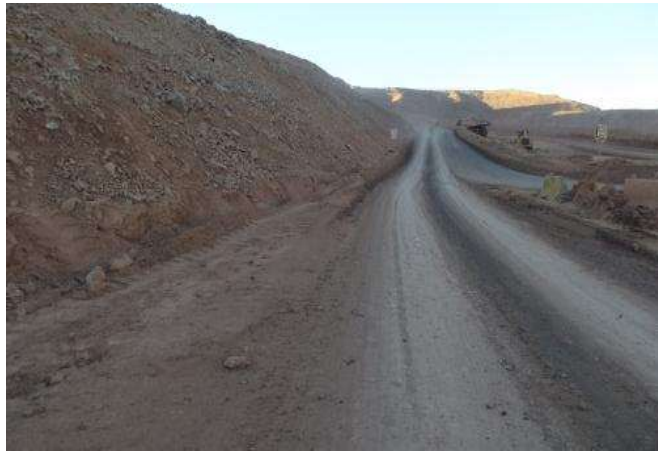
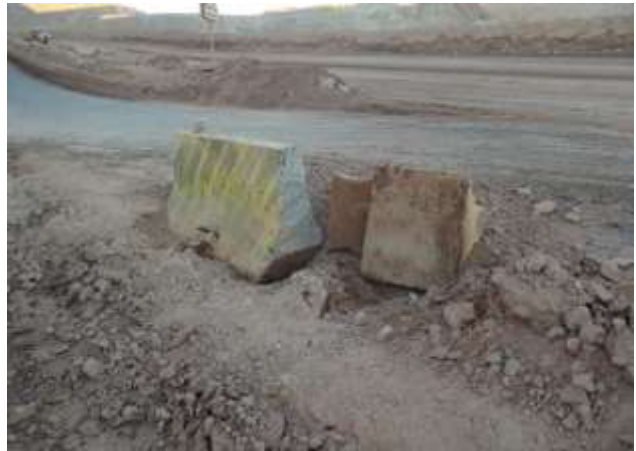
777 Travel path onto the LVA from the haul road / damaged barricade
