# SAFETY ALERT NOTIFICATION

<b>OPERATION:</b>	Henderson Mill			<b>Incident:</b>	
<b>ISSUED BY:</b>	Phil Lawlor			<b>Injury:</b>	
<b>DATE:</b>	2/11/2015			<b>Property Damage:</b>	<b>X</b>
<b>TIME:</b>	1:05 a.m.			<b>Process Loss:</b>	<b>X</b>
<b>LOCATION/DEPARTMENT:</b>	Nokes Building Caustic Transfer - Operations				
<b>INCIDENT DESCRIPTION:</b>	<p>At the end of dayshift on February 10, 2015 a caustic transfer was completed. Flush water was left on and the caustic storage tank valve was not completely closed. This caused the caustic storage tank to overflow and flood both the Caustic and Nokes sides of the Nokes building with caustic solution.</p> <p>At 01:05 a.m. on Feb 11, MCC P1 tripped, caused by the Nokes building flooding. A 480V portable heater was plugged in, using an extension cord, to the temporary power outside the Nokes building (set up during building construction activities). The connection between the heater and the extension cord was lying on the floor of the Caustic building. When this was submerged it caused electricity to go to ground, tripping the MCC. The emergency generator power turned on at this point, re-energizing the Nokes building and the 480V extension

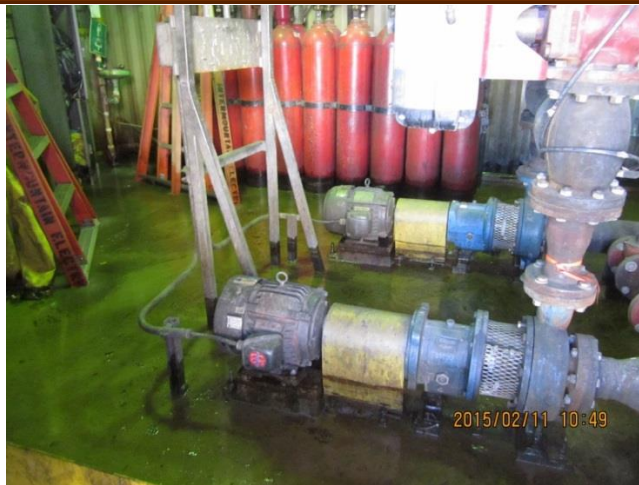
<b>PROBABLE DIRECT CAUSES:</b>	Failure to follow rule or procedure- The SOP for caustic transfer was not followed properly. Flush water was left on and caustic storage tank valve not closed completely. Inadequate Warning System - The High alarm was set to 100% so the alarm did not engage in the Mill Control room since the tank overflows before reaching alarm point.
<b>IMMEDIATE CORRECTIVE ACTION:</b>	<ul style="list-style-type: none"><li>- The building power was isolated following LOTOTO procedures.</li><li>- The material was pumped out of the building back into concentrator.</li><li>- The emergency response team cleaned the building.</li><li>- The Maintenance and electrical personnel inspected the building for any hazards or damage.</li></ul>
<b>REQUIRED ACTIONS:</b>	<ul style="list-style-type: none"><li>- The team will perform a detailed review and improvement of the Caustic Transfer SOP</li><li>- An Electrical review of the current Nokes Building Power supply will be completed to determine if any protection/safety upgrades are warranted.</li><li>- A Root Cause Analysis will be completed.</li><li>- FCX sites should verify there aren't non-rated power cords in locations vulnerable to being submerged.</li><li>- FCX sites should verify that secondary containment is adequate for their designed application.</li><li>- FCX sites should verify that alarm systems are set appropriately.</li></ul>

**Flooded Caustic Building**

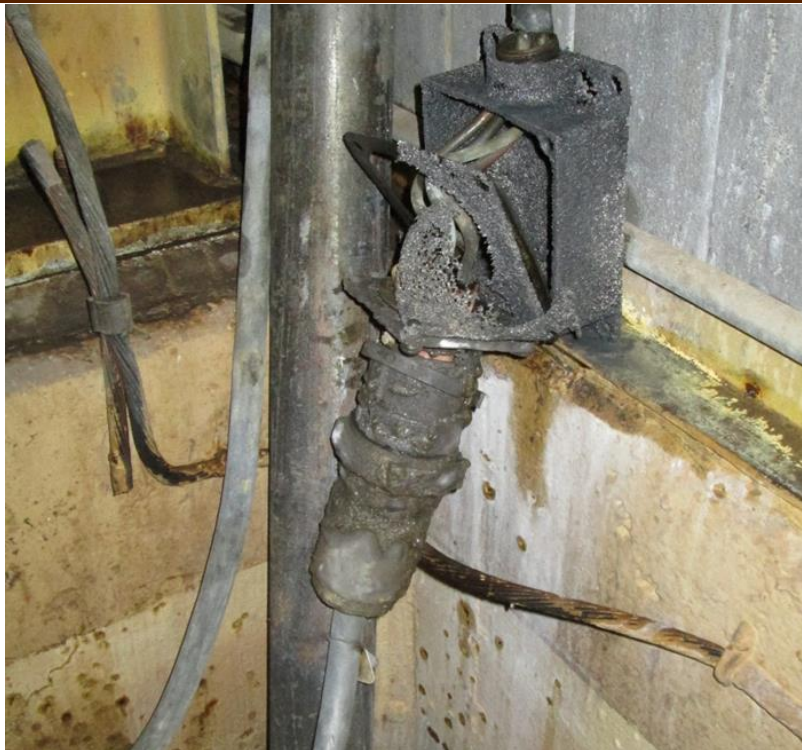
**480V extension cord connection**
