SAFETY ALERT NOTIFICATION

OPERATION:	El Paso Operations			Incident:	
ISSUED BY:	Dale Gossett / Health and Safety Manager			Injury:	
DATE:	4/9/14			Property Damage:	X
TIME:	11:00 am			Process Loss:	X
LOCATION/DEPARTMENT:	El Paso Refinery Tankhouse				
INCIDENT DESCRIPTION:	On 3/30/14, at approximately 5:15 pm, the El Paso Refinery experienced an arc flash event in the tankhouse on top of one of the refining cells. Cell #26 on Section 11 on 3 had been cut out for repair. At the time of the event this tank had been out of service for 84 days. When a tank is taken out of service for repair, copper bars are put in place over the tank to complete the circuit so electro refining can continue. With the bars being in place for so long the contact points became dirty and were no longer making sufficient contact to carry the current and the tank buss bar began to arc. There were no employees working in or travelling through this section of the Tank house at the time of the event. El Paso's rectifiers are designed to detect this type of event when it happens and quickly shutdown when arcing started. There were no injuries, but there was a process loss of about 30 minutes, and some damage to t

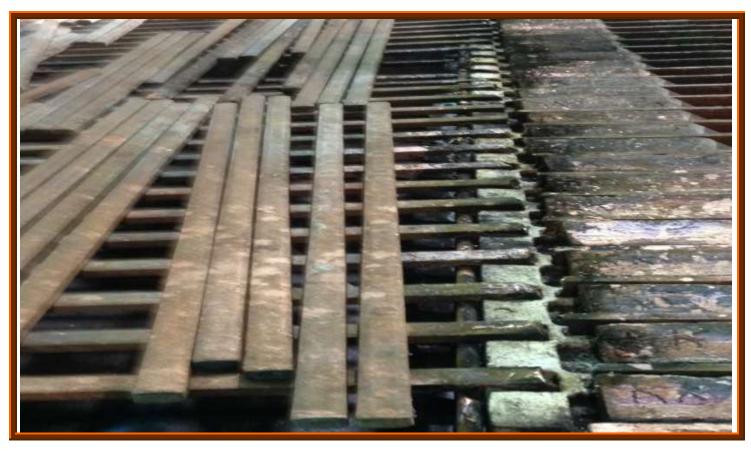
DETAILS OF INJURY TYPE:	No Injuries				
POTENTIAL FOR INJURY:	Fatality	Lost Time	Permanent Disability	Other Potent	ial
				Potential for First	st Aid
PROBABLE DIRECT CAUSES:	Dirty contacts between copper bars installed over cell, and contact points allowed arcing to start.				
IMMEDIATE CORRECTIVE ACTION:	The area was observed; the contacts and suspension bars were cleaned and put back into place. The rectifier was re-energized.				
REQUIRED ACTIONS:	 Procedure was updated to ensure that the buss/bars will be cleaned and put back into place every 28 days going forward. This will be communicated and documented. Review current energy control procedures with subject matter experts to identify best practice for these types of events. Maintenance team will use thermography to observe tanks that are out of production and take readings/notes on how they are performing. If problems are found (heating) they will be corrected. Refinery will look into better ways to take a cell out of service, such as a cut out bridge like is used in some FMI EW's. Refinery will communicate with and benchmark other refineries with similar processes to identify current practices. EW's will also be reviewed but it should be noted that while similar in some ways, the two processes are different.
