POTENTIAL FATAL EVENT ADVISORY		PFE #	PFE – 2017 - 12
		IMS #	78885
 	PTFI - Dewatering Plant Dryer Structure Collapse	OPERATION:	PTFI DWP Ops.
		INCIDENT DATE:	7/27/2017
		TIME:	10:35
		TYPE:	Injury
		PFE Follow-Up:	
Issued By: George Marges, Sr. Manager DWP Ops. & Pipeline Mtc.		Contact For Additional Details: gmarges@fmi.com ; +62 901469363

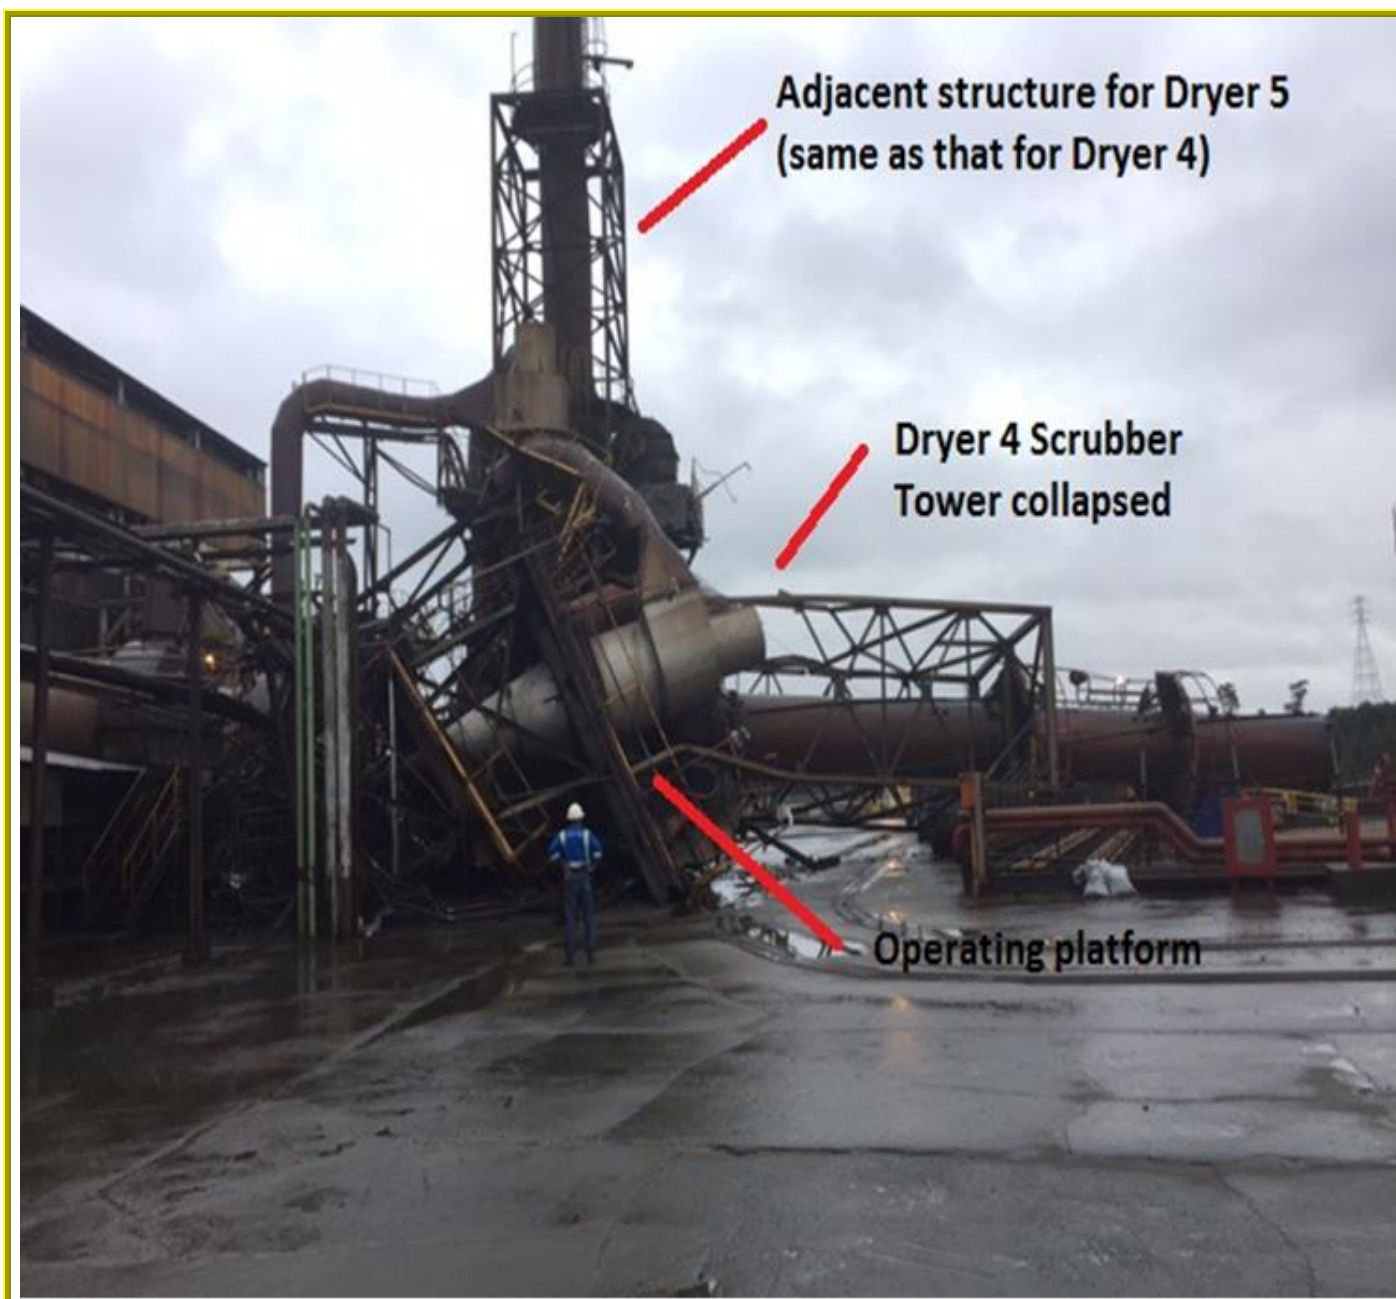
On 10:35pm on Thursday 27th July, 2017 the structure supporting the scrubber unit on Dryer No.4 at the Dewatering Plant (DWP) at Portsie collapsed. There were 2 workers from operations on the fan level permanent working platform (approx. 7 meters above ground level) checking the leaking spray water pipe at the time of the collapse. The structure fell over slowly and the workers were able to hold the hand railings to prevent them falling to the ground. One worker sustained cuts to his head due to contact with the structure, the other worker was not injured. He was evacuated to hospital and is currently undergoing observation. Both workers were wearing appropriate PPE for the task. There were actually two other workers standing at the collapse drop point, but they managed to escape when the accident occurred.

- Building structure integrity risk was not analyzed and rated properly.
- Inadequate risk monitoring system as part of current corrosion remediation program.

Adjacent structure for Dryer 5
(same as that for Dryer 4)

Dryer 4 Scrubber
Tower collapsed

Operating platform
