E FREEPORT- MCMoRAN		
		Safety Alert #	SA – 2016 - 10	
	SAFETY ALERT NOTIFICATION		N/A	
			External	
	Valve Failure (External Company)	INCIDENT DATE:	12/6/2016	
		TIME:		
		TYPE:	Injury	
Issued By: DOHS	Contact For Additional Det	Contact For Additional Details: Mitch Kruger or Steven Richardson

INCIDENT DESCRIPTION

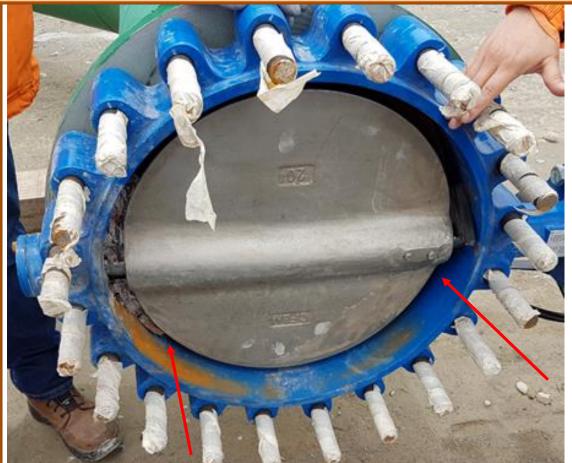
- A key issue was confusion regarding the pressure ratings and naming conventions of butterfly valves. The valve that failed was a rubber-seated butterfly valve with a pressure rating of 150 psi. However, the valve that had been specified was an "ANSI/ASME Class 150" valve, which would have had a pressure rating up to 275 psi. It is often common-place for both of these valves to be generically referred to as "150-pound valves", which can easily lead to confusion regarding the distinction between the two classifications.

- The end-point butterfly valve was a lug-type and was installed without a down-stream flange. While some valve manufacturers allow this type of installation indefinitely without affecting the pressure rating, others stipulate a reduced pressure rating in absence of a downstream flange. The failed valve was a rubber-seated butterfly valve that requires the installation of a downstream flange. Without the downstream flange to secure the seal, the rubber seat material failed and broke free from the valve body, leaving a gap between the metal valve body and the butterfly disk.

High-velocity water jetted out from around the perimeter of the disk and impacted the individual, causing fatal injuries.

Figure 1 Las Bambas valve involved in the incident. The rubber seat material failed and broke free, leaving a gap between the metal valve body and the butterfly disk.

- Ensure applicable employees understand the design specifications of the valves they operate and maintain (reference materials/photos are included below).
- Sites should evaluate isolation practices to ensure employees performing maintenance on equipment understand the critical controls required to perform work safely.
- Verify that valves are installed according to manufacturer specifications.
