SAFETY ALERT NOTIFICATION		Safety Alert #	SA – 2017 - 10

<h2 style="margin: 0;">Air Cannon Fires During Chute Inspection</h2>		IMS #	77618
		OPERATION:	Morenci
		INCIDENT DATE:	6/2/2017
		TIME:	8:00
		TYPE:	Injury
Issued By: Tim Messick (tmessick@fmi.com)		Contact For Additional Details: Kyle Silvester (ksilveste@fmi.com)

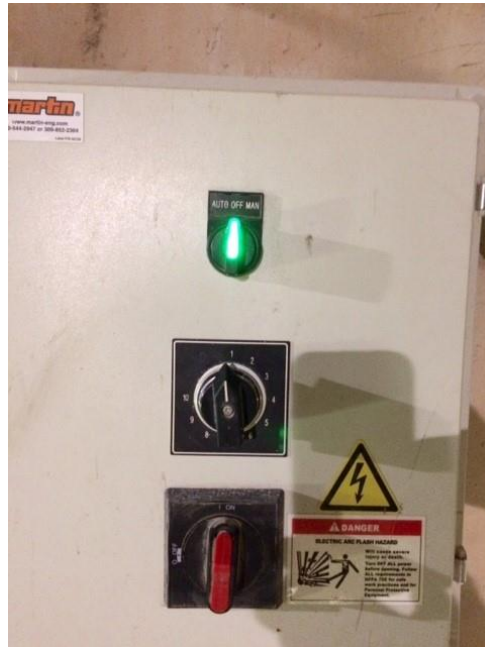
Photo 1
Martin Air Cannon Controller

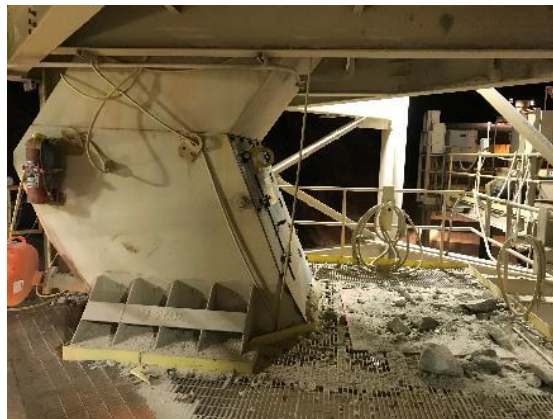
Photo 2
Chute being inspected. Chute contains a total of six air cannons, however it is uncertain which one fired first. An air cannon can be seen to left of photo.

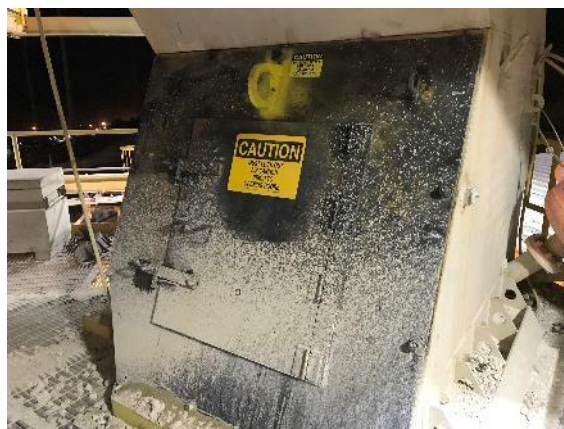
Photo 3
Inspection chute door with air cannon on right side.

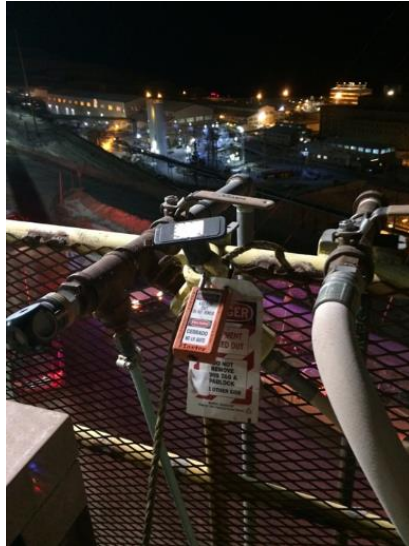
Photo 4
In-line Lockout Valve with employee lock.

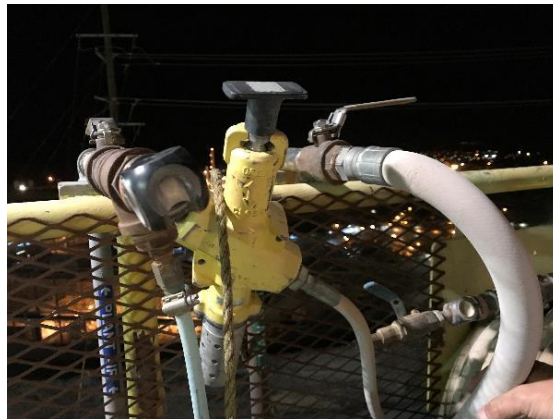
Photo 5
Norgren In-line Lockout Valve - Plunger Knob on top / bleed off on bottom

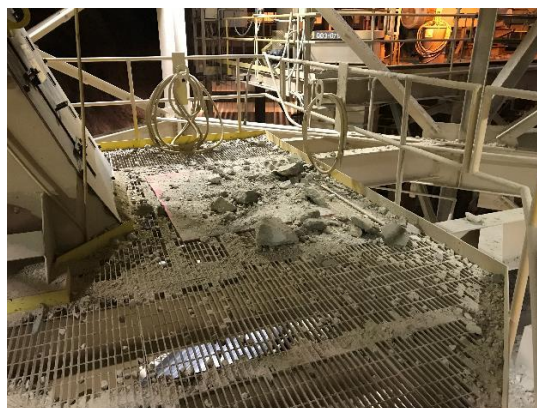
Photo 6
Floor in front of chute was clean prior to incident according to employee. Debris is dead bed material.
