SAFETY ALERT NOTIFICATION		Safety Alert #	SA – 2017 - 11
  Bagdad Broken Socket, Mill Maintenance		IMS #	78529
		OPERATION:	Mill Maintenance
		INCIDENT DATE:	7/12/2017
		TIME:	9:45 am
		TYPE:	Injury
Issued By: John Melfi		Contact For Additional Details: jmelfi@fmi.com (928) 925-8203

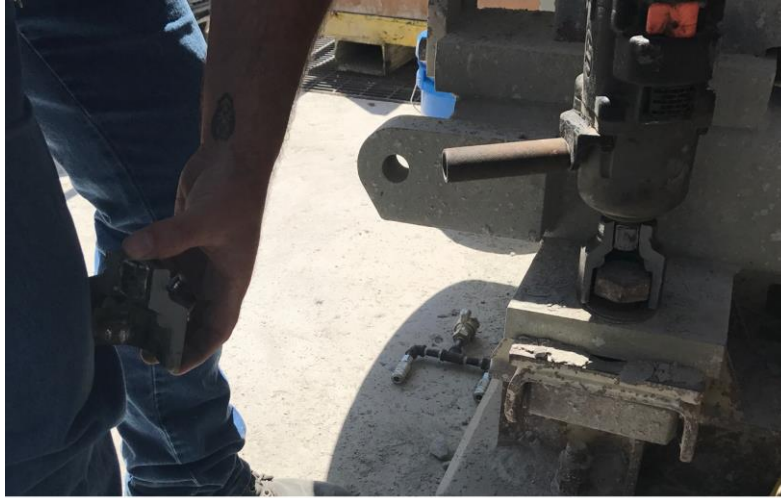
- **Use of defective (cracked) and wrong sized socket for the job.**

Photo showing 1-inch impact with broke 2-3/8" socket.
Broken piece flew apart striking employee in the knee.

- **Re-inspect tools for safety defects.**
- **Communicate the use of proper tools, inspection and associated safe guards.**

- Verify tools are effectively removed from service when safety deficiencies are identified.
- Communicate investigation finding to all employees.

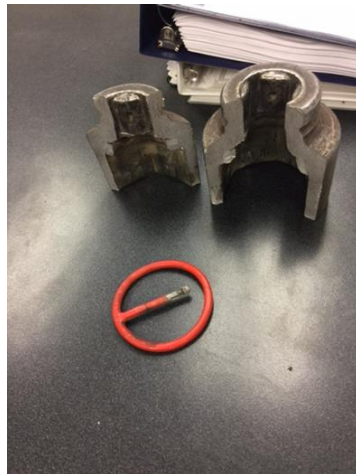
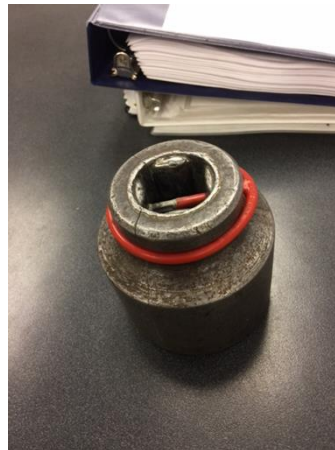
Upon further investigation it was identified the socket was the wrong size for the job (should have used a 2-1/4 inch socket) and a keeper ring was not used in this process.

Photos showing the broken socket after the accident
and a red keeper ring which should have been used
as a best practice.
