SAFETY ALERT NOTIFICATION		Safety Alert #	SA – 2017 - 14
 	<h2>Bagdad Mine Operations</h2>	IMS #	78837
		OPERATION:	Bagdad
		INCIDENT DATE:	7/25/2017
		TIME:	21:50
		TYPE:	Near Miss HEHI Event
Issued By: Lloyd Murphy Sr. Health & Safety Specialist		Contact For Additional Details: (928) 925-8204

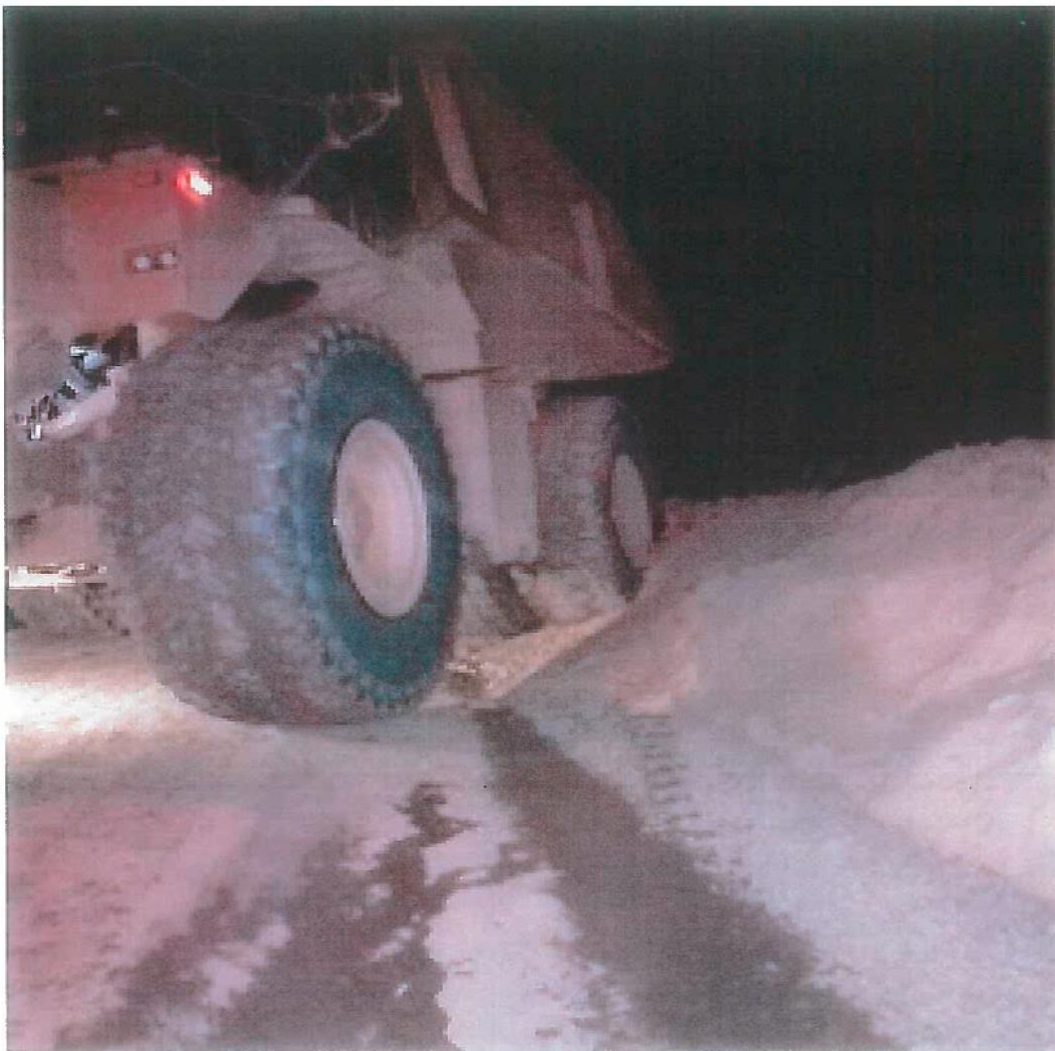
On Monday night shift at approximately 21:50 the driver of a loaded haul truck #216 (HT-216) reported that the engine had stalled out on the ramp above S-22. The maintenance supervisor instructed the driver to set his park brake, restart the truck and proceed to the tie down. The HT-216 operator successfully re-started the truck and proceeded up the ramp when a second shut down occurred. The operator went through the process of re-starting the engine and continued up the ramp when a third shut down occurred. The driver encountered problems when again attempting to restart the engine; the truck rolled backwards approximately 30 feet into the berm and stopped.

- Bad wiring harness
- Failure to set park brake upon restart
- Procedures in place to inspect and restart a downed haul truck on a ramp that required the utilization of a safety berm had not been implemented.

Picture: Haul Truck Final Location

- If a haul truck stalls on flat level ground, it must be properly secured and wait for mechanics after the second event.
- On ramps equipment must be properly secured (safety berm installed), not moved after the first event, and only then moved after a mechanic has evaluated the cause.
