## SAFETY ALERT NOTIFICATION

### Bagdad - Shovel Cable Reel Unloading

Safety Alert #	SA - 2017 - 16
IMS #	79086
OPERATION:	GSC Warehouse
INCIDENT DATE:	8/7/2017
TIME:	8:50 am
TYPE:	Property Damage HEHI

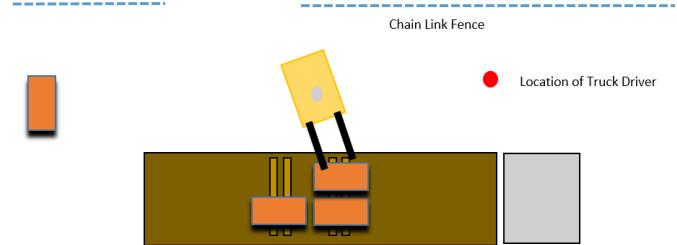
Diagram 1:  
Picture of  
forklift and  
driver location  
prior to event.

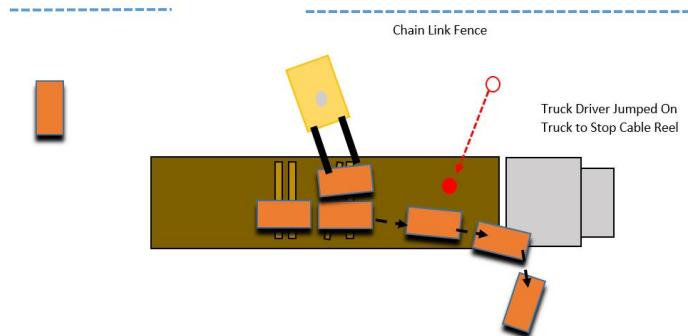
Diagram 2:  
Picture depiction  
of driver jumping  
on flatbed trying  
to stop reel from  
rolling off.

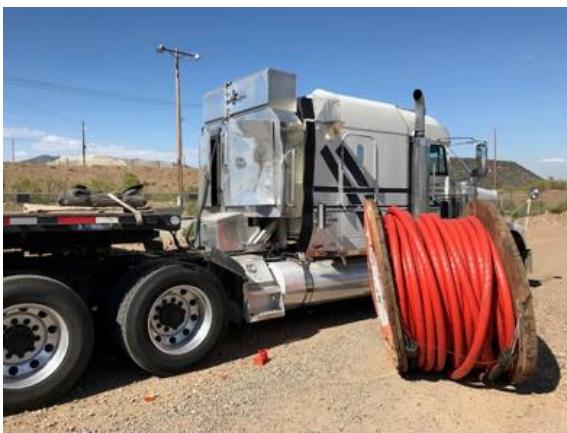
Picture 1: Final location of shovel cable reel.

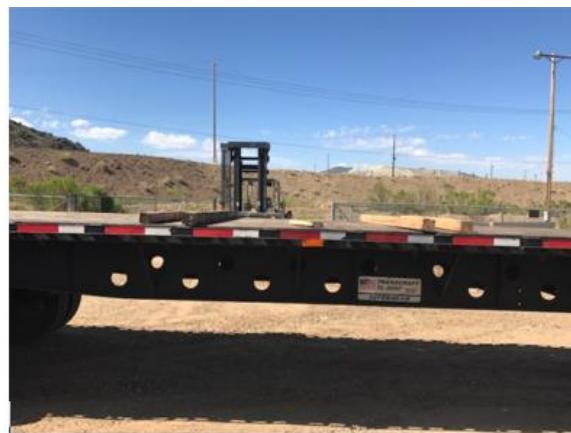
- Inexperienced forklift operator.
- Inadequate evaluation of risks associated with unloading of shovel cable reels.
- Improper cribbing of load. Originally the truck driver had the cable reels on a lowboy trailer; however, reloaded prior to delivery to a normal flatbed. Typically the cribbing is set immediately adjacent to the cable reels to prevent them from rolling. In this case the driver set the cable reels directly on the cribbing; however, the cable reels were not in contact with the flatbed itself.
- Lack of clearance to perform the task. Proximity of chain link fence restricted the movements of the forklift operator; the forklift operator failed to ask the truck driver to reposition the vehicle prior to unloading.

Picture 2: Actual cribbing spacing. The cable reels were setting on the wood 4x4's and were not in contact with flatbed.

- Identify correct shipping and receiving criteria. This will identify the correct load securement methods and Positioning of cribbing.
- Review and implement formalized procedure for unloading cable reels or other similar items.
