SAFETY ALERT NOTIFICATION		Safety Alert #	SA – 2017 - 9

<h2>Chino EW Electric Shock</h2>	IMS #	77255
		OPERATION:	Chino Hydromet
		INCIDENT DATE:	5/21/2017
		TIME:	16:00
		TYPE:	Injury
Issued By: Rex Burgener		Contact For Additional Details: Rex Burgener

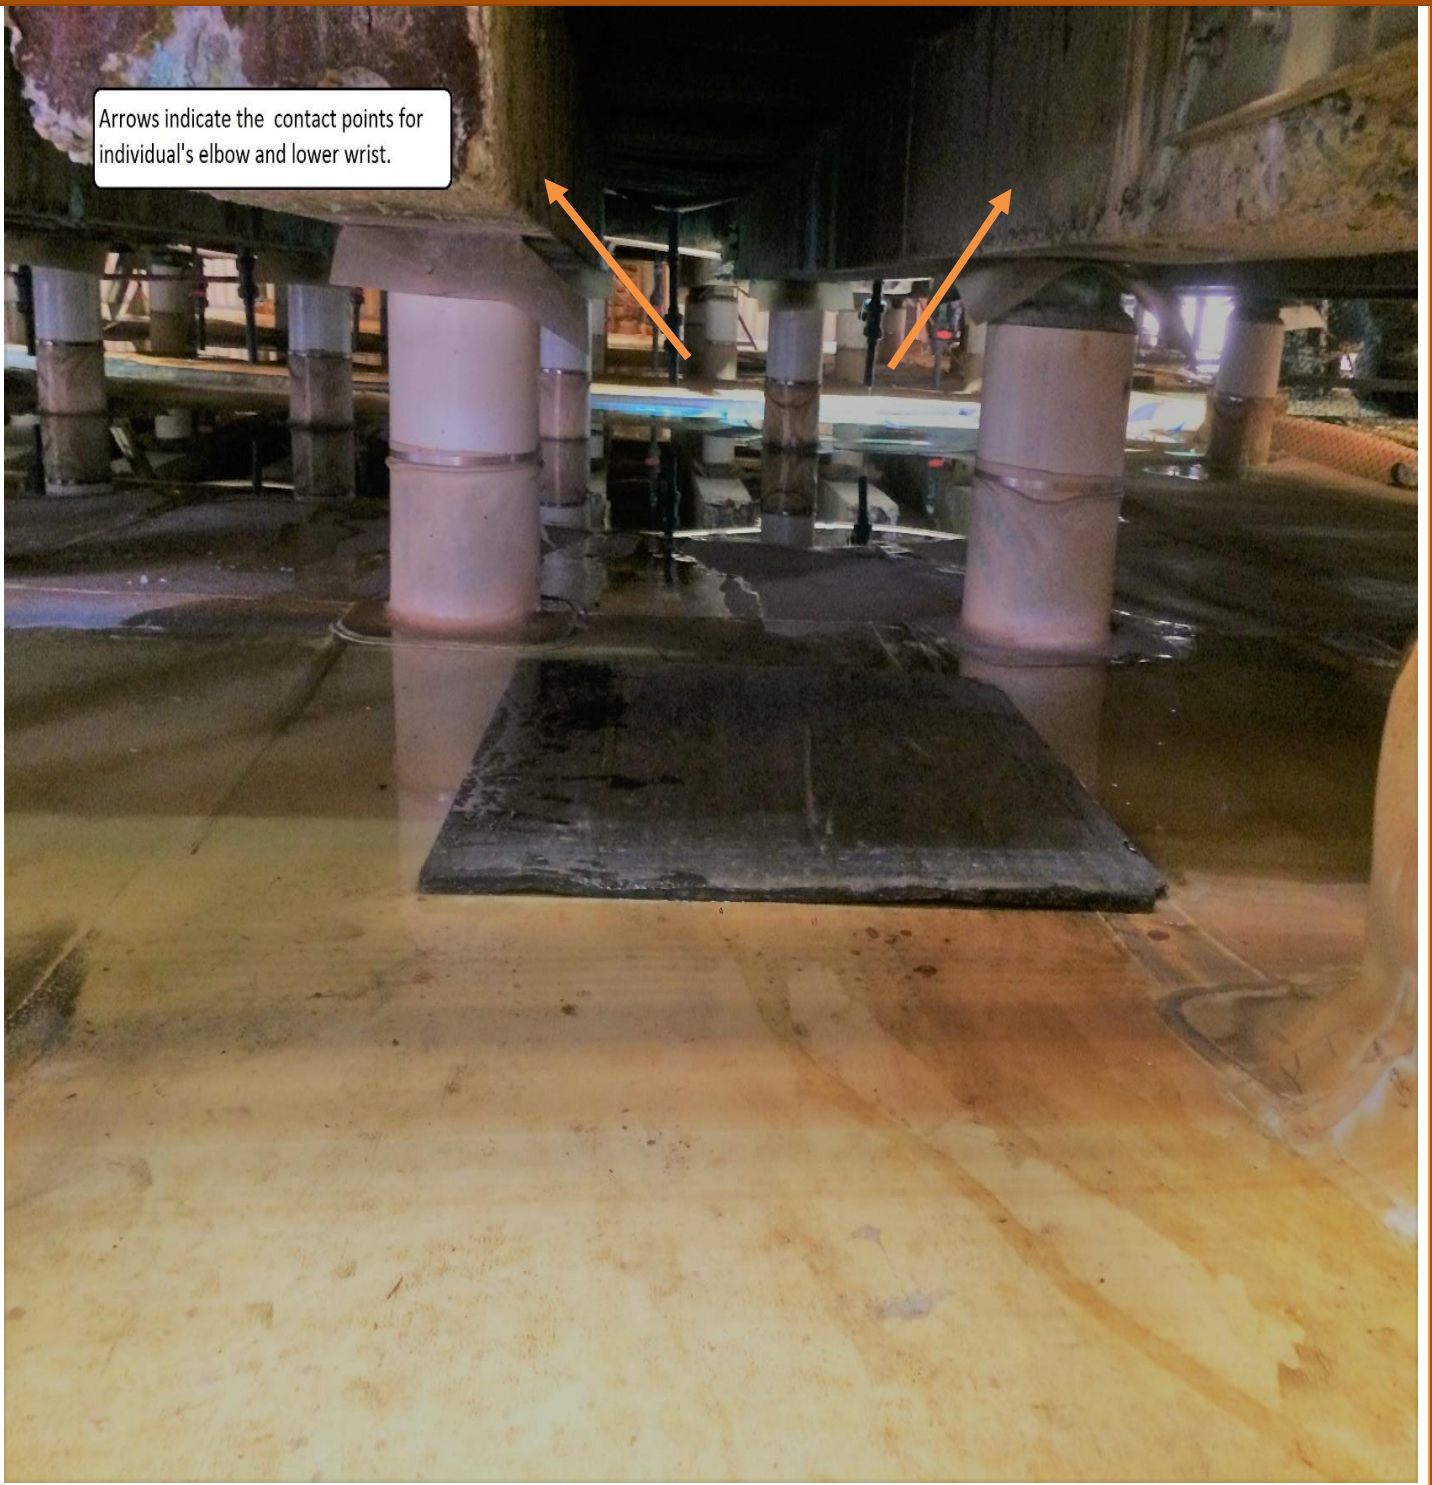
Arrows indicate the contact points for individual's elbow and lower wrist.
