SAFETY ALERT NOTIFICATION	Safety Alert #	SA – 2016 - 7
	IMS #	72360
Track Dozer identified booster in push material	OPERATION:	Morenci
	INCIDENT DATE:	10/20/2016
	TIME:	Approx 10:00 am
	TYPE:	Near Miss
Issued By: Trish Roberson – Superintendent of Mine Operations Fragmentation	Contact For Additional Details: 928-865-7442

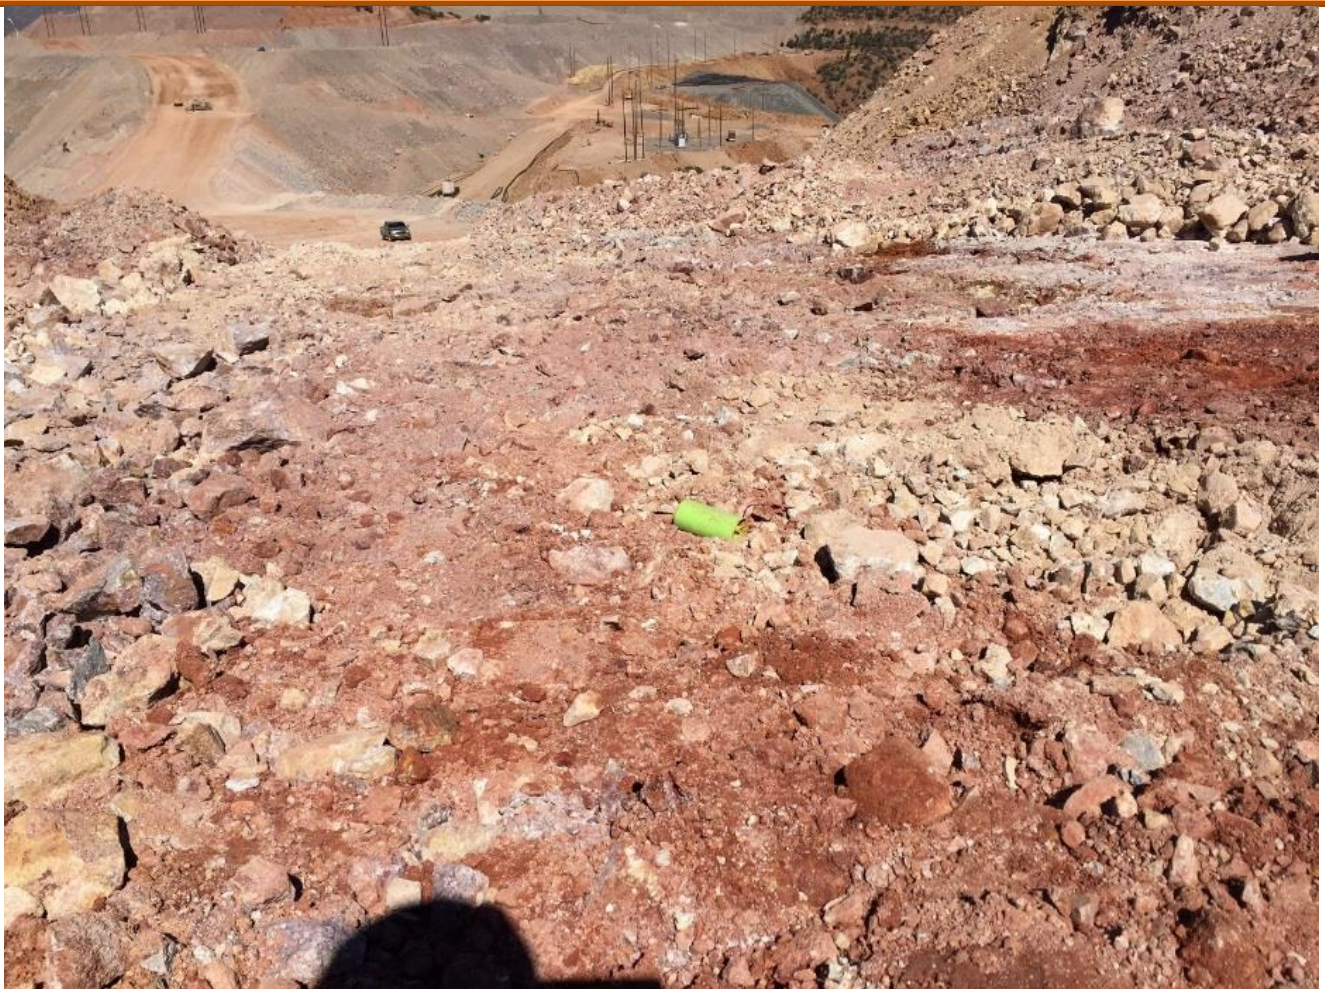
On the morning of 10/20/16, a track dozer was pushing material down to construct a ramp. When the operator looked behind him to start backing up, he saw a 1 lb booster that still had an I-Kon and Excel detonator inside. The employee immediately contacted his supervisor and the blasting crew and the area was evacuated of personnel and equipment. Morenci Blasting secured the booster and detonators.

Booster found in work area

1. Blasting coordinated with Operation to clear all equipment from the area to outside of the 500' clearing radius and all personnel to outside the 1500' clearing radius.
2. Morenci D&B worked with SWE and Orica to determine the cause of this I-Kon failure by safely returning the detonator to the manufacturer for analysis.

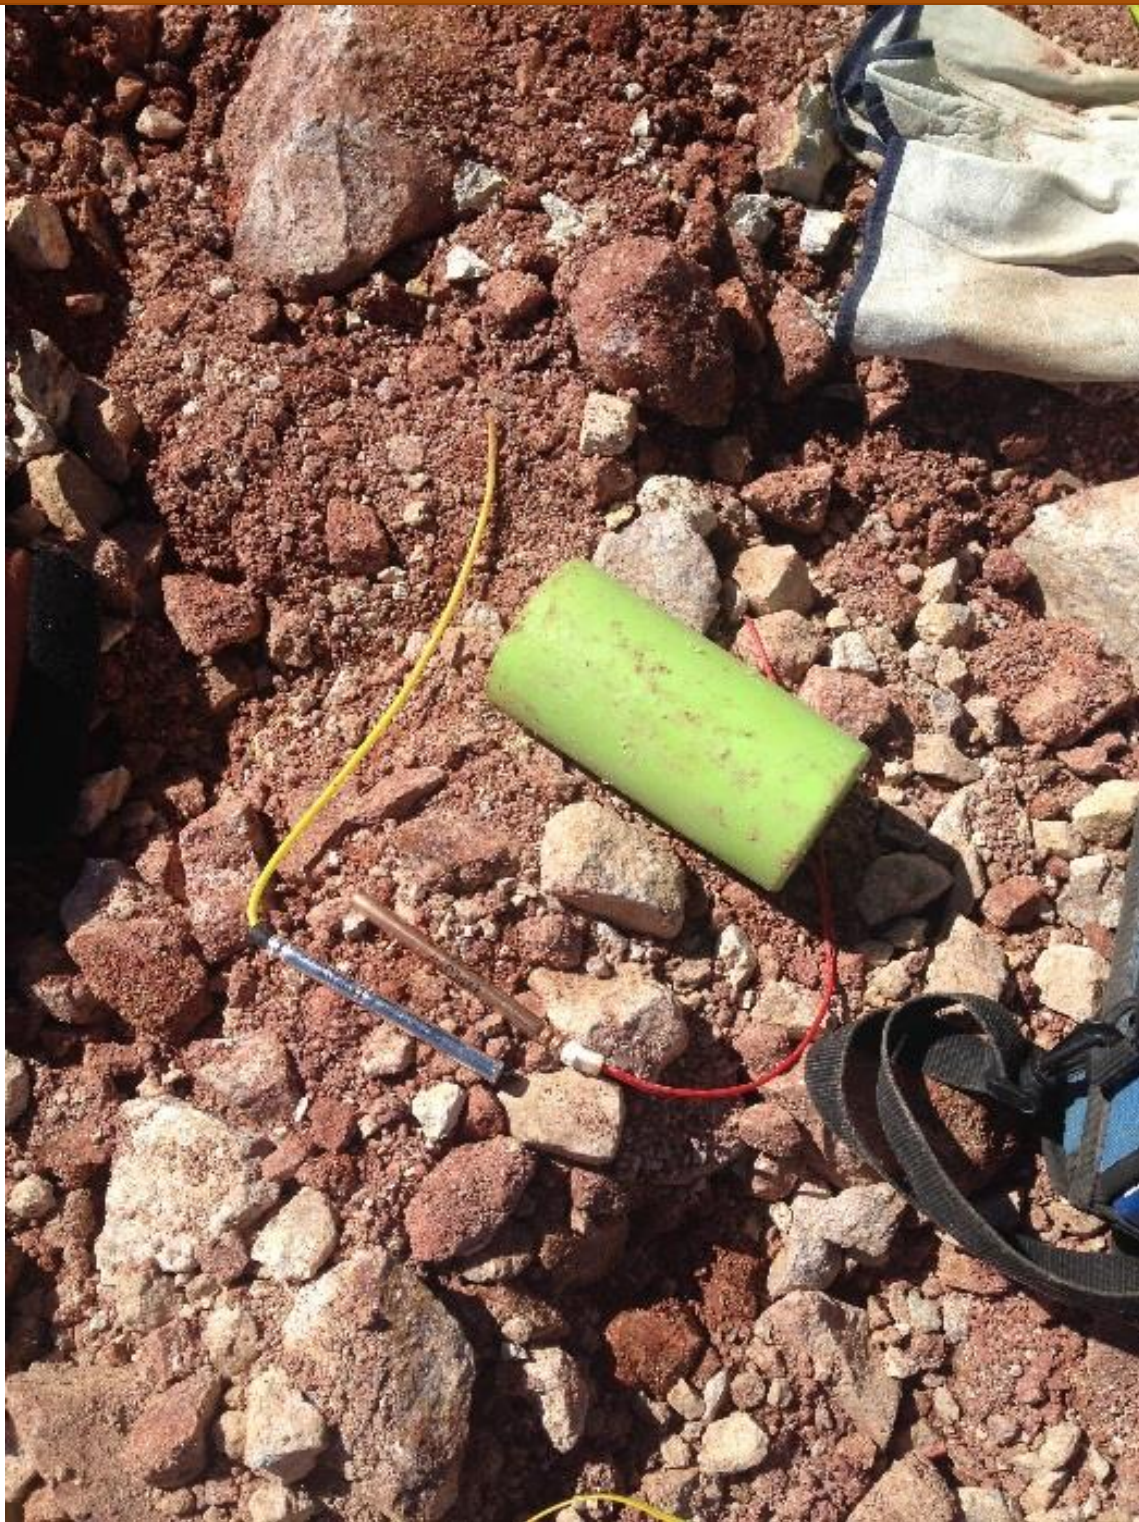
The booster and detonators did not show any signs of damage or deformation. The I-Kon detonator was connected to a blast logger and the detonator ID was obtained. A 'Fuse Head Error' (rendering the detonator unable to fire) was identified by the blast logger as well. The I-Kon detonator was removed from the booster and was secured in the field magazine for analysis. The remaining recovered products were successfully destroyed later that same day.

The I-Kon detonator returned a 'Fuse Head Error' after being rehooked to the logger. A 'Fuse Head Error' is a product issue in which the Fuse Head detaches from the circuit board. Discussion was held with SWE and was advised to save the I-Kon detonator if possible for return to the manufacturer. Both detonators were safely and easily removed from the booster as the booster was not deformed or damaged. The I-Kon detonator was returned to Orica for analysis.

The final determination from Orica was that the detonator failed to fire due to a broken/intermittent bridge wire on the fuse head that may have dislodged or broke during the initiation of the blast. This is a very rare manufacturing defect due to the rigid controls that Orica uses in their process. This particular detonator was traced back to the original manufacturing lot and production records were checked. There were no noted issues in the production records.

Recovered Booster with i-Kon Detonator and Non-Electric Detonator removed

1. Emphasize the importance of vigilance when working in broken material. All tests and checks showed that the I-Kon successfully fired and Morenci D&B had no indications of an issue. Personnel should always be aware of their surroundings and watching when working in broken material.
2. Report any I-Kon issues to Orica and return detonator, if safely possible, for analysis and further improvement.
